# Long-Term Effects of Electrochemical Chloride Extraction on Laboratory Specimens and Concrete Bridge Components

PUBLICATION NO. FHWA-HRT-10-069

SEPTEMBER 2011

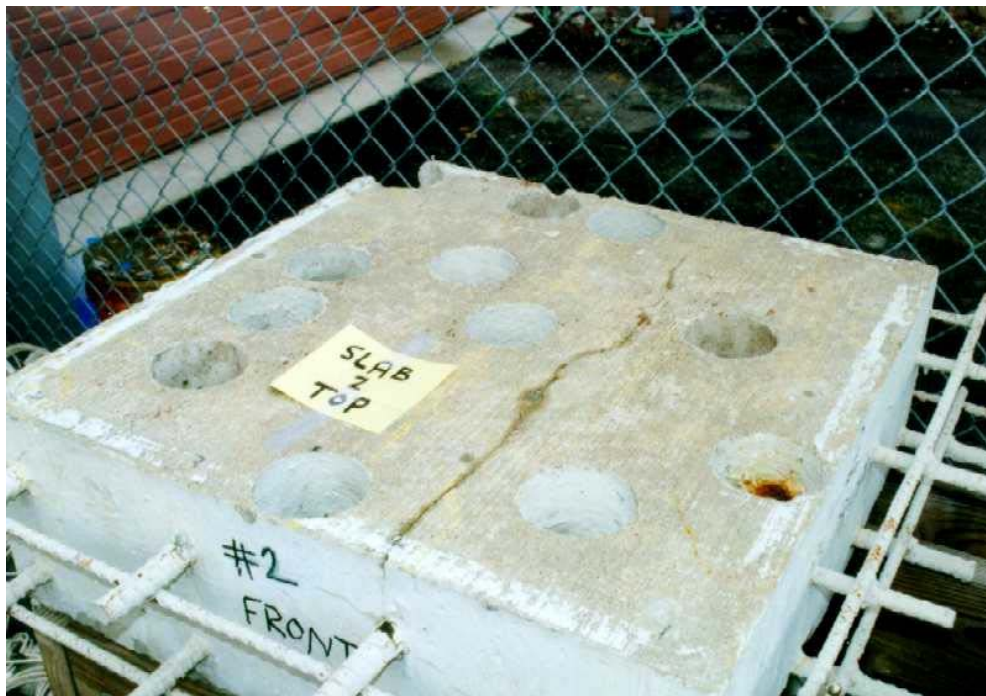
**Figure 8. Photo. Corrosion on the ends of rebars exposed in core holes of slab 2.**

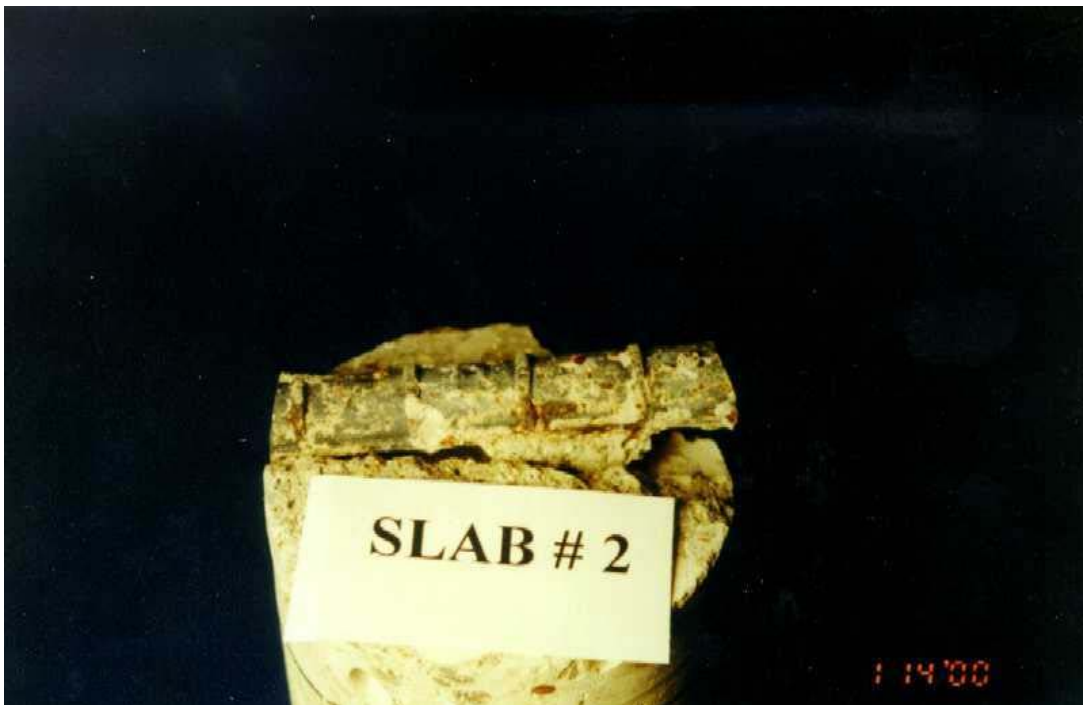
Delaminations detected on the surface of the slab increased, and by the end of the study, approximately 66 percent of the slab surface was delaminated. The presence of the crack along the rebar, cracks in the core holes, and cracks on the sides of the slab correlated with the delaminations that were detected. An autopsy of the single core collected from the slab in December 1999 indicated ongoing corrosion in localized areas of the extracted rebar. Expansive corrosion is shown figure 10.

**Figure 10. Photo. Autopsy of core extracted from slab 2 in December 1999.**

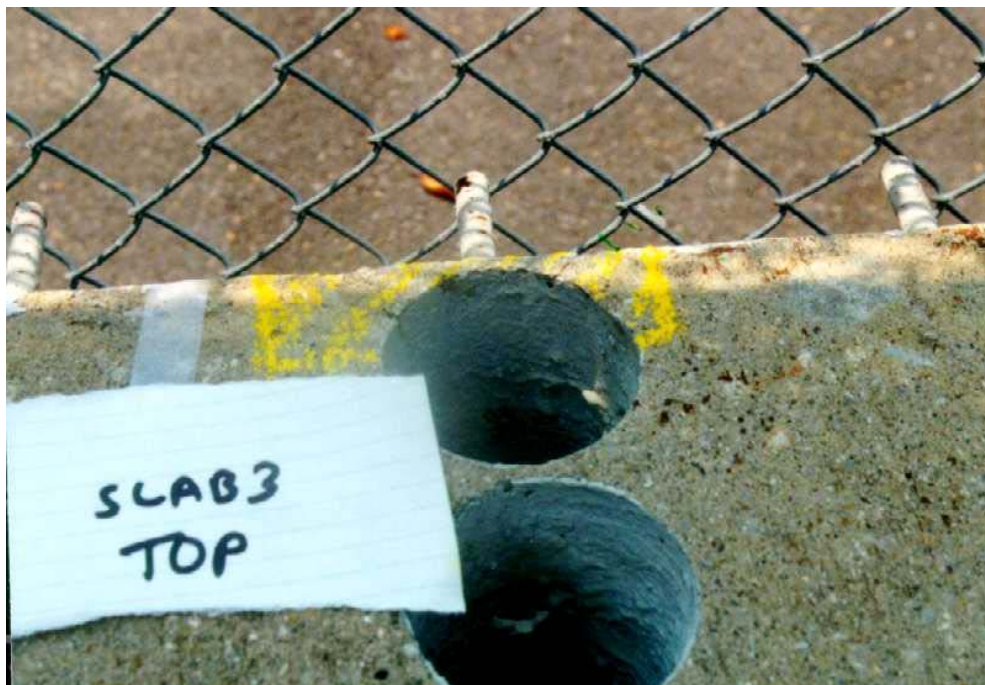
Figure 13. Photo. Delamination (marked in yellow) found on the top surface of slab 3.

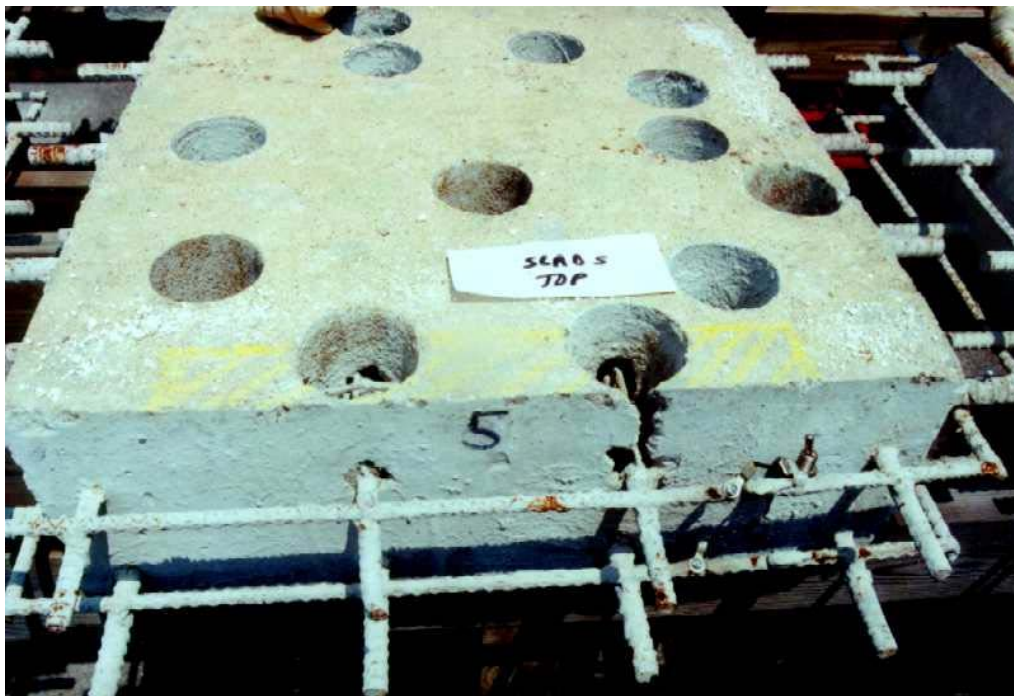
**Figure 17. Photo. Delaminations (marked in yellow) and concrete failure near a core hole on slab 5.**

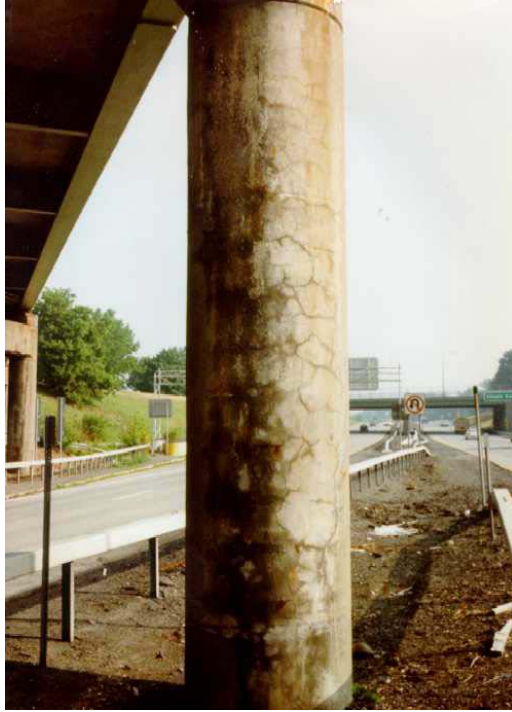
During the first visit, patched areas on all columns were identified, and cracks were observed in all patched areas (see figure 37). A majority of cracks in patched areas were considered to be shrinkage cracks and did not exhibit signs of ongoing corrosion. During the second trip, a significant increase in cracking was observed, and many of the cracks inside and outside patched areas exhibited rust staining (see figure 38 through figure 40). Further increases in cracking and rust staining were observed during the third visit. Total cumulative crack length for cracks outside patched areas is presented in table 5.

**Figure 37. Photo. Cracking on the patched areas on one of the columns of the Campus Loop Bridge in Albany, NY, during the first evaluation in 1995.**

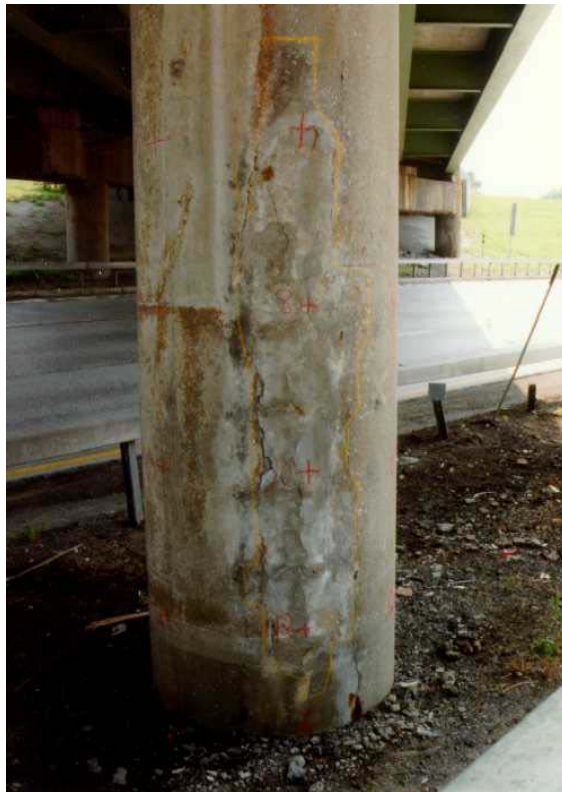
**Figure 38. Photo. First view of cracks and rust staining in patched and nonpatched areas of the columns of the Campus Loop Bridge in Albany, NY, during the second visit in 1996.**

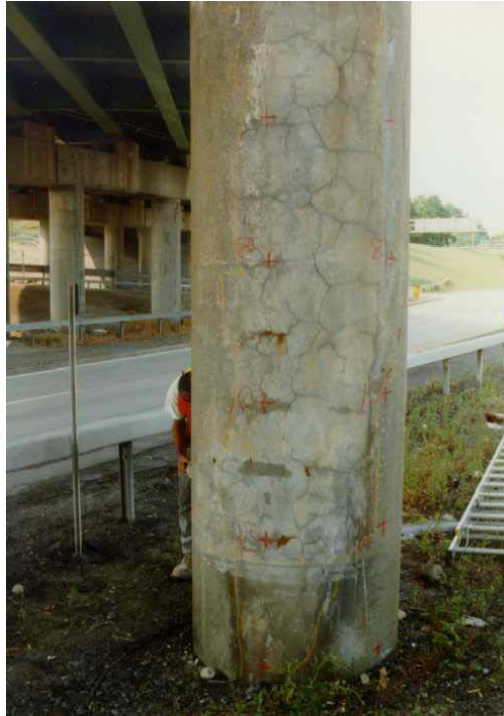
**Figure 39. Photo. Second view of cracks and rust staining in patched and nonpatched areas of the columns of the Campus Loop Bridge in Albany, NY, during the second visit in 1996.**

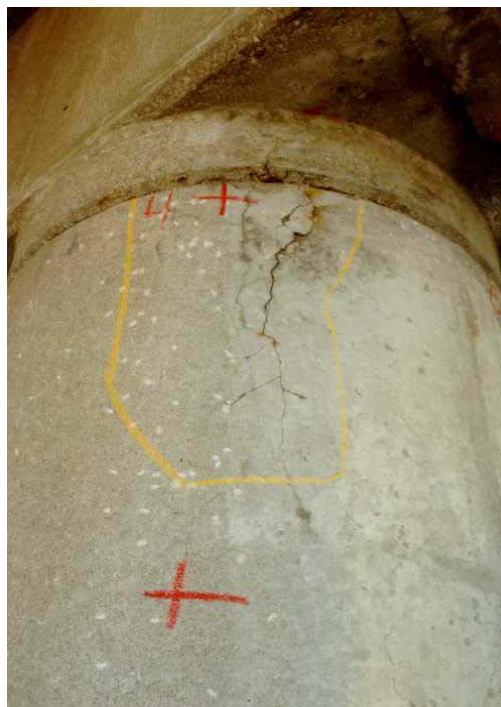
**Figure 40. Photo. Cracks and rust staining in a nonpatched area of a column of the Campus Loop Bridge in Albany, NY, during the second visit in 1996.**

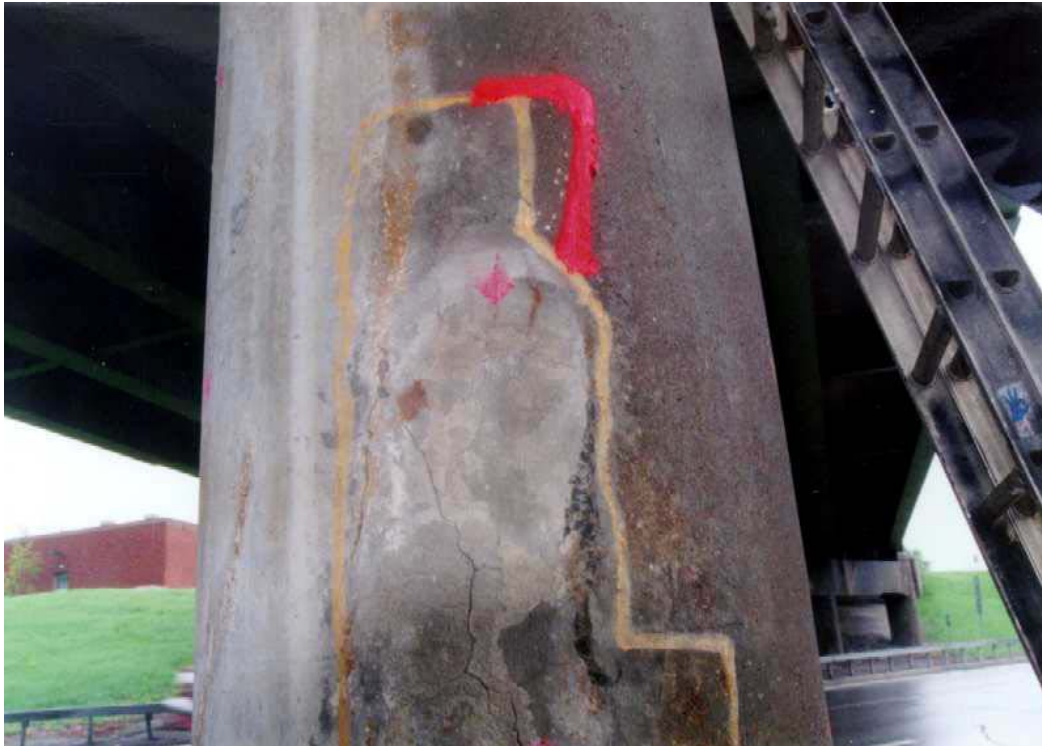
A delamination survey was performed on each column during each evaluation. By 1995, all patches on all columns were completely delaminated (see figure 42 through figure 44). In 1996, delaminations extended from the patches into the original concrete. Delaminations not associated with any patches were also detected. Cumulative percent delaminations as a function of time are presented in table 6.

**Figure 42. Photo. First view of a completely delaminated patch (marked in yellow) on a column of the Campus Loop Bridge in Albany, NY.**

**Figure 43. Photo. Second view of a completely delaminated patch (marked in yellow) on a column of the Campus Loop Bridge in Albany, NY.**

**Figure 44. Photo. Third view of a completely delaminated patch (marked in yellow) on a column of the Campus Loop Bridge in Albany, NY.**
