# Highway Concrete Pavement Technology Development and Testing: Volume IV— Field Evaluation of Strategic Highway Research Program (SHRP) C-206 Test Sites (Early Opening of Full-Depth Pavement Repairs)

PUBLICATION NO. FHWA-RD-02-085

AUGUST 2006

U.S. Department of Transportation  
**Federal Highway Administration**

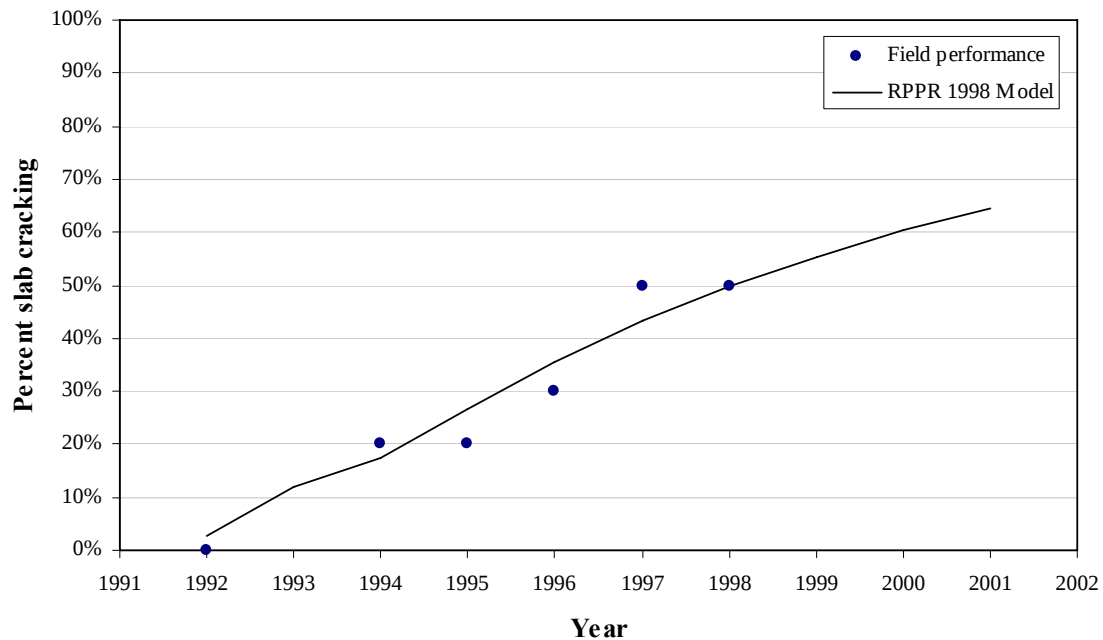
**Figure 4. Comparison of field performance of 4.6-m repairs in the GADOT section and predicted cracking using the rigid pavement performance/rehabilitation (RPPR) 1998 model (Yu et al., 1998).**

The cracking of the longer (4.6-m) repairs in the GADOT section is consistent with expectations. The Georgia sections were placed at night and opened to traffic at 6 a.m. At the time of concrete hardening, there was no difference in the temperature between the top and bottom of the PCC slab. Thus, the repair slabs were built flat with no built-in temperature gradients. Although an excessive built-in negative temperature gradient is undesirable because it contributes to top-down cracking, a moderate amount of built-in negative curling is beneficial because it moderates the effects of high daytime temperature gradients (Yu et al., 1998). Without any built-in curling, the 4.6-m repair length is excessive for a 230-mm repair slab. Differential shrinkage does provide equivalent built-in temperature of about  $-2.2^{\circ}\text{C}$  ( $28.04^{\circ}\text{F}$ ), but that is not enough to counter sufficiently the effects of high daytime temperature gradients.

The results of fatigue analysis are shown in figure 4, along with the observed slab cracking. The model was run with built-in curling of  $-2.2\text{ }^{\circ}\text{C}$  ( $28.04\text{ }^{\circ}\text{F}$ ), which accounts for differential shrinkage. The effects of damage due to early opening are illustrated in figure 5. As shown in table B1 in appendix B, the amount of fatigue damage attributable to early opening was minimal (Miner's damage of 0 to 0.07, except for 0.10 for the last patch). The damage due to early opening has the effect of shifting the time (or traffic) versus cracking curve upward, as illustrated in figure 5. However, for the Georgia sections, early opening to traffic had a negligible effect on the fatigue life of the repairs, even for the 4.6-m repairs. In fact, the last three 4.6-m repairs placed in the GADOT section (i.e., the repairs that were opened to traffic at the lowest strength) did not crack. For shorter repairs, the effects of early opening (and fatigue damage in general) are inconsequential.

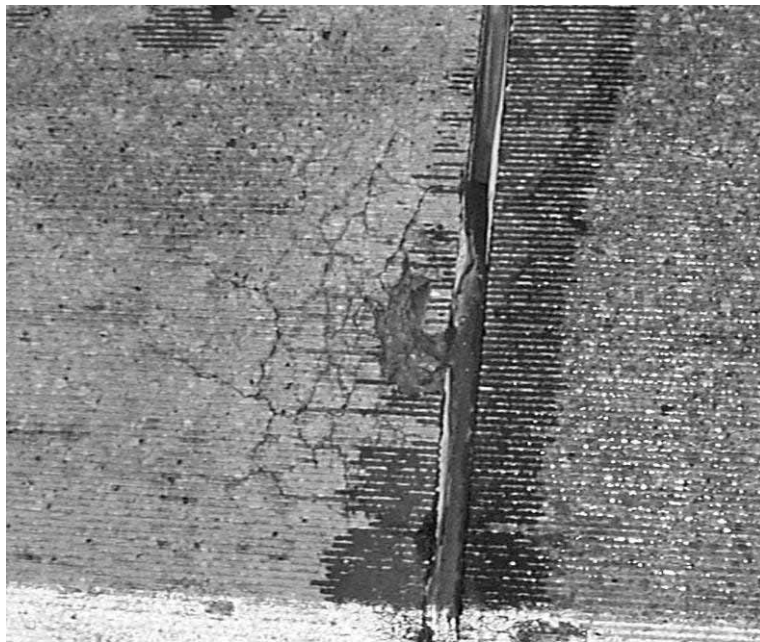
**Figure 7. Map cracking observed in FS section in 1997.**

As mentioned in appendix A, the VES and FS sections started to show map cracking in 1997 (figure 7). The suspected cause of the map cracking is delayed ettringite formation (DEF). DEF is possible if the concrete temperature during hydration exceeds about 70 °C. The peak temperature in the VES section was just above this threshold temperature, and that in the FS section was significantly higher (80.6 °C). Core testing confirmed DEF in these sections.

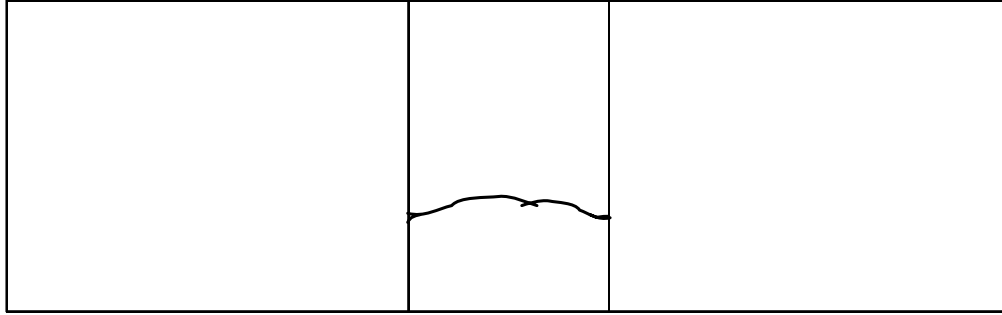
**Figure 8. Illustration of typical longitudinal cracking in Ohio sections.**

By far the most significant distress in the Ohio test sections is the early development of longitudinal cracking in nearly all repairs. Typical longitudinal cracking at this site is illustrated in figure 8. These cracks typically occurred in about the outer one-third of the slab. The rate of development of longitudinal cracking in Ohio sections is shown in figure 9. By the 2-month follow-up survey conducted under SHRP C-206, 100 percent of the FS section and 90 percent of the RSC 1 section had developed longitudinal cracking. By the time of first survey under this project in 1994, five of the eight sections had developed additional longitudinal cracking. Under SHRP C-206, the following were identified as possible causes of the cracking problem:

- The restriction of horizontal movement in the transverse direction caused by dowels.
- Excessive curling stress.
- Excessive compressive force exerted on the repairs by surrounding concrete.

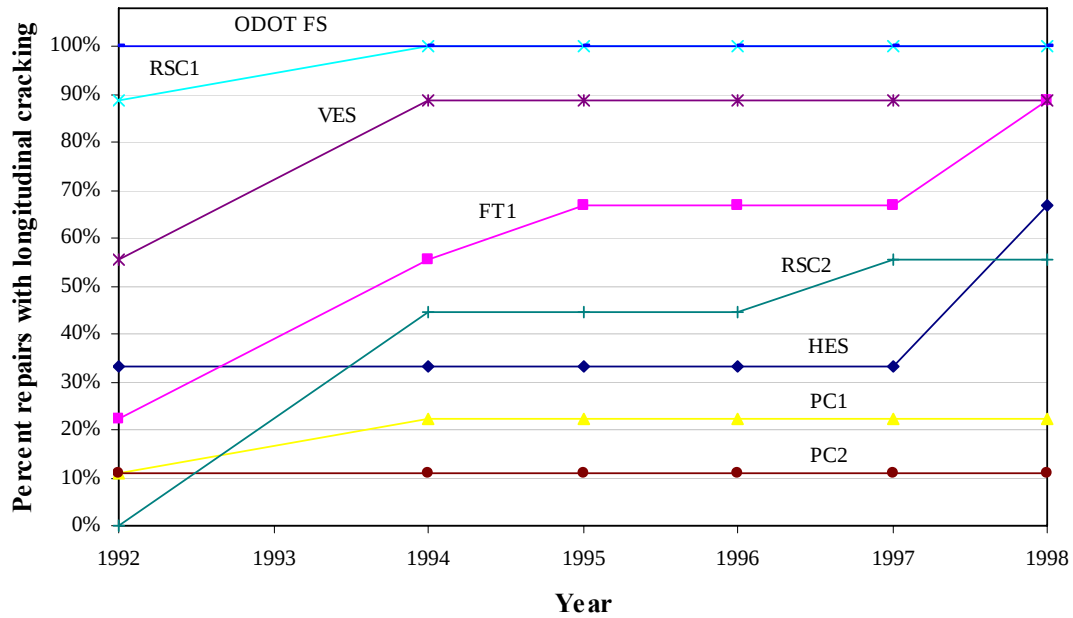
**Figure 9. Development of longitudinal cracking in Ohio sections.**

The performance of Ohio sections was plagued by the longitudinal cracking that developed in the majority of repairs shortly after construction. The cracks appeared within weeks of construction. Three sections also developed transverse cracks and corner breaks, but those distresses are secondary cracking that is unlikely to have occurred had the longitudinal cracking not occurred. Transverse fatigue cracking is not an issue for short (1.8-m) repairs.

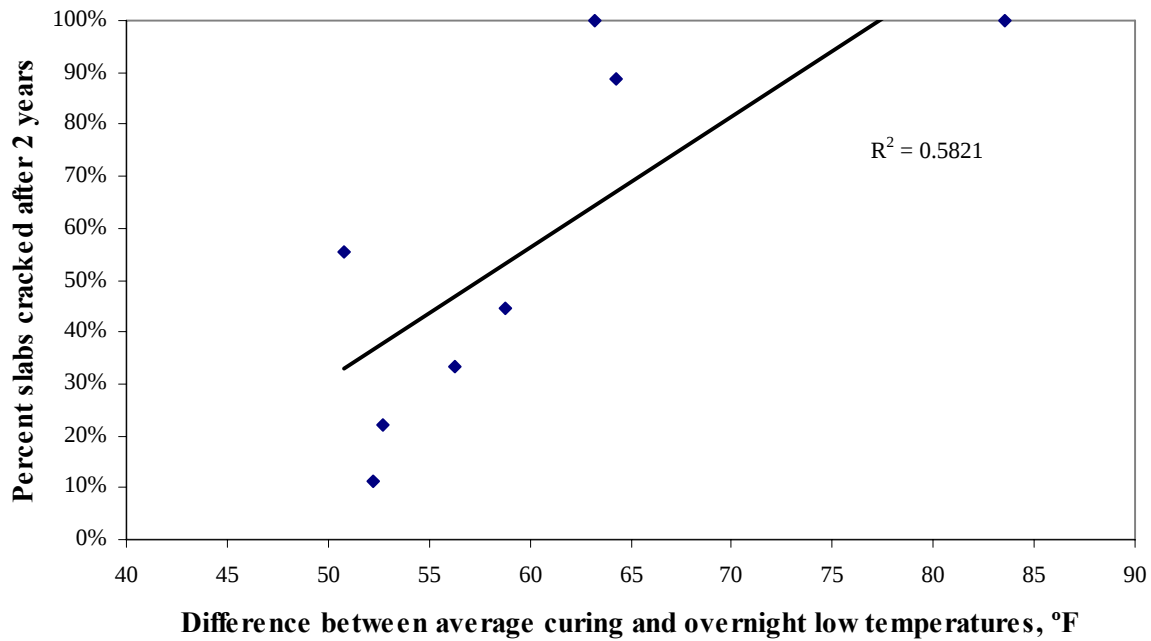
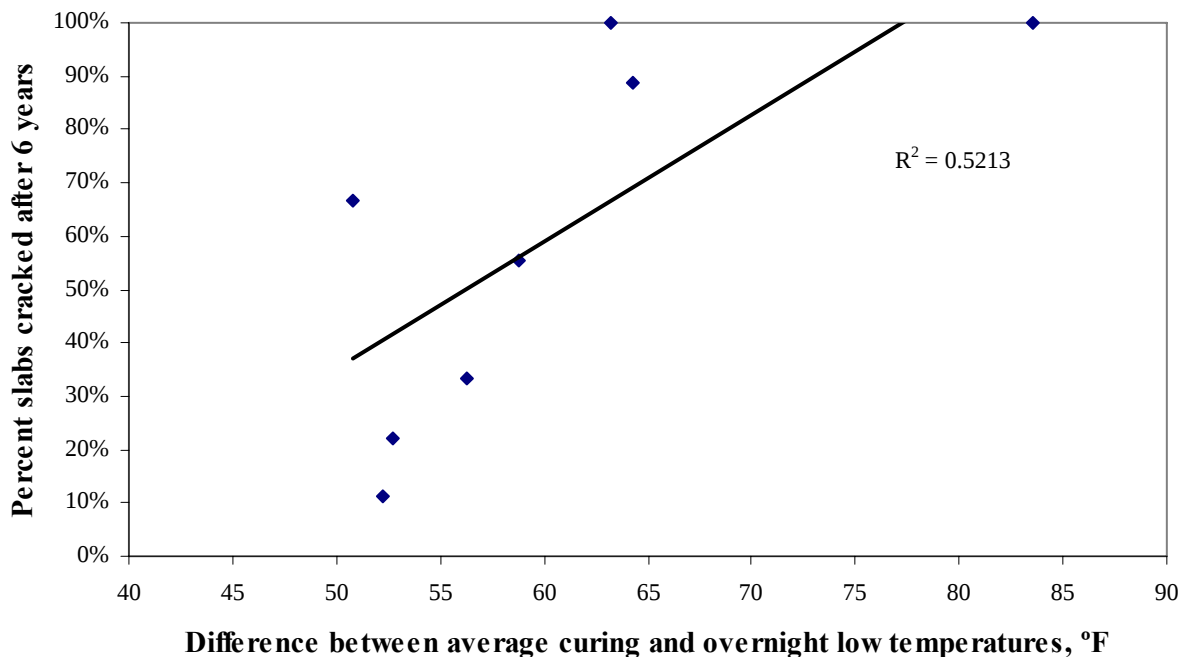
correlation between this parameter and longitudinal cracking in Ohio sections is shown in figures 10, 11, and 12 for the correlation at 2 months, 2 years, and 6 years of age. Figure 10 shows excellent correlation between this parameter and longitudinal cracking. If the cracking is caused by dowel restraint (of the horizontal movement in the transverse direction), this should be an effect that mostly influences the early-life behavior. Various factors would alleviate this effect at later ages, including creep and higher material strength. This is consistent with the trends shown in figures 10, 11, and 12. The best correlation is exhibited in figure 10 at 2 months of age, and the correlation becomes progressively worse for later ages.

The results shown in table 9 and figures 10 through 12 strongly suggest that the climatic conditions during construction played a major role in early development of longitudinal cracking in the Ohio sections. Figure 10 shows that if the difference between average curing temperature and overnight low temperature is less than about 10 °C (50 °F), the risk of developing longitudinal cracking due to dowel restraint is relatively low. That difference was less than 5 °C (41 °F) for all the Georgia sections, and none of the Georgia sections developed longitudinal cracking.

The risk of early age cracking can be evaluated using FHWA's software HIPERPAV (McCullough and Rasmussen 1999; Forster 1998). The software takes key environmental, structural design, mix design, and construction inputs and generates a graph showing the development of PCC strength and stress over the first 72 hours after placement. If the stress exceeds the strength at any time, a high potential for uncontrolled cracking is indicated. For such cases, adjustments can be made to mixes, curing practice, or time of PCC placement to reduce the potential for cracking. Where a significant difference between the average curing temperature and overnight low temperature is possible (i.e., greater than 10 °C (50 °F)), the use of HIPERPAV is recommended.

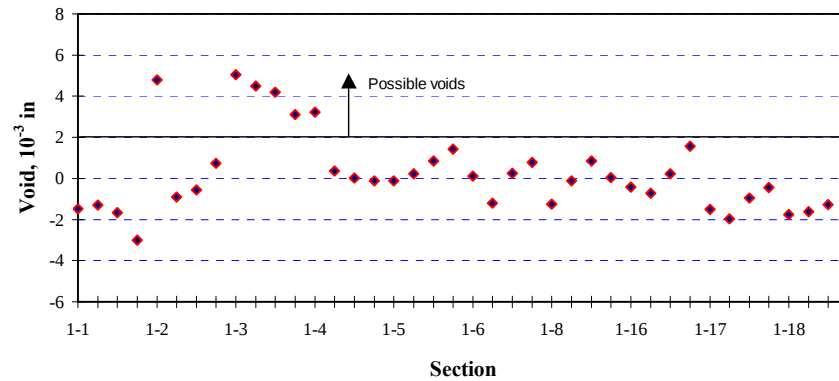
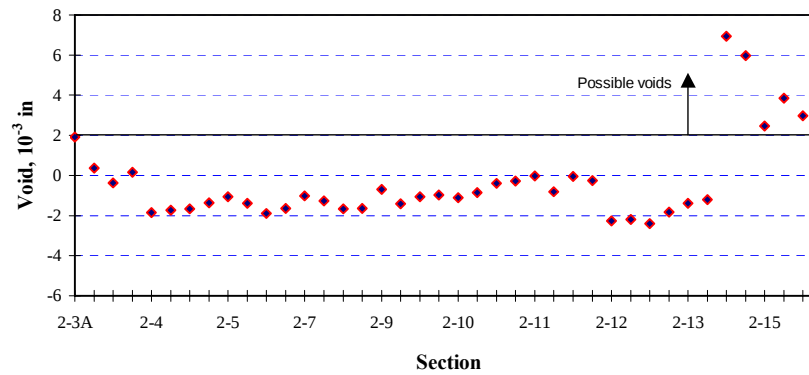
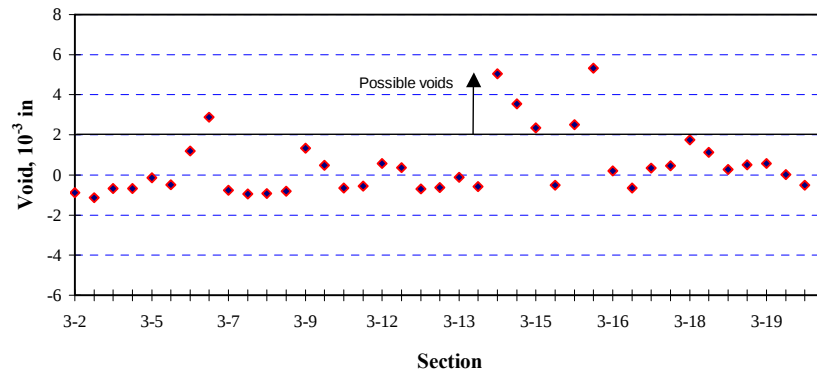
The intercept values from the load-deflection plots are shown in figures A4, A5, and A6. The figures show possible voids under the repairs 1-3, 2-13, 2-15, 3-13, and 3-15, but most joints tested show good support under the joints. These results show that the slabs were not curled up at the time of testing.
