# Highway Concrete Pavement Technology Development and Testing: Volume V— Field Evaluation of Strategic Highway Research Program (SHRP) C-206 Test Sites (Bridge Deck Overlays)

PUBLICATION NO. FHWA-RD-02-086

AUGUST 2006

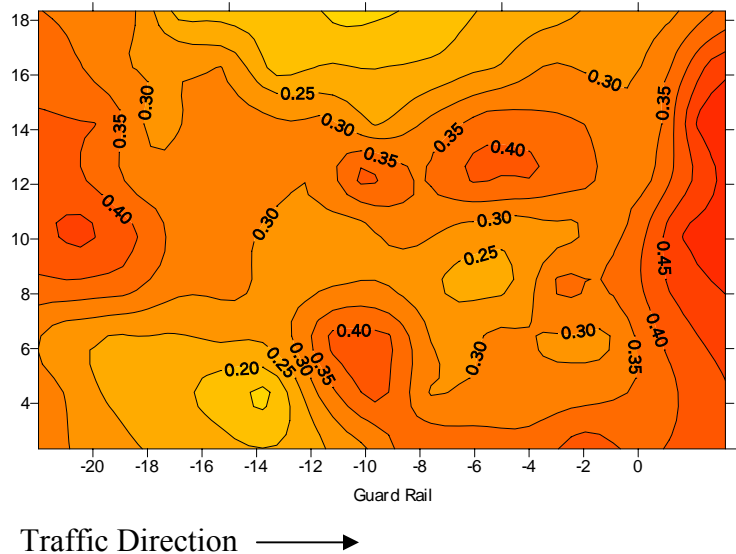
**Figure 5. Equipotential map of half-cell potentials for I-270 NB (silica fume-modified concrete).**

An equipotential map for the northbound SFC test section in 1997 is shown in figure 5. The most negative potentials were seen at the ends of the bridge and near the cracked delaminations. No area of more negative potentials was associated with the longitudinal construction joint. Approximately three-quarters of the readings were more negative than  $-250$  mV, indicating that corrosion is likely occurring over most of the deck. The alignment of the areas of rapid potential changes with the edges of the bridge and the cracked delaminations indicate that the overlay is not providing sufficient protection from water and waterborne chlorides in these locations.

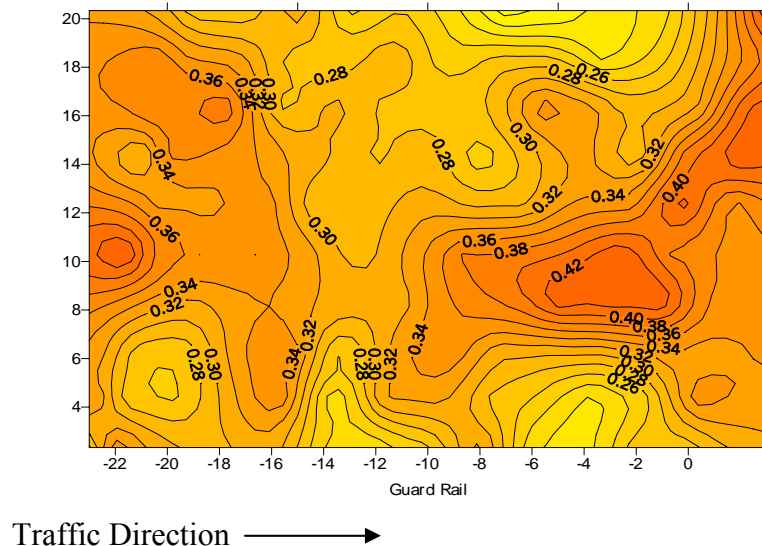
**Figure 7. Equipotential map of half-cell potentials for I-270 southbound (latex-modified concrete).**

An equipotential map of the half-cell data for the I-270 southbound test section in 1997 is shown in figure 7. The most negative potentials were seen in the areas of the construction joint, the ends of the bridge, and near cracked delaminations. The majority of the readings were more negative than -250 mV. Also, indicative of corrosion in the structure are the relatively large differences in potential across the area surveyed, as indicated by the closely spaced lines on the contour plot. The most negative potentials along the edges of the bridge, the construction joint, and the cracked delamination indicate that the overlay is not providing sufficient protection from water and waterborne chlorides in these locations.

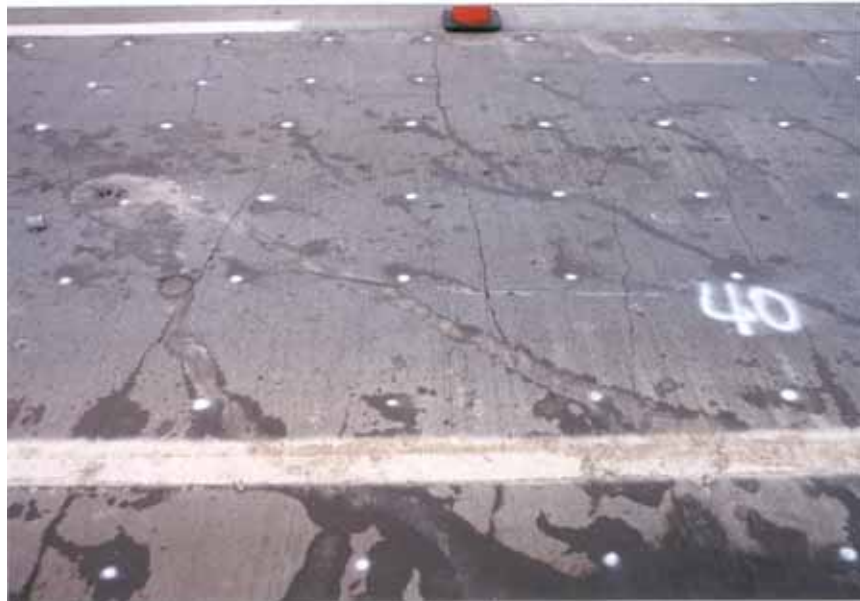
**Figure 26. Photograph showing typical cracking associated with the southbound test section of U.S. 41 SFC.**

Inspection of the deck of the southbound SFC structure revealed the three spans also performing differently. Span 1 was different than Spans 2 and 3 due to its many large and raveled cracks. Many of the cracks increased in length or joined nearby cracks over the five years of the study. In Spans 2 and 3, many of the newer cracks were longitudinal but a few transverse cracks also developed. Span 3 was more heavily cracked than Span 2. In the last year of the study, many of the cracks in the two spans that earlier were only visible after a rainstorm, were now plainly visible when the deck was dry. Figure 26 shows some typical cracking associated with the southbound test section.

The southbound test section SFC is performing well. No delaminations were found in any of the spans in 1994 or 1995 and the center span had no delaminations found in any year of the study. The total delaminated area of all three areas is  $6.59 \text{ m}^2$  ( $71 \text{ ft}^2$ ), 3.72 percent of the total area. The northbound LMC test section performed much worse than the southbound SFC section. All three spans of the northbound structure had delaminations in the first year of the study (1994). The center span is performing the best with only  $4.46 \text{ m}^2$  ( $48 \text{ ft}^2$ ) square meters or 7.55 percent of the area delaminated. The two end spans are performing much worse with  $16.40 \text{ m}^2$  ( $176 \text{ ft}^2$ ) (27.8 percent) and  $11.47 \text{ m}^2$  ( $123 \text{ ft}^2$ ) (19.4 percent) of the surface area delaminated.

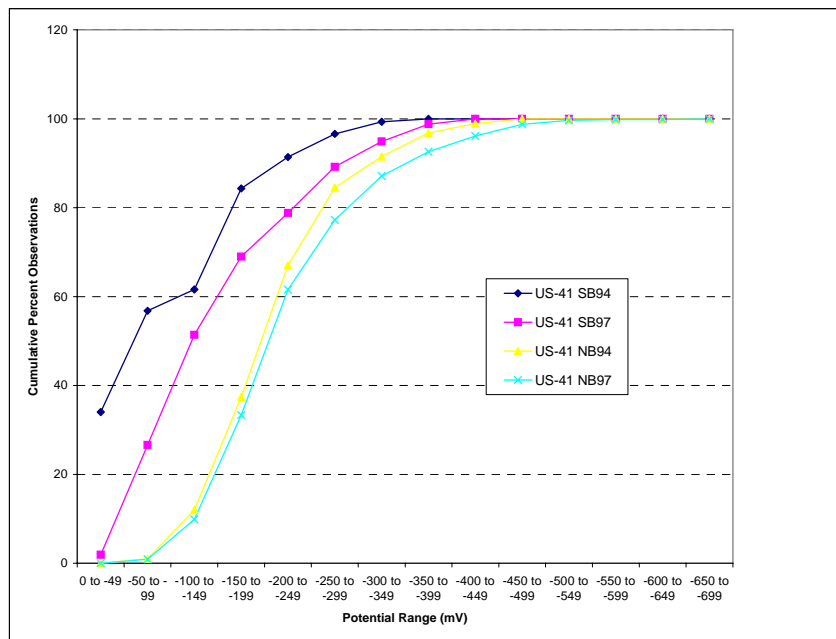
**Figure 33. Cumulative frequency diagram for U.S. 41 (NB and SB) for years 1994 and 1997.**

A cumulative frequency diagram for both test sections of U.S. 41 is shown in figure 33. The figure shows the shift to the right for both test sections. The shift in the curve for the southbound SFC spans is much greater than that for the northbound spans LMC. However, the northbound spans LMC had more negative values both initially and at the end of the study than the southbound SFC spans. An equipotential map of the half-cell readings for the southbound spans SFC of U.S. 41 is shown in figure 34. The figure for Span 1 indicates there is corrosion occurring along the edge between the travel and passing lane and at the two ends of the span. The figures for Span 2 and Span 3 indicate corrosion is occurring in isolated areas and also at the ends of the spans. An equipotential map for the half-cell readings for the northbound spans LMC is shown in figure 35. The maps for Span 1 and Span 3 indicate corrosion occurring over much of both spans and especially along the edge between the travel and passing lanes. The map for Span 2 indicates isolated areas of corrosion but most areas are at the ends of the span.
