# Long-Term Monitoring of Pavement Maintenance Materials Test Sites

PUBLICATION NO. FHWA-RD-98-172

JUNE 1998

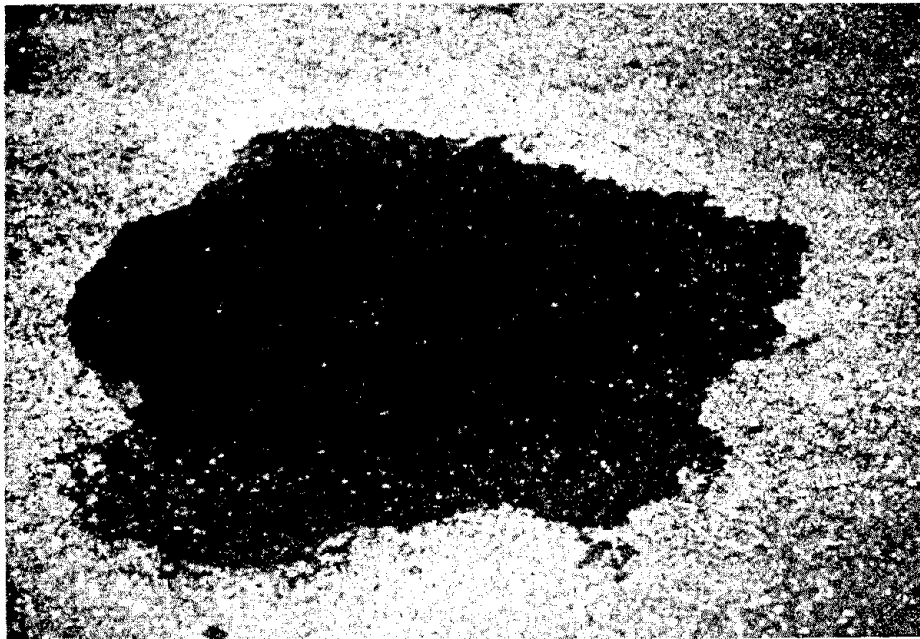
Some of the more significant distresses noted at the test sites were dishing, raveling, and edge disintegration. However, bleeding was prevalent among the PennDOT 486 patches but was not widespread among the other patches placed. Figures 30 through 34 show examples of bleeding, shoving, cracking, raveling, and edge disintegration as they were noted in the field.

Figure 30. Example of bleeding distress.

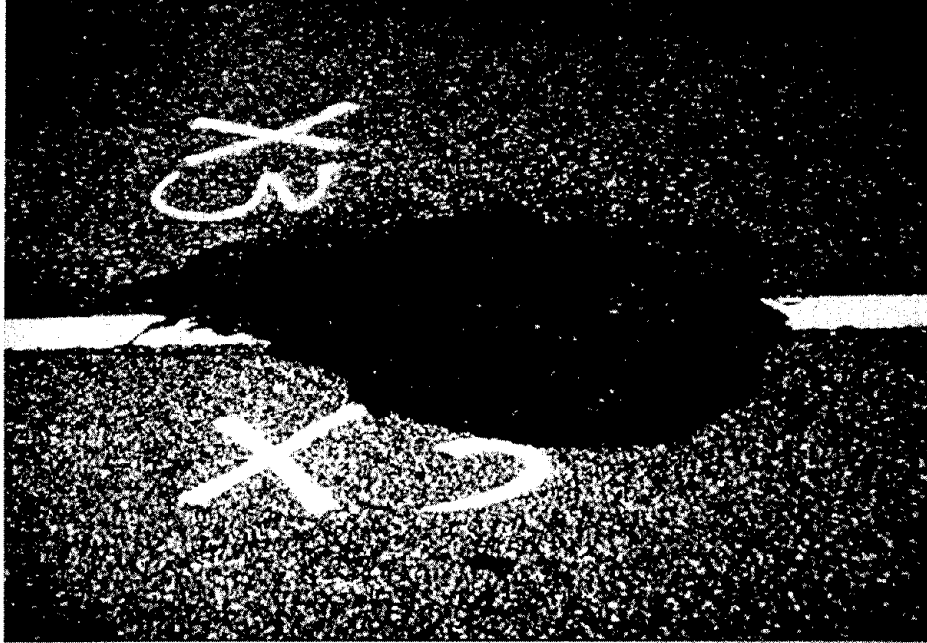
Figure 31. Example of shoving distress.

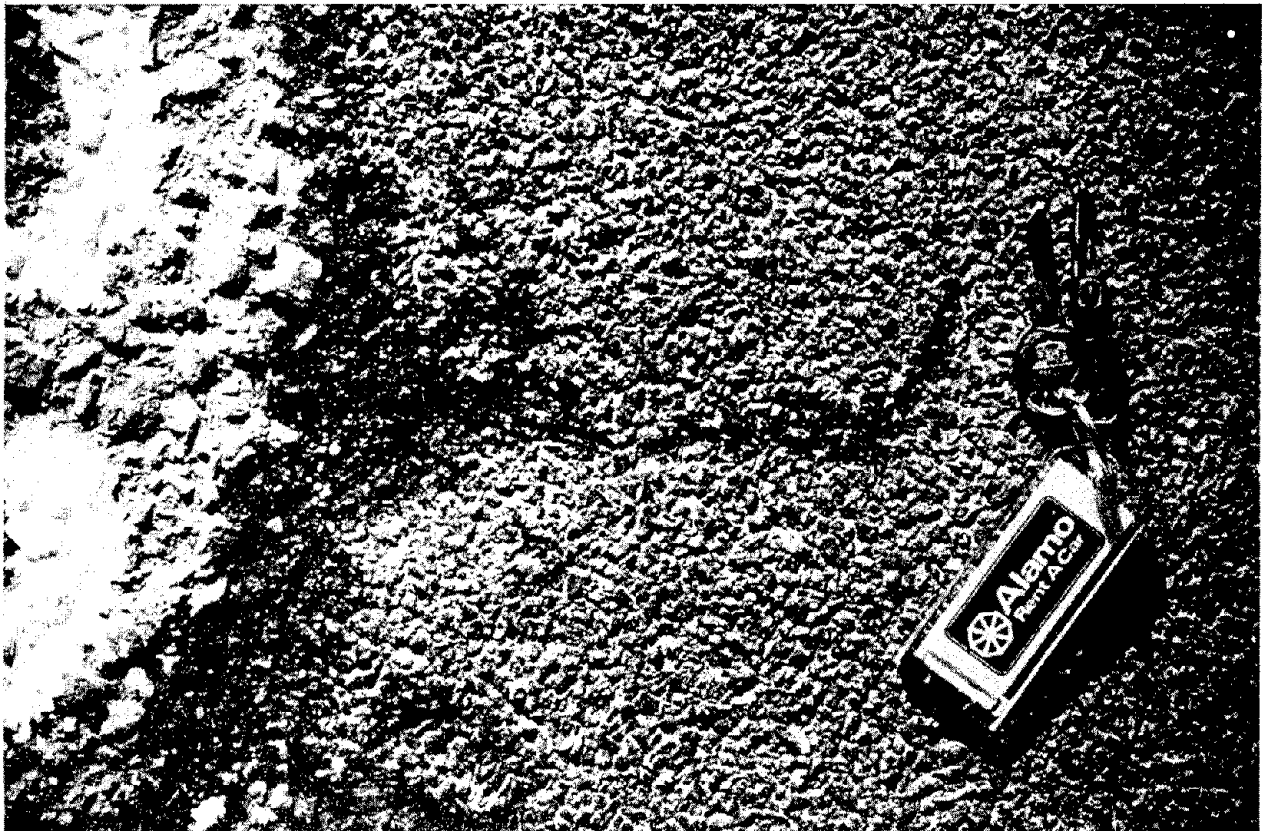
Figure 32. Example of cracking distress.

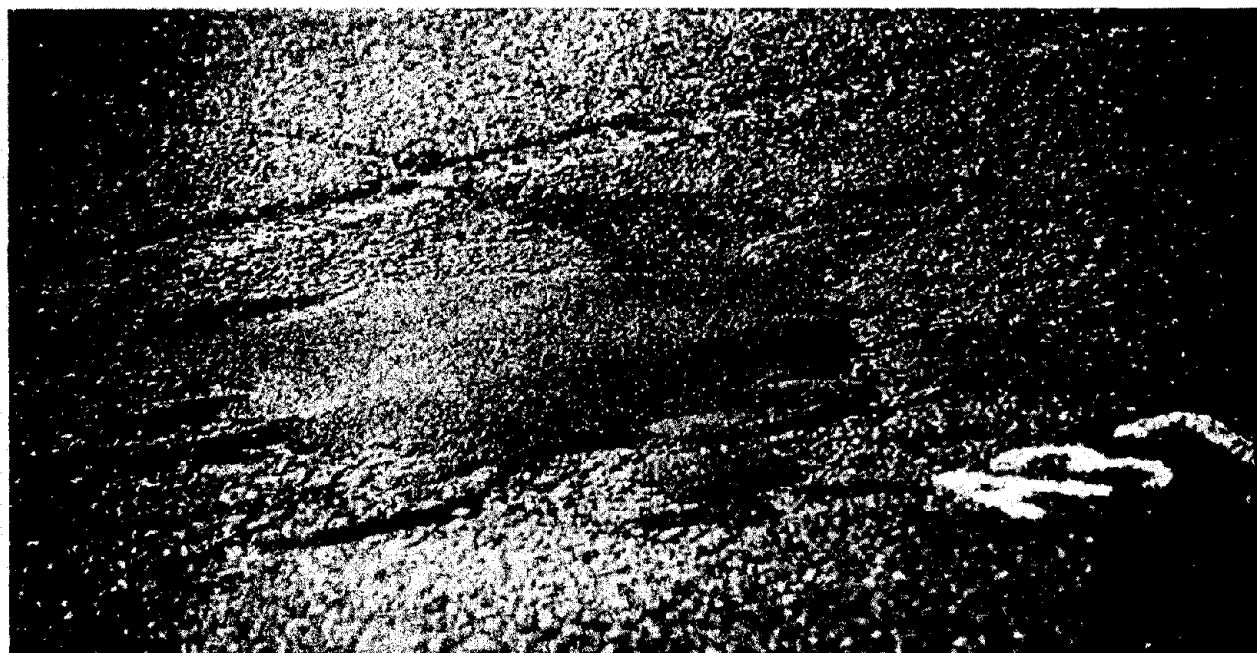
Figure 34. Example of edge disintegration distress.
