LTPP Pavement Maintenance Materials: SHRP Crack Treatment Experiment, Final Report

PUBLICATION NO. FHWA RD-99-143

SEPTEMBER 1999

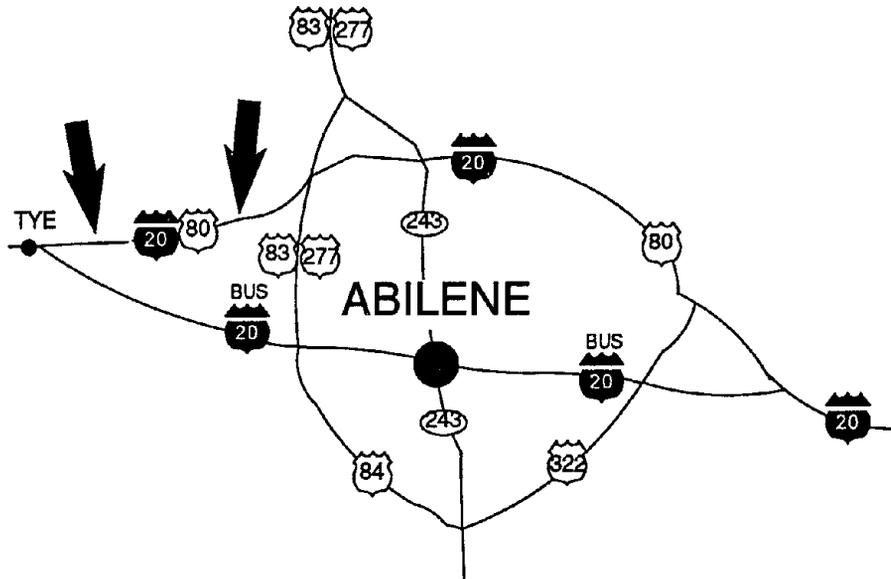
Figure 3. Abilene, Texas transverse crack-seal test site.

This crack-seal test site, representing the dry-nonfreeze climate, was located between mileposts 278 and 282 in the westbound driving lane of Interstate 20 near Abilene, Texas (see figure 3). The pavement section was originally constructed in the mid-1960s using 76 mm of AC, 203 mm of crushed limestone base, and 406 mm of crushed caliche subbase placed on a 152-mm lime-stabilized subgrade. A 64-mm AC overlay with a geofabric interlayer was placed in 1989.

Pavement condition at the time of installation was fairly good. Transverse cracks were the only significant form of distress present. These cracks were typically about 3 mm wide and were spaced fairly regularly—between 15 and 18 m. Very little spalling and secondary cracking was observed along the transverse cracks.

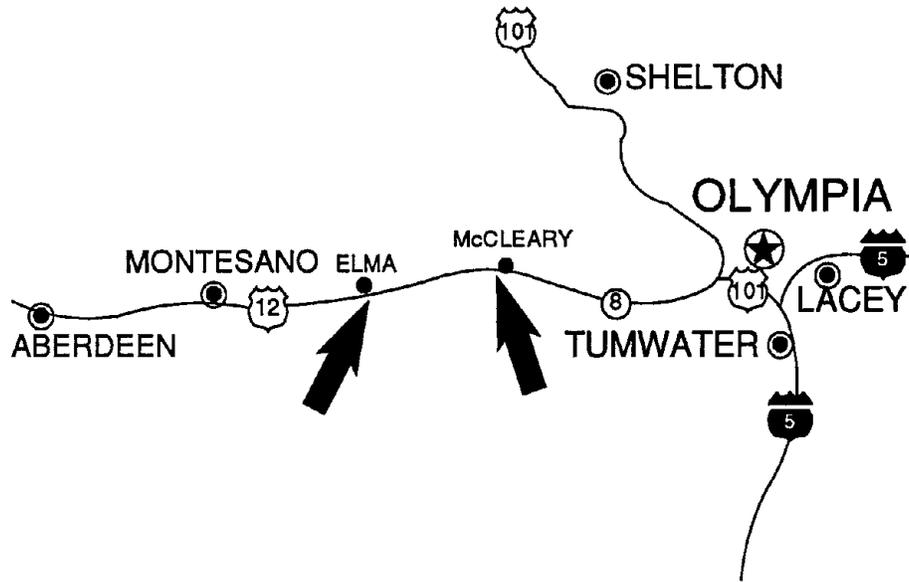
Figure 4. Elma, Washington transverse crack-seal test site.

This wet-nonfreeze crack-seal test site was located between mileposts 0 and 7.25 in the eastbound passing lane of Washington State Route 8 near Elma, Washington (see figure 4). The pavement section was originally constructed in 1964 as a full-depth AC pavement. An AC overlay in the mid-1980s brought the total depth of AC to 229 mm.

When this road was selected as a crack-seal site, overall pavement condition was fairly good. Transverse cracks were present, typically at 23 to 31 m. The cracks, ranging between 3 and 6 mm wide, were accompanied by very few spalls and secondary cracks. Some rutting was evident in the wheelpaths, but usually to depths no greater than 6 mm.

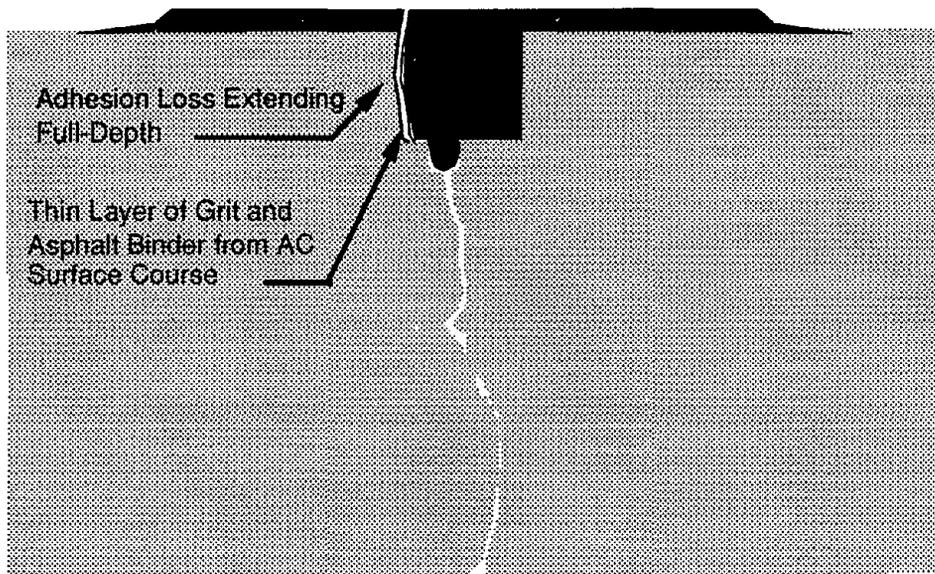
For configuration D of the rubberized asphalt seals, between 95 and 98 percent of the failures were the result of full-depth cohesion loss. In this type of failure, the overband is worn away by traffic and the remaining sealant thickness is insufficient to withstand the internal stress brought by crack-opening movement. This mode of failure was almost as predominant in the fiberized asphalt and low-modulus rubberized asphalt seals.

Figure 33. Illustration of full-depth adhesion loss in recessed band-aid.

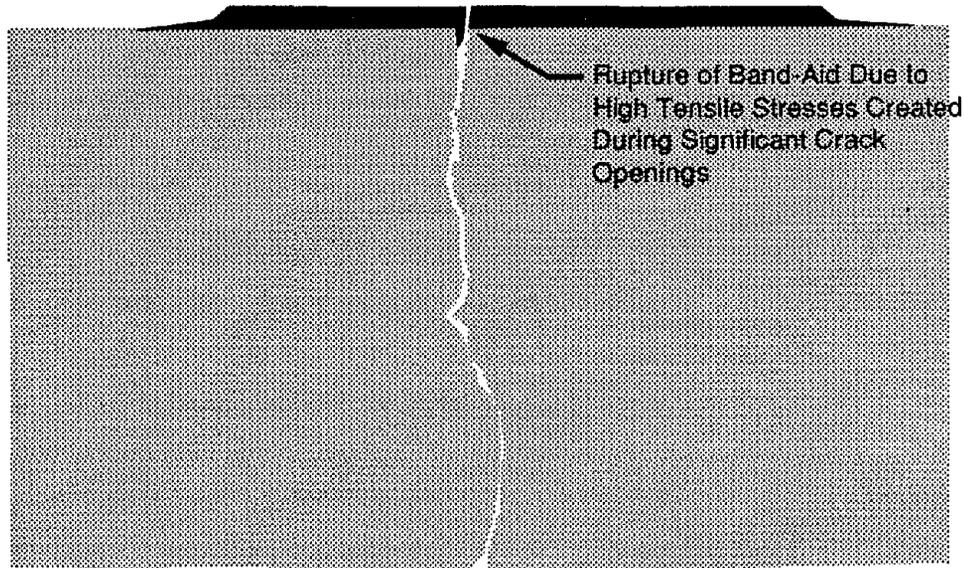
Figure 34. Illustration of full-depth cohesion loss in simple band-aid.

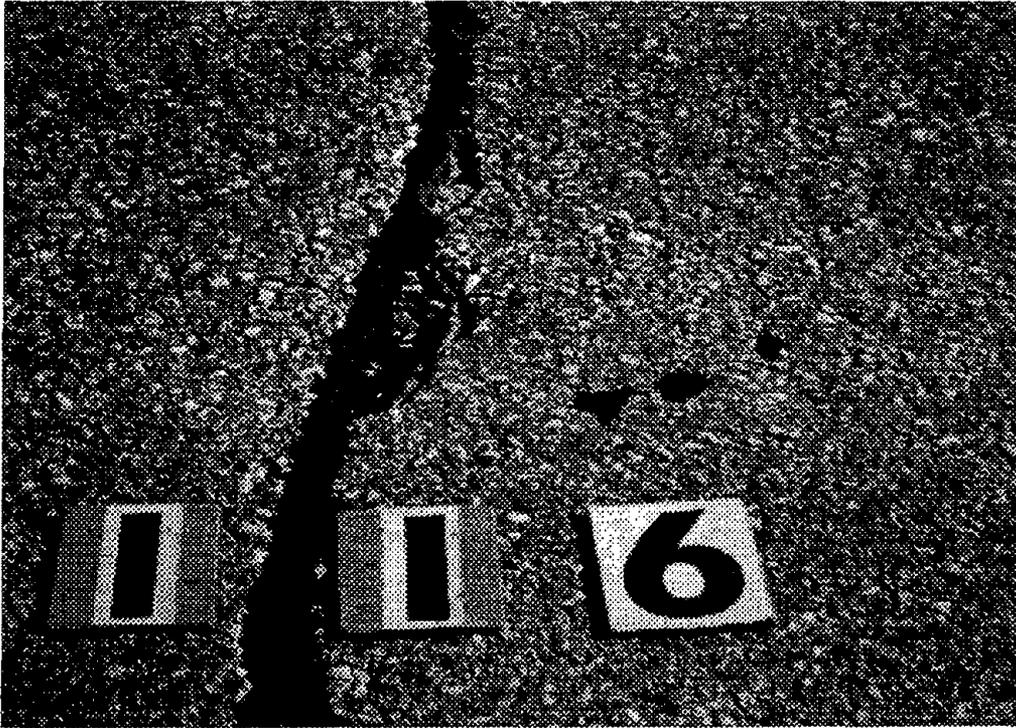
Figure 35. Typical spall and secondary crack adjacent to 890-SL silicone seal.
