**Long Term Pavement Performance
Specific Pavement Studies**

**Colorado SPS-5
Construction Report on SHRP 080500
Colorado Department of Transportation**

**Western Region Contractor
Nichols Consulting Engineers, Chtd.**

October 1994

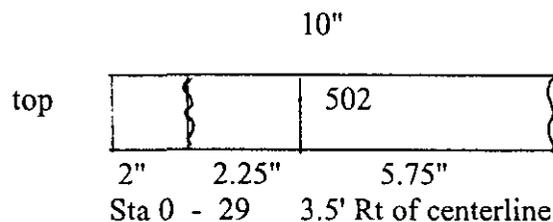
Core 502 broke apart 2" from the top debonding at a lift joint. There was minor fines loss due to drilling in the top 2" and at the lift joint, however the rest of the core did not show any visual loss. There was free asphalt floating on the drilling water.

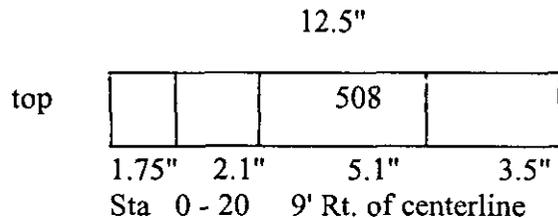
Core 508 did not indicate any distress. There was free asphalt on the drilling water.

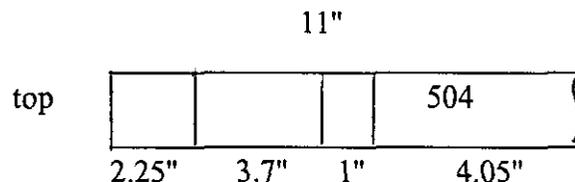
Core 504 showed some minor loss of material at the interface 3.85" below the top surface. There was not any other distress in the core. There was free asphalt on the drilling water.

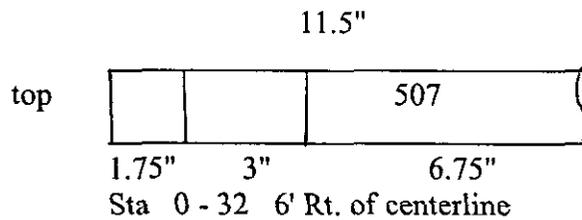
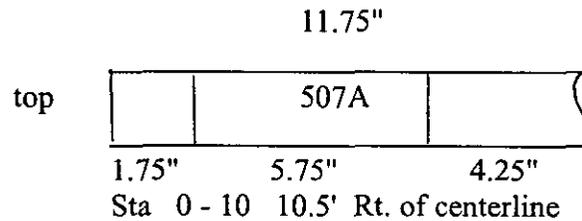
Two cores were taken from this section to compare distress levels. Core 507 was taken from a midlane raveled and cracked area. There was distress in the top lift of this core only. The crack does not extend into the second lift of plantmix. There was loss of material in the top lift, however the core remained in tact. There was free asphalt on the drilling water. Core 507A was taken in the right wheel path in what appeared to be a severely cracked and raveled area. This core showed loss of material in the top lift and minor fines loss in the rest of the core. the cracking and raveling is limited to the top lift and does not extend below it. There was free asphalt on the drilling water.

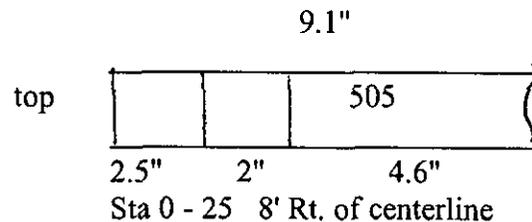
Core 505 was taken over a fairly wide crack. The top 2.5" lift fell apart and a piece of the next lift to a 1.5" depth also broke apart. There was considerable material loss in the top lift and some fines loss down to 4.5", however there was little damage to the rest of the core except for the broken area. There was free asphalt on the drilling water.

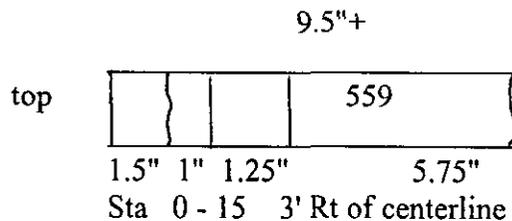
Core 559 was taken from a crack in the left wheelpath. The entire length of the core could not be retrieved. It was drilled to a depth to 18", the core barrel length, however this did not reach the total depth and the core broke at 9.5" after considerable effort was made trying to lift the core out. The top 1.5" delaminated and broke apart. The crack extended 2.5" in the core. Visual observation of the core hole showed the crack is propagating from the top down into the lower layers. There was not any free asphalt in the drilling water.
