Long Term Pavement Performance

Colorado SPS-5

FORENSIC EVALUATION REPORT

January 1995

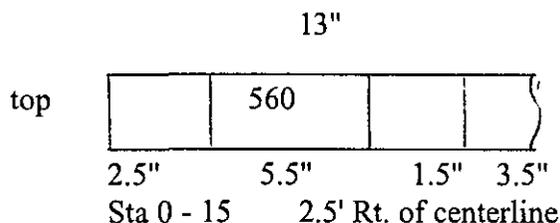
080560

Core 560 is in good condition. There was not any damage incurred drilling the core, however there was a fair amount of asphalt floating on the drilling water which may indicate a water sensitivity problem.

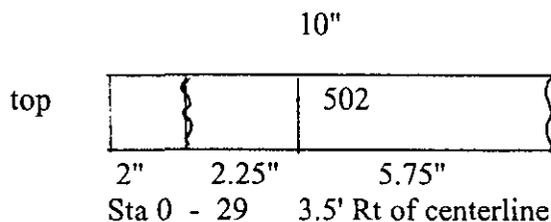
080502

Core 502 broke apart 2" from the top debonding at a lift joint. There was minor fines loss due to drilling in the top 2" and at the lift joint, however the rest of the core did not show any visual loss. There was free asphalt floating on the drilling water.

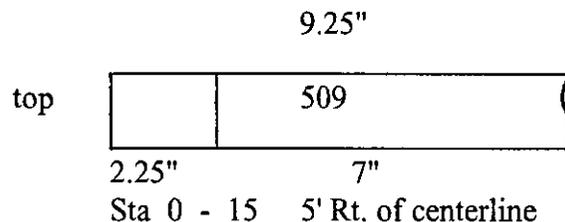
Core 509 was taken at the edge of a crack. There was moderate loss of material along the edge of the crack down to the lift interface (2.25"). The remainder of the core did not show any distress or loss of material due to coring. There was free asphalt floating on the drilling water.

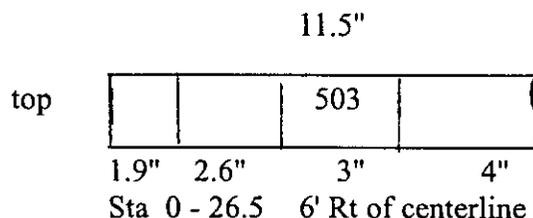
Core 503 showed a very minor loss of fines at the top lift interface. The rest of the core did not show any distress, however there was free asphalt on the drilling water.

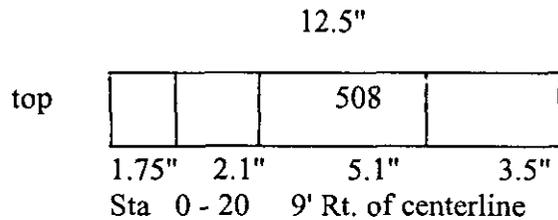
Core 508 did not indicate any distress. There was free asphalt on the drilling water.

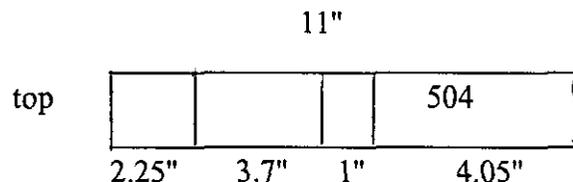
080504

Core 504 showed some minor loss of material at the interface 3.85" below the top surface. There was not any other distress in the core. There was free asphalt on the drilling water.

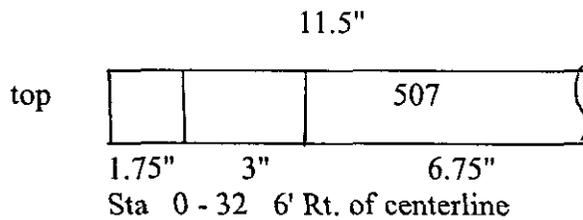
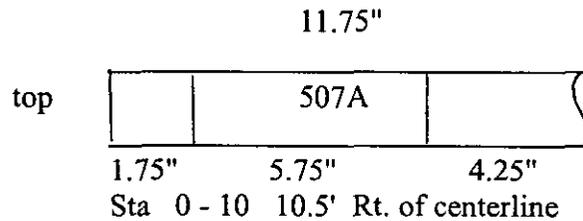
080507

Two cores were taken from this section to compare distress levels. Core 507 was taken from a midlane raveled and cracked area. There was distress in the top lift of this core only. The crack does not extend into the second lift of plantmix. There was loss of material in the top lift, however the core remained in tact. There was free asphalt on the drilling water. Core 507A was taken in the right wheel path in what appeared to be a severely cracked and raveled area. This core showed loss of material in the top lift and minor fines loss in the rest of the core. the cracking and raveling is limited to the top lift and does not extend below it. There was free asphalt on the drilling water.

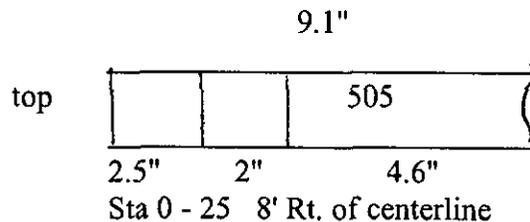
080505

Core 505 was taken over a fairly wide crack. The top 2.5" lift fell apart and a piece of the next lift to a 1.5" depth also broke apart. There was considerable material loss in the top lift and some fines loss down to 4.5", however there was little damage to the rest of the core except for the broken area. There was free asphalt on the drilling water.

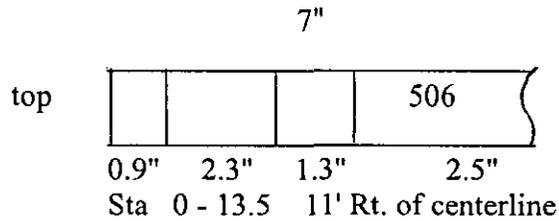
080506

Core 506 was taken from the right edge of the lane where raveling was more sever. There was loss of fines in the top 1" and a minor loss of fines in the bottom lift. There was free asphalt on the drilling water.

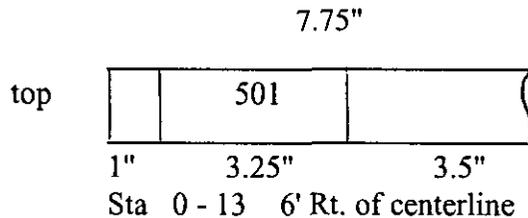
080501

Core 501 shows no distresses. There was free asphalt on the drilling water.

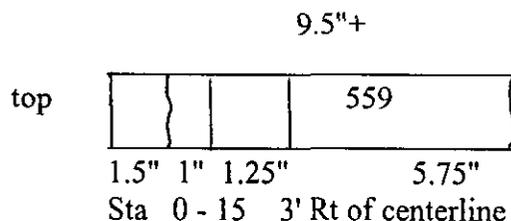
080559

Core 559 was taken from a crack in the left wheelpath. The entire length of the core could not be retrieved. It was drilled to a depth to 18", the core barrel length, however this did not reach the total depth and the core broke at 9.5" after considerable effort was made trying to lift the core out. The top 1.5" delaminated and broke apart. The crack extended 2.5" in the core. Visual observation of the core hole showed the crack is propagating from the top down into the lower layers. There was not any free asphalt in the drilling water.
