**CALIFORNIA SPS-6**

**Construction Report on Section 060600  
California Department of Transportation**

**Western Region Contractor  
Nichols Consulting Engineers, Chtd.**

**April 1996**

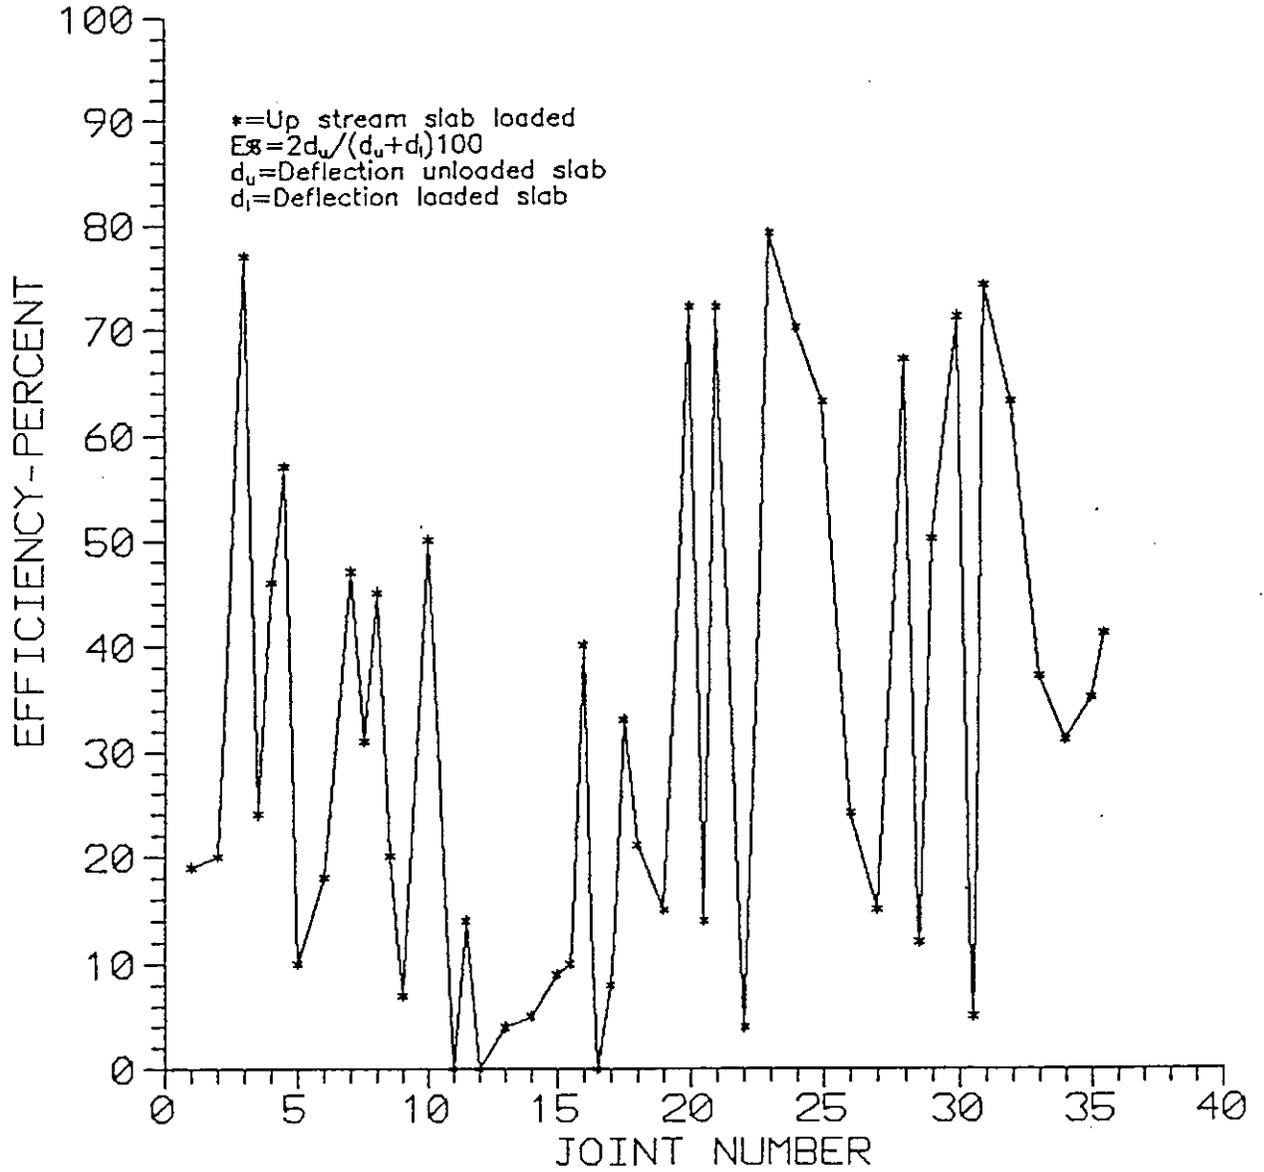
JOINT EFFICIENCY EXISTING PCCP  
SHRP TEST SECTION 60605

FWD testing was started on May 6th. Sensor #7 malfunctioned and testing was discontinued. Caltrans transverse joint deflection measurements showed that the average joint efficiency of the existing PCC slabs in this section was only 32%, as shown in Figure 6. Because of the poor condition of the slabs and poor load transfer, it was decided by the Resident Engineer to replace all slabs in the outside (SHRP) lane. Therefore, FWD testing was not completed and no distress survey was performed.

Figure 6. Joint efficiency existing PCCP SHRP test section 60605.

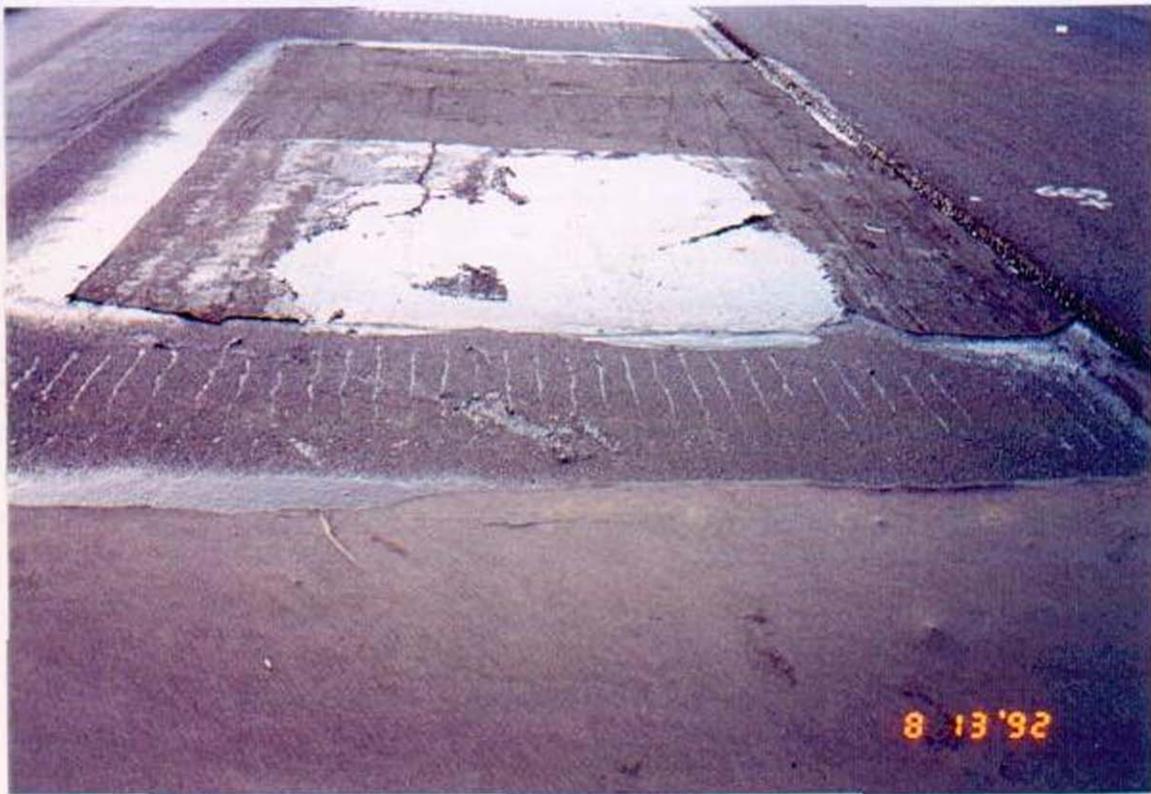
Photo 11. Section 060610, fabric patch - emulsion too hot.

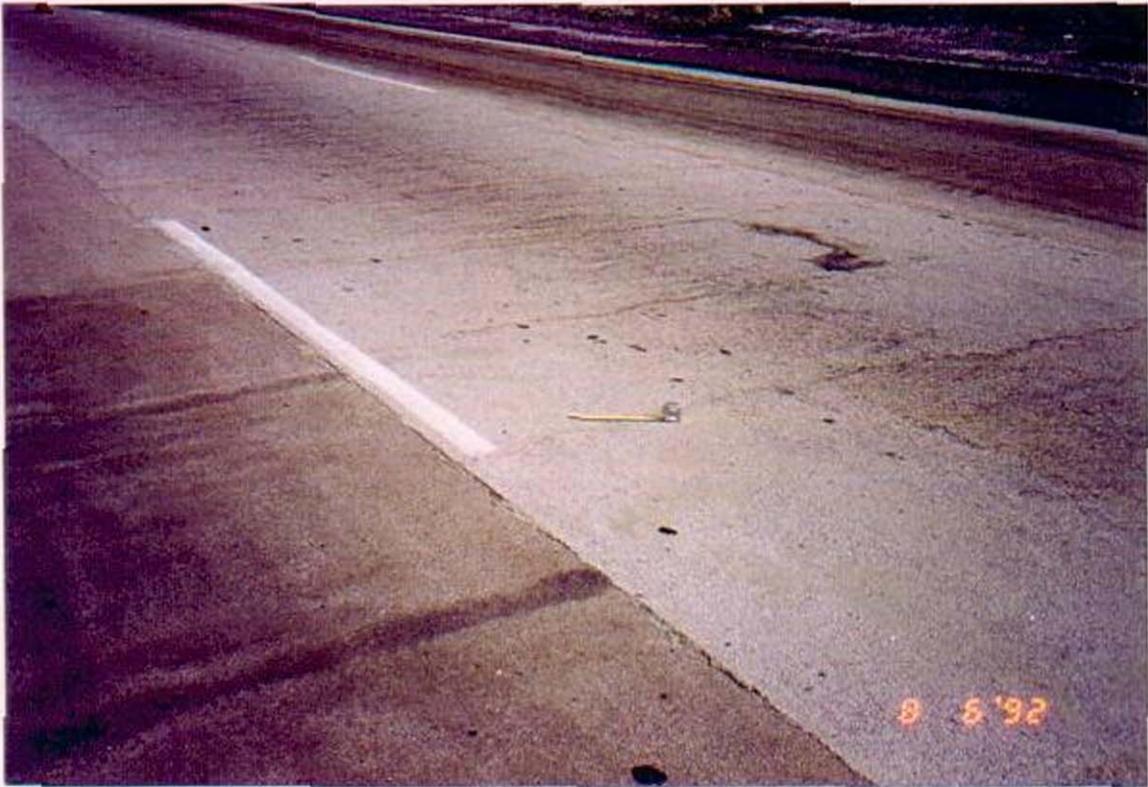
Photo 15. Section 060611, urethane polymer resin overlay - cracking after months of traffic.

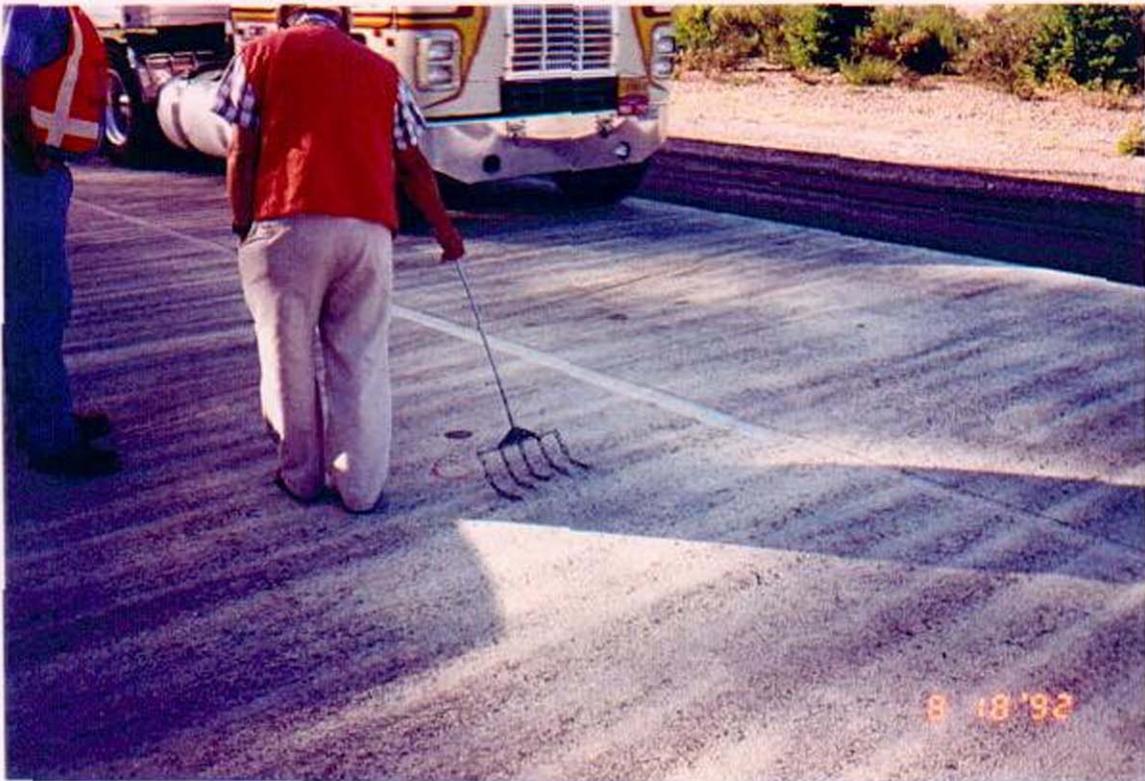
Photo 16. Section 060612, checking for delamination of latex emulsion.

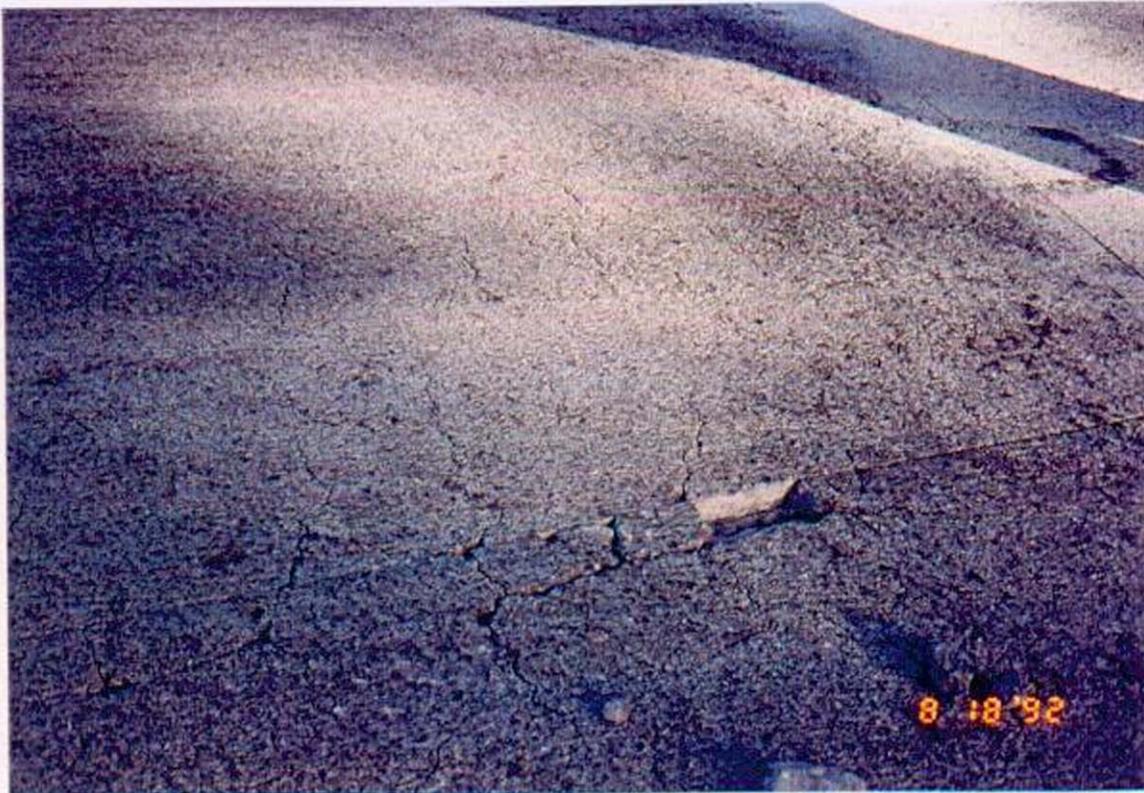
On May 29th, the Resident Engineer estimated that 40% of the MLE overlay in the outer two driving lanes had shrinkage cracking.

The SHRP driving lane (#3) was paved on June 22nd and 23rd. By August 15th debonding was occurring between Stations 751+25 and 759+06. It was decided to remove the MLE between these limits and place a 0.35 ft. AC overlay with a pavement reinforcing mesh. Due to these modifications, the overall length of the MLE test section was reduced to 223'. Also, debonding along several transverse joints occurred in the test section. The debonded MLE was removed and polyester concrete was used to repair these areas.

Photo 17. Section 060612, cracked and delaminated latex.

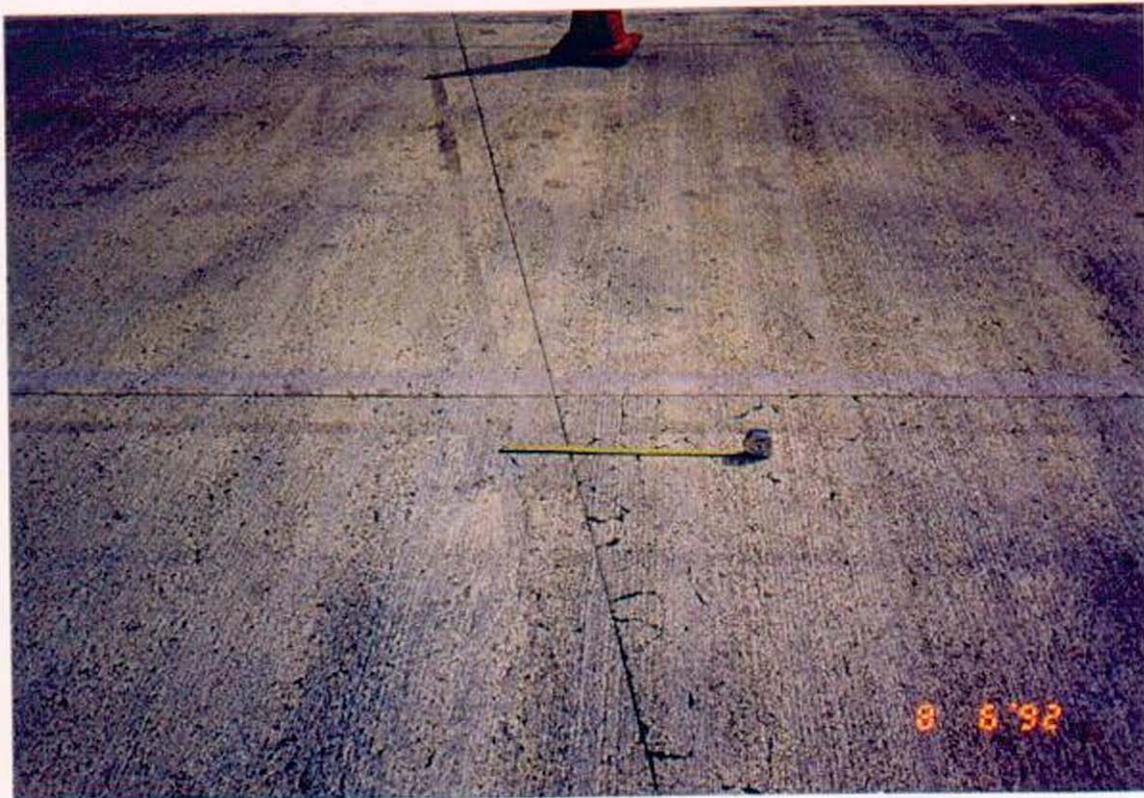
Photo 18. Section 060612, modified latex emulsion - cracking at joints of pumping (outside Community Center).

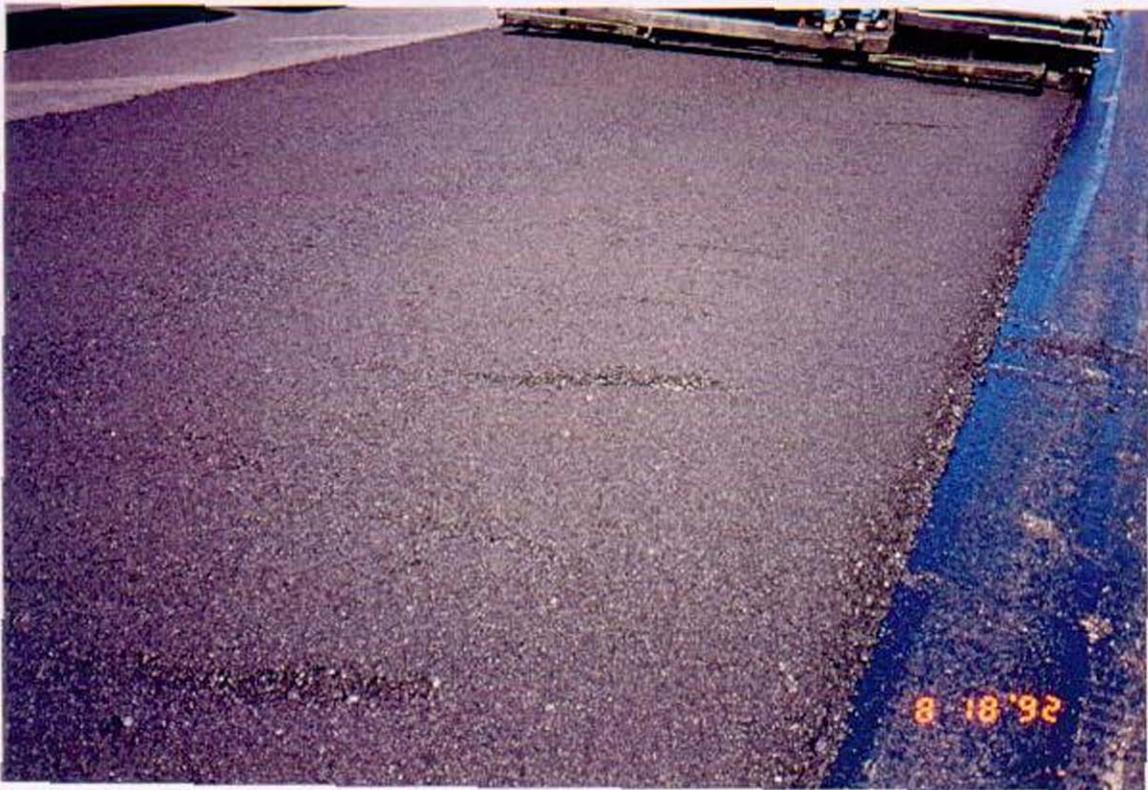
Photo 23. Section 060613, paving over glass grid - note bad spots due to "rolling" of glass grid below AC.

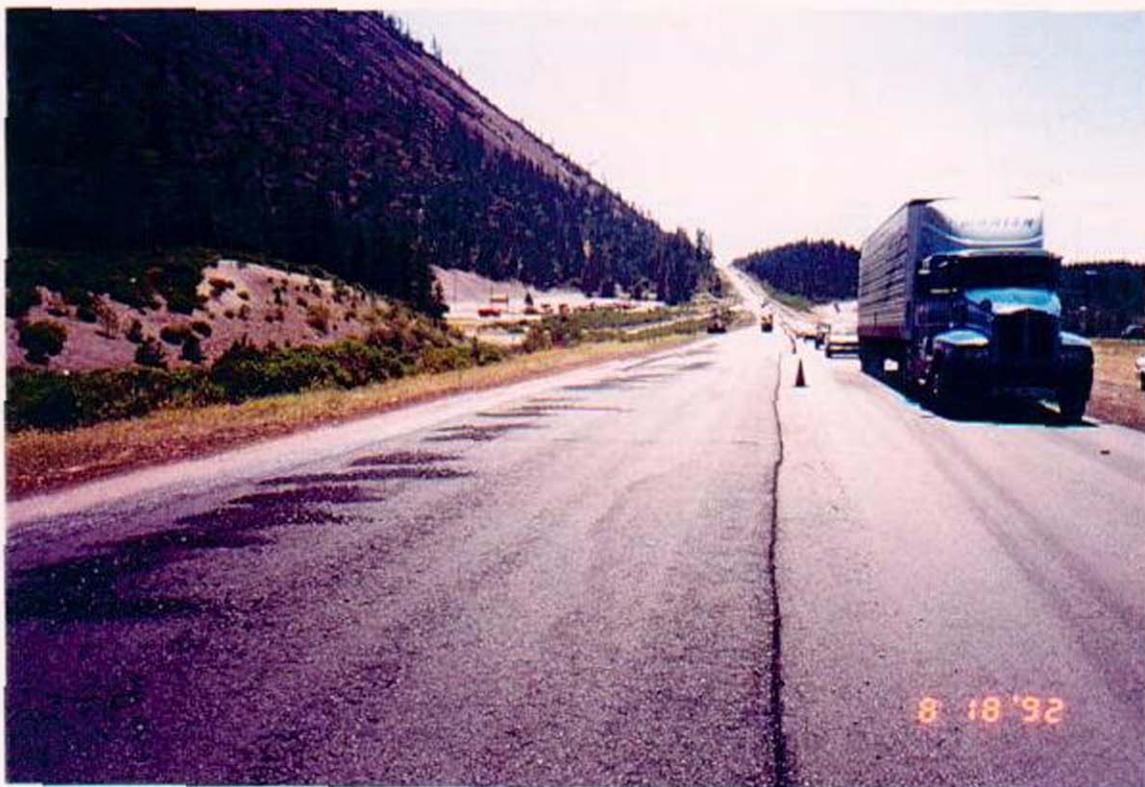
Photo 24. Section 060613, hand patches over rolled glass grid.
