# Highway Concrete Pavement Technology Development and Testing: Volume I— Field Evaluation of Strategic Highway Research Program (SHRP) C-202 Test Sites (Alkali-Silica Reaction (ASR))

PUBLICATION NO. FHWA-RD-02-082

AUGUST 2006

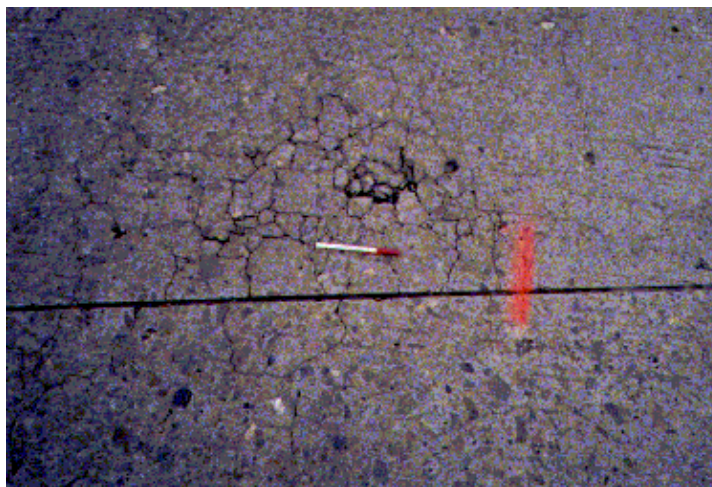
Figure 3 shows an example of joint distress of high severity, and figure 4 shows an example of joint distress of medium severity.

**Figure 3. Joint distress of high severity (Winnemucca, NV).**

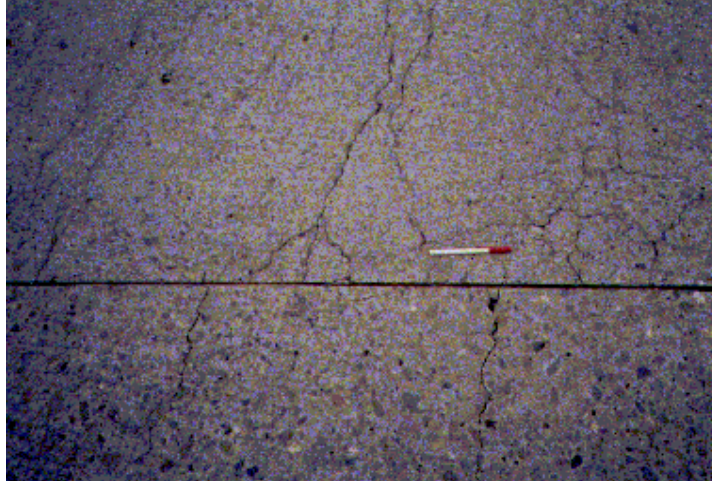
**Figure 4. Joint distress of medium severity (Winnemucca, NV).**

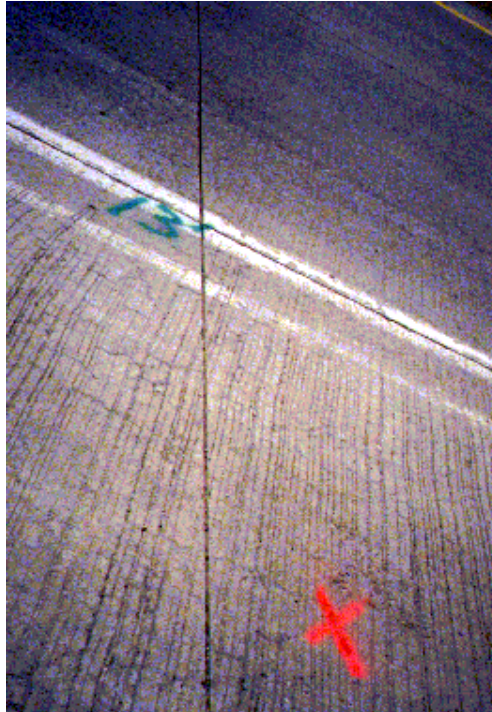
will be discussed and used to compare the sections. The severely map cracked areas typically appeared in the wheelpaths, especially at the joints. These areas represent locations where spalling or loss of concrete pieces has occurred or is likely to occur in the near future. Sometimes loss of base support and depressions occur. The number and area of interconnected “pockets” of severe cracking were noted during the visual survey and were recorded in category 8a in the SHRP LTPP recording sheets.

**Figure 11. Photograph showing widespread map cracking in shoulder area of Winnemucca test site.**

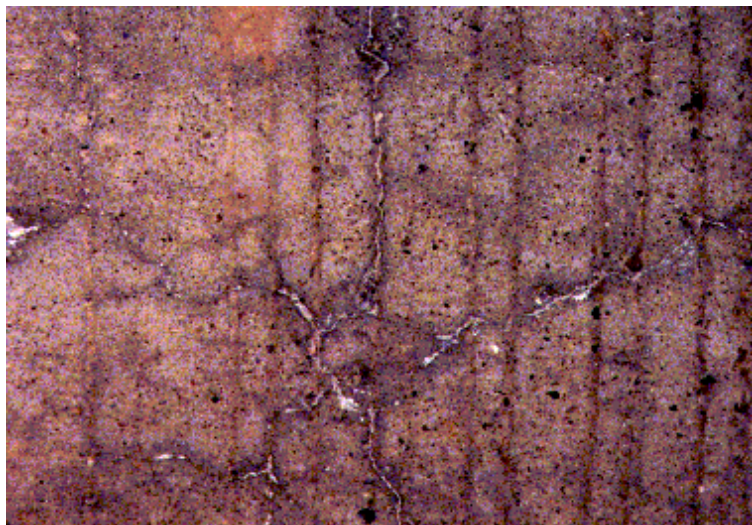
**Figure 12. Close-up of map cracking with efflorescence (Winnemucca, NV).**

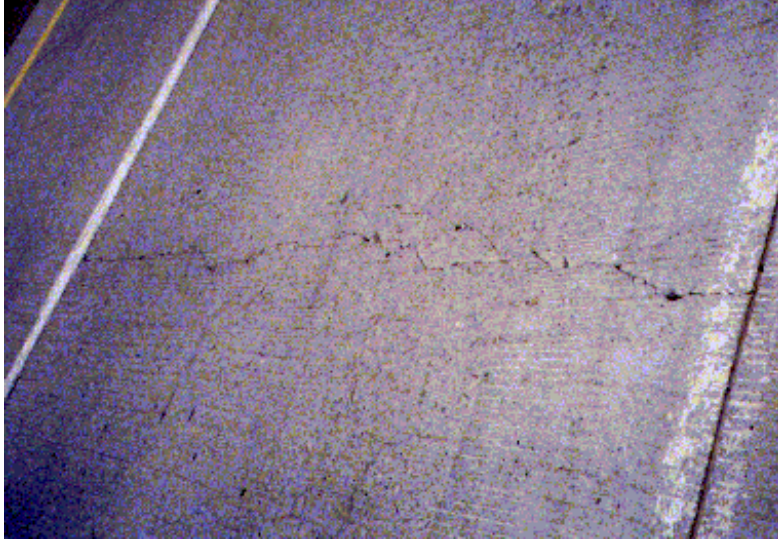
All of the test sections have several transverse cracks, such as that shown in figure 15. Some extend full width while others only reach partway across the lane. Some other transverse cracks, such as the one in figure 16, intersect with longitudinal cracks. A comparison of the transverse cracking for each year is shown in figures 17 through 21. Table 3 indicates the number of transverse cracks in each section for all years of the study. A transverse crack consists of a single distinct crack or a single crack with only a few branches. The number of transverse cracks in a section can decrease if the crack becomes part of an area of severe map cracking.

**Figure 15. Full-width transverse cracking in test section (Winnemucca, NV).**

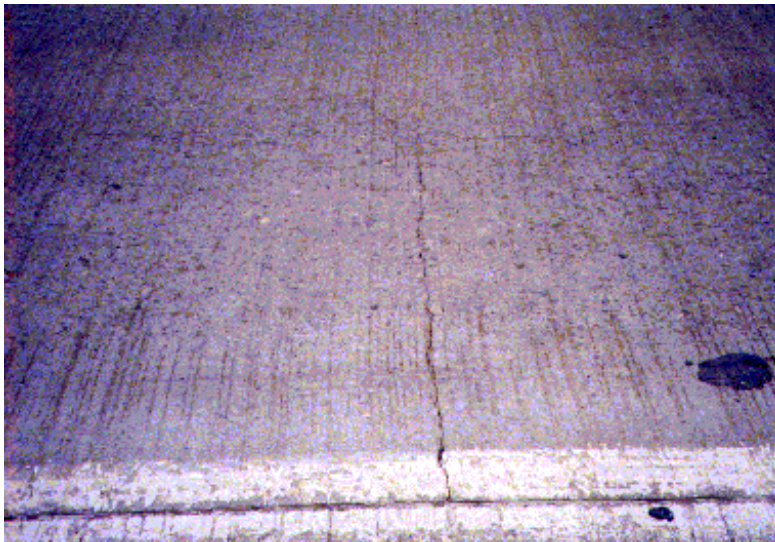
**Figure 16. Transverse cracking with intersecting longitudinal crack (Winnemucca, NV).**

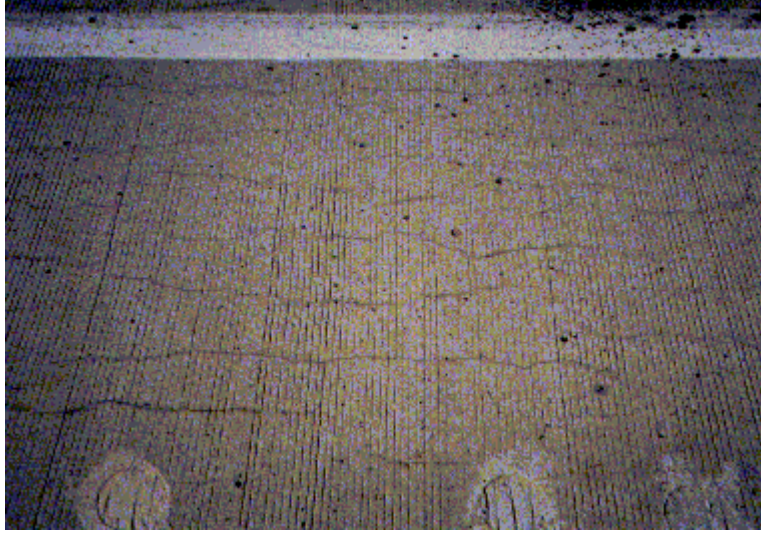
Extensive longitudinal cracking, with cracks more closely spaced near the longitudinal joint with the adjacent travel lane, was noted in all sections. The longitudinal cracks were usually short with no inter-connecting transverse cracks. Figures 23 and 24 show photographs of typical longitudinal cracking. Figure 24 also shows some of the typical asphalt patching along the longitudinal joint between the shoulder and travel lanes. The only areas within the sections not covered with longitudinal cracking are along the curb side. Table 15 gives a brief description of the condition of each section in 1998. The table follows the position of the test sections from the south to the north.

**Figure 23. Typical longitudinal cracking (Newark, DE).**

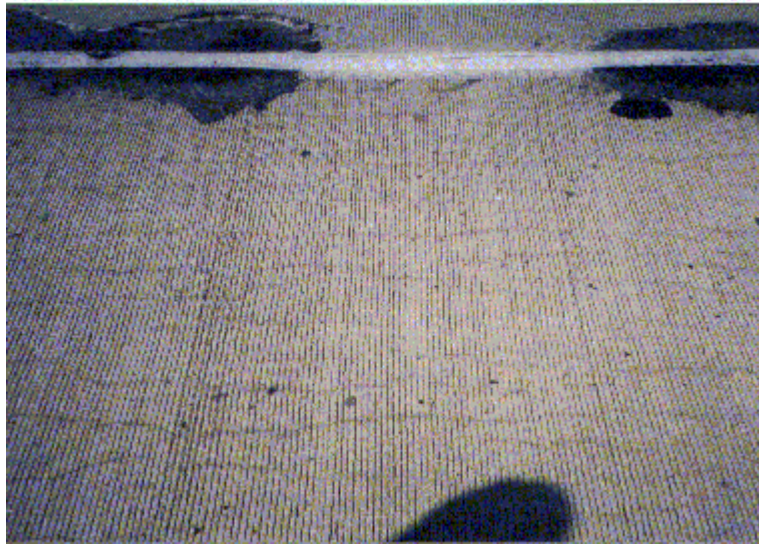
**Figure 24. Typical longitudinal cracking and example of asphalt patching along joint between shoulder and travel lane (Newark, DE).**

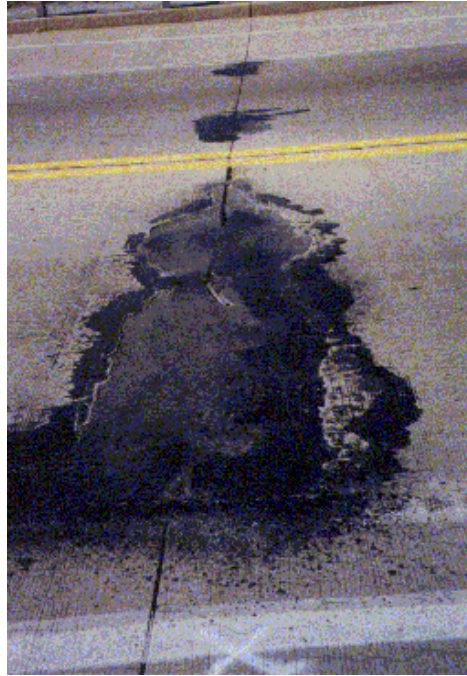
Many of the joints had been patched in the wheelpath areas with large asphaltic concrete patches. Figure 27 shows a typical asphalt concrete patch along a transverse joint in the travel lane. Also, extensive patching was noted on the traffic side of the longitudinal joint along test section 2. Figure 28 shows a patch in the center of the travel lane. Visual observations of the joints along the pavement were made of both the travel and passing lanes.

**Figure 27. Asphalt concrete patching along transverse joint in travel lane (Newark, DE).**

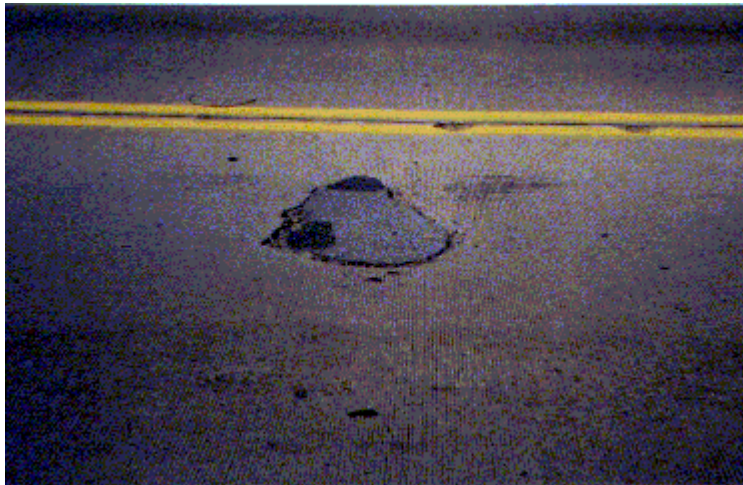
**Figure 28. Asphalt patch in center of section in travel lane (Newark, DE).**

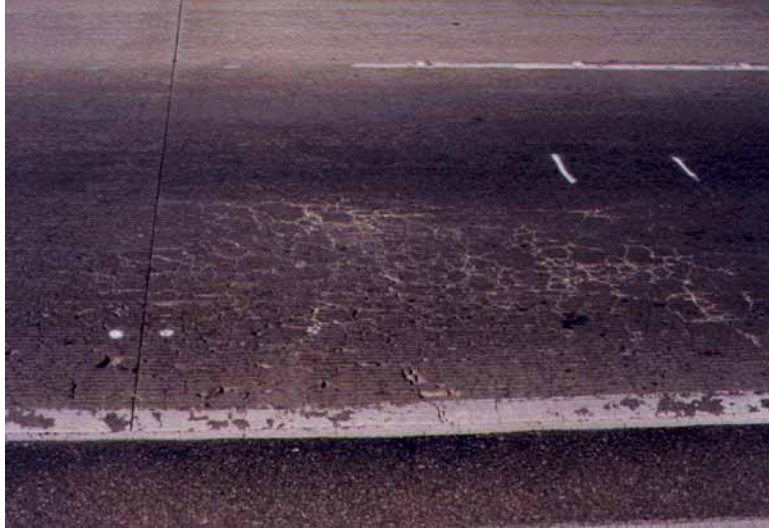
**Figure 39. Example of high-severity map cracking (Boron, CA).**

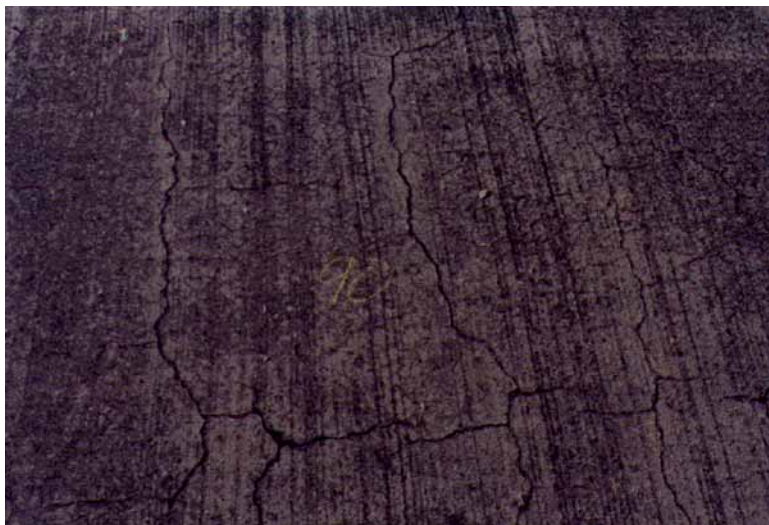
**Figure 40. Close-up photograph showing typical map cracking (Boron, CA).**

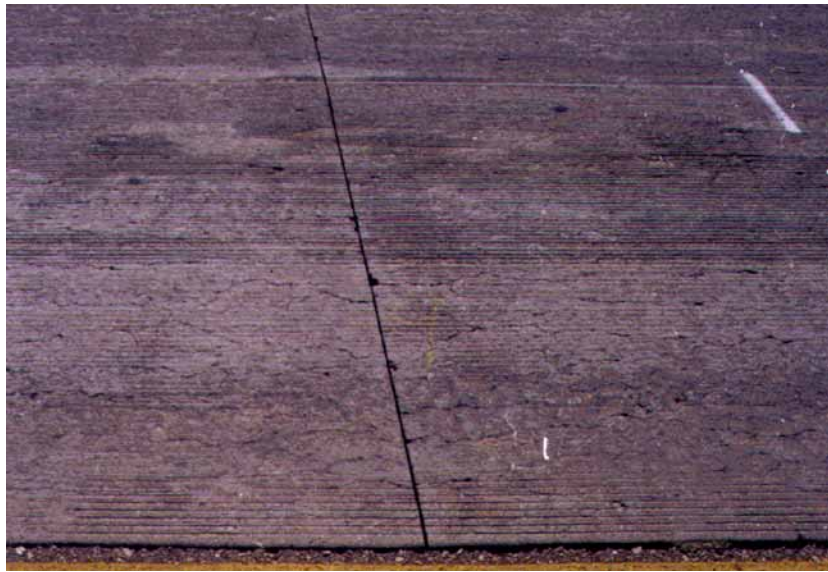
shows an example of high-severity joint distress. According to the LTPP criteria for rating joint distress, the entire length of each joint was rated at the highest severity level if at least 10 percent of the joint length had the higher severity distress.

**Figure 45. Photograph showing medium-severity joint distress (Boron, CA).**

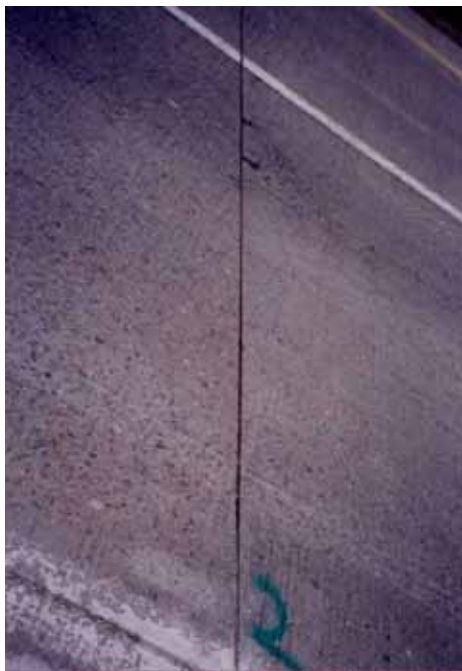
**(a)** Control section 3 (C3)

- Control 3 (C3)—This section is in slightly better condition than the other two control sections except that it has more transverse cracking. A considerable amount of high-severity spalling exists at the joints; however, a few areas within the transverse joints have not yet spalled.
- Lithium 2 (L2)—This section is performing better than the lithium 1 section, but it was initially in better condition. Some areas along the transverse joints are not spalled, and the

amount of high-severity spalling is less. The map cracking in the wheelpath is mostly medium severity with some low severity, and the cracking in the centerline area is roughly half low and half medium severity.
