# Highway Concrete Pavement Technology Development and Testing: Volume II— Field Evaluation of Strategic Highway Research Program (SHRP) C-203 Test Sites (Freeze-Thaw Resistance)

PUBLICATION NO. FHWA-RD-02-083

AUGUST 2006

U.S. Department of Transportation  
**Federal Highway Administration**

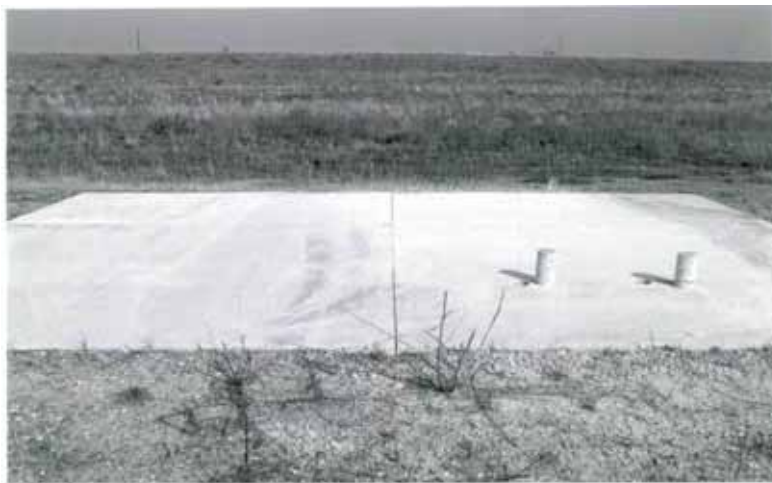
**Figure 1. Test panels for mixture MN7 showing cores taken in 1994.**

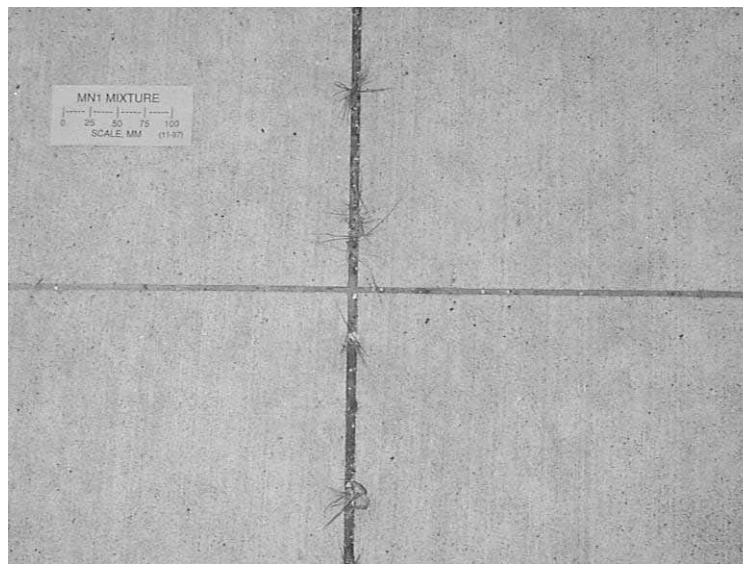
**Section 1—15 percent fly ash, 3.9 percent air content**—Very light surface scaling (visible sand particles are about 0.2 mm diameter) over the whole surface. See figure 2 for 1998 photograph of section 1.

**Figure 2. Photograph of Minnesota test section 1 (1998). Most of the surface texture (brooming) is still visible. Sand particles up to 2 mm are visible in a very lightly scaled surface.**

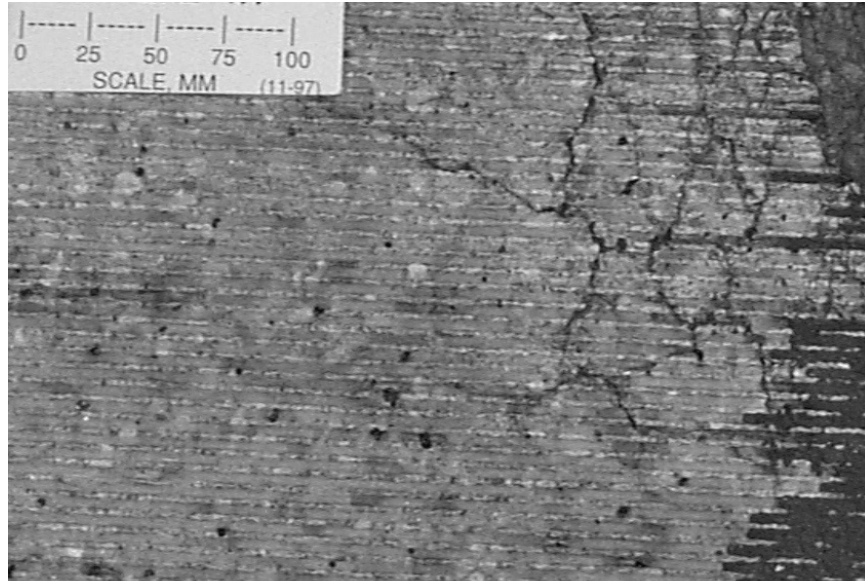
The patches were examined annually from 1994 through 1998. No additional surface defects were noted in any of the patches from 1994 through 1996. In 1997, surface map-pattern cracking was noted in varying degrees (see figure 4). The cracking was generally worse in the wheelpath near the transverse joints between the patches and the original pavement (figure 5). By 1998, the severity of the cracking had increased; some patches had been repaired with asphalt concrete where the deterioration had produced potholes.

Samples were taken from portions of the patches, and microscopic examination of the samples indicated that both cracks and air voids in the concrete were filled with ettringite.

**Figure 4. Surface cracking in patch, mixture I3  
(parallel lines on surface are the result of  
surface diamond grinding soon after construction).**

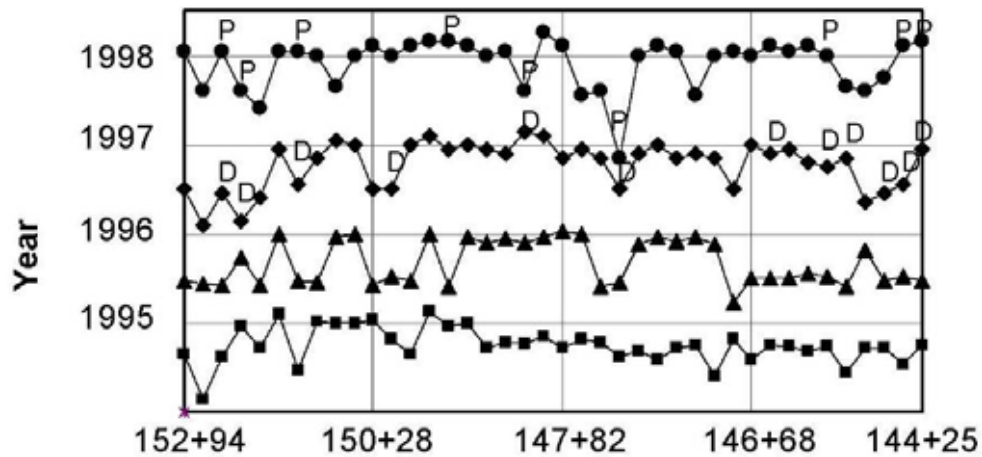
Figure 6. Field NDT velocity measurements.

However, an examination of the concrete velocity measurements indicates that many sections have some degree of deterioration. Direct comparisons of the velocity values from year to year cannot be made, probably because temperature effects could not be taken into account (pavement temperature measurements at either the surface or at depth were not part of the scope of work). By normalizing the data to the approximate maximum value recorded each year (assuming the maximum values represent non-deteriorated concrete), the values can be compared. Figure 6 shows the concrete velocities for each test joint for all 4 years of testing. Visual examination during 1997 and 1998 indicated cracking near the transverse joints, which appeared to be D-cracking. These joints are marked with a "D" in figure 6. Also, in 1998 tests could not be conducted at some of the transverse joint locations because the concrete near the joints was missing right adjacent to the joint or had been patched. These are marked with a "P" in figure 6. Tests were conducted (and test values are plotted in figure 6) for these locations, but the actual testing location was a few inches (depending upon the extent of the patching or damaged concrete) further back from the original joint location. Since D-cracking severity decreases with increasing distance from the joint, these test results labeled "P" can be expected to be higher than they would have been if the test could have been conducted right at the joint.

D-cracking has reappeared adjacent to some of the patches and can be identified both visually and with the NDT velocities (Vokes et al., 1997). Areas with visual D-cracking are identified with a “D” in figure 6. D-cracking has reappeared in all of the sections made with aggregate having a 25-mm top size, except for three of the sections listed as being on ATB, which may reduce the moisture availability from the subbase. This suggests that none of the edge treatments was successful in significantly delaying the return of D-cracking. D-cracking has returned to some of the sections made with 19-mm aggregate, and the 19-mm sections with no evidence of D-cracking include both treated sections and control sections with no treatment. A few of the 12-mm sections also have D-cracking but, as expected, the smaller aggregate size has reduced the D-cracking potential.
