# Highway Concrete Pavement Technology Development and Testing: Volume IV— Field Evaluation of Strategic Highway Research Program (SHRP) C-206 Test Sites (Early Opening of Full-Depth Pavement Repairs)

PUBLICATION NO. FHWA-RD-02-085

AUGUST 2006

U.S. Department of Transportation  
**Federal Highway Administration**

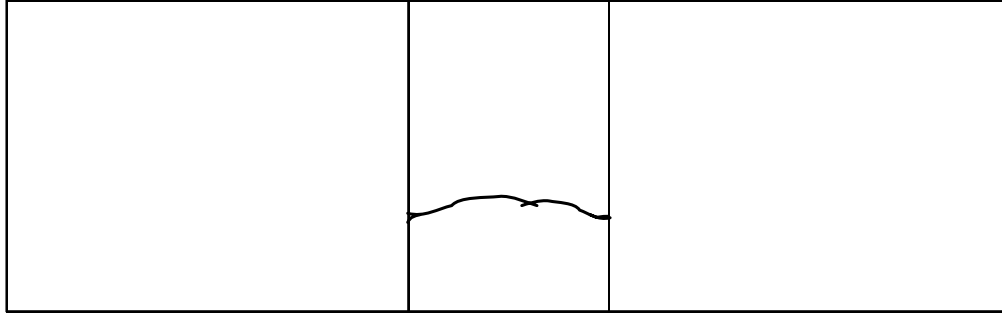
By far the most significant distress in the Ohio test sections is the early development of longitudinal cracking in nearly all repairs. Typical longitudinal cracking at this site is illustrated in figure 8. These cracks typically occurred in about the outer one-third of the slab. The rate of development of longitudinal cracking in Ohio sections is shown in figure 9. By the 2-month follow-up survey conducted under SHRP C-206, 100 percent of the FS section and 90 percent of the RSC 1 section had developed longitudinal cracking. By the time of first survey under this project in 1994, five of the eight sections had developed additional longitudinal cracking. Under SHRP C-206, the following were identified as possible causes of the cracking problem:

- The restriction of horizontal movement in the transverse direction caused by dowels.
- Excessive curling stress.
- Excessive compressive force exerted on the repairs by surrounding concrete.

**Figure 8. Illustration of typical longitudinal cracking in Ohio sections.**

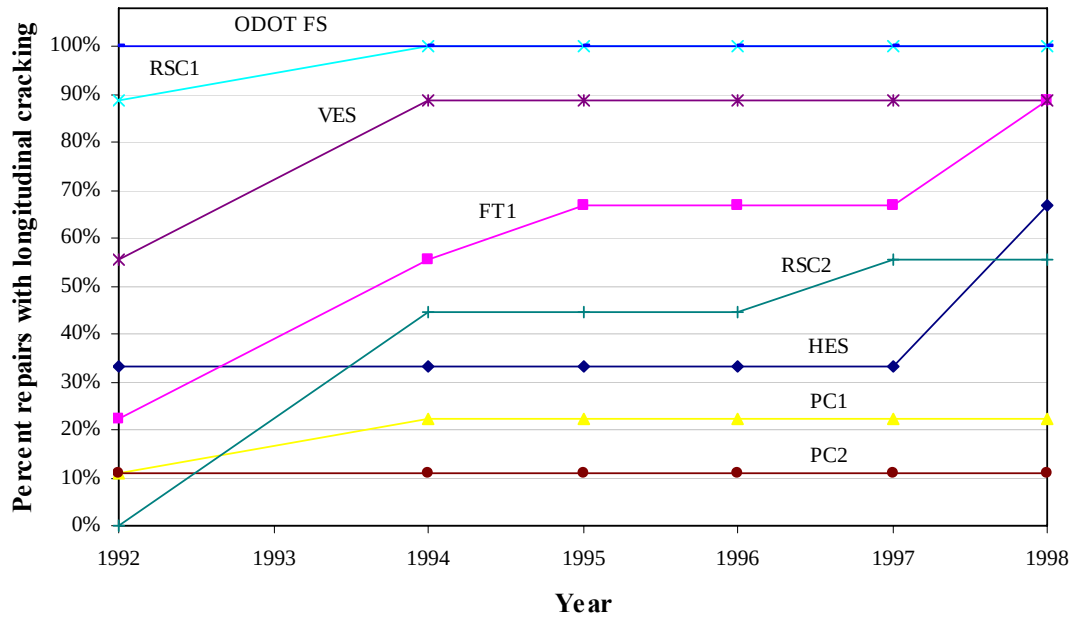
**Figure 9. Development of longitudinal cracking in Ohio sections.**

Of the three potential causes considered, the last (excessive compressive force) is unlikely, because the repair concrete was set during the hottest part of the day. By the time the repairs were opened to traffic (typically 5:30 p.m.), the surrounding concrete was well into the daily cooling cycle. Excessive built-in curling, in combination with a highly nonlinear negative temperature gradient, can cause top-down cracking (overnight, in extreme cases); however, a high rate of cracking also occurred in sections that had relatively low temperature gradients at the time of concrete hardening. On the other hand, the RSC 2 section, which had a very high temperature gradient at the time of concrete hardening, had a relatively low level of cracking (none at the time of the 2-month evaluation). Temperature conditions at the time of concrete hardening and peak temperatures reached during hydration are summarized in table 7.

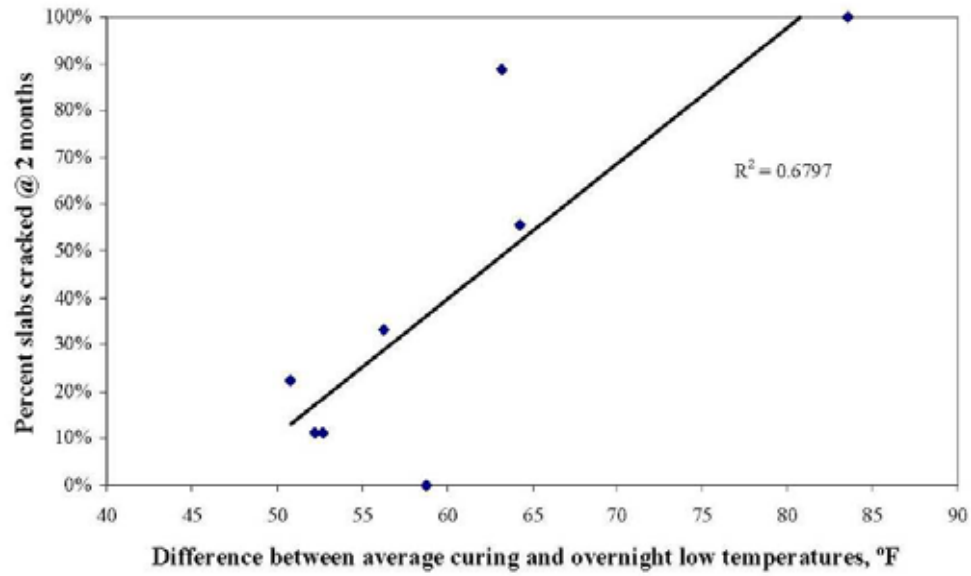
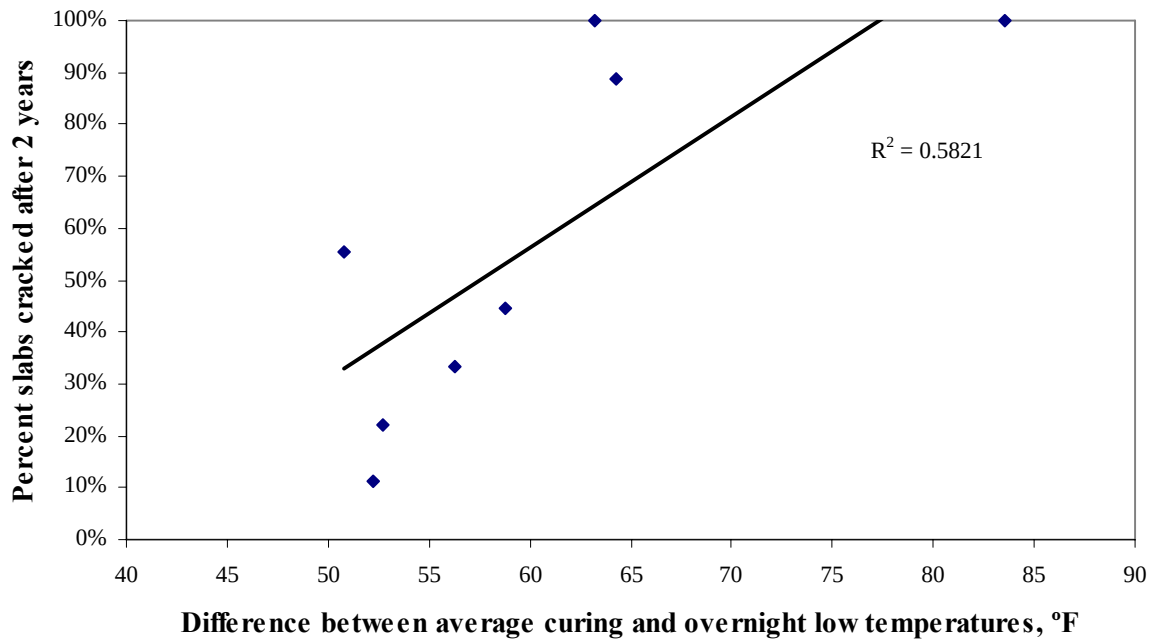
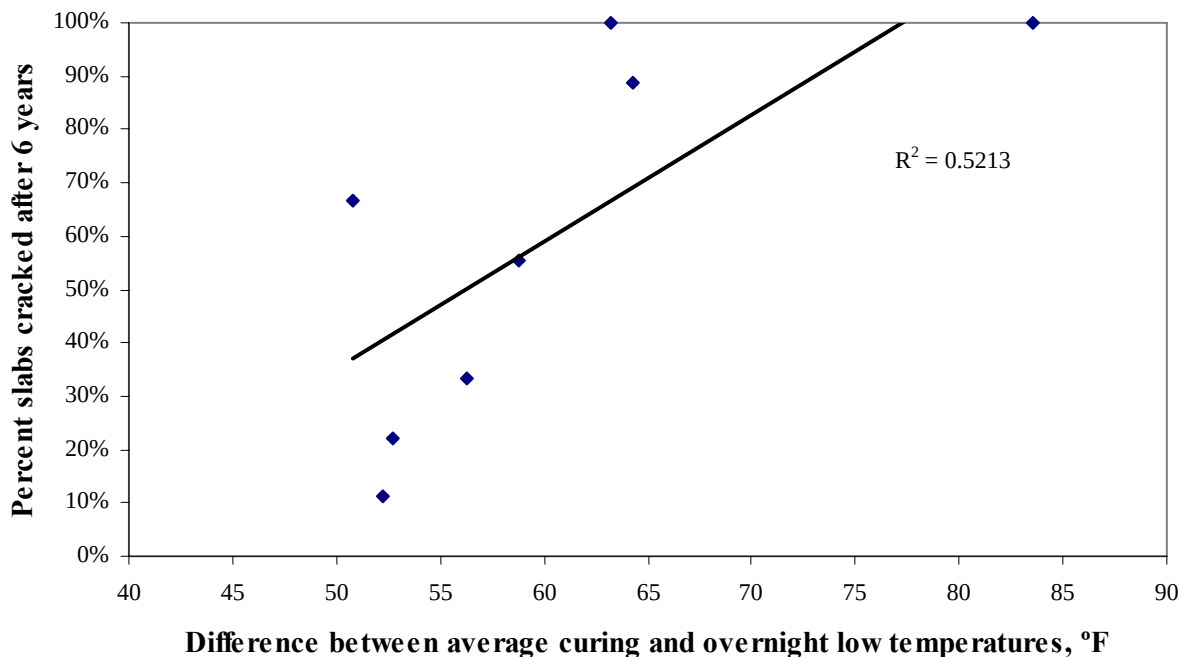
correlation between this parameter and longitudinal cracking in Ohio sections is shown in figures 10, 11, and 12 for the correlation at 2 months, 2 years, and 6 years of age. Figure 10 shows excellent correlation between this parameter and longitudinal cracking. If the cracking is caused by dowel restraint (of the horizontal movement in the transverse direction), this should be an effect that mostly influences the early-life behavior. Various factors would alleviate this effect at later ages, including creep and higher material strength. This is consistent with the trends shown in figures 10, 11, and 12. The best correlation is exhibited in figure 10 at 2 months of age, and the correlation becomes progressively worse for later ages.

The results shown in table 9 and figures 10 through 12 strongly suggest that the climatic conditions during construction played a major role in early development of longitudinal cracking in the Ohio sections. Figure 10 shows that if the difference between average curing temperature and overnight low temperature is less than about 10 °C (50 °F), the risk of developing longitudinal cracking due to dowel restraint is relatively low. That difference was less than 5 °C (41 °F) for all the Georgia sections, and none of the Georgia sections developed longitudinal cracking.

The risk of early age cracking can be evaluated using FHWA's software HIPERPAV (McCullough and Rasmussen 1999; Forster 1998). The software takes key environmental, structural design, mix design, and construction inputs and generates a graph showing the development of PCC strength and stress over the first 72 hours after placement. If the stress exceeds the strength at any time, a high potential for uncontrolled cracking is indicated. For such cases, adjustments can be made to mixes, curing practice, or time of PCC placement to reduce the potential for cracking. Where a significant difference between the average curing temperature and overnight low temperature is possible (i.e., greater than 10 °C (50 °F)), the use of HIPERPAV is recommended.

- The temperature data from the Ohio site suggest that the risk of longitudinal cracking is high if the difference in average curing temperature and nighttime low temperatures exceeds about 10 °C (50 °F). The use of HIPERPAV is recommended in adverse conditions to avoid premature failures.

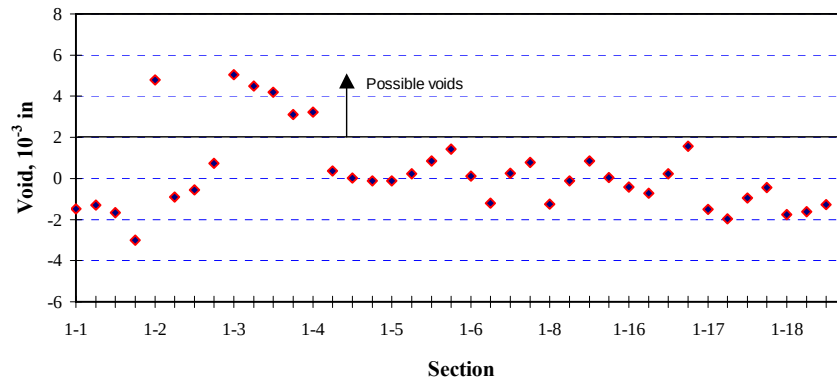
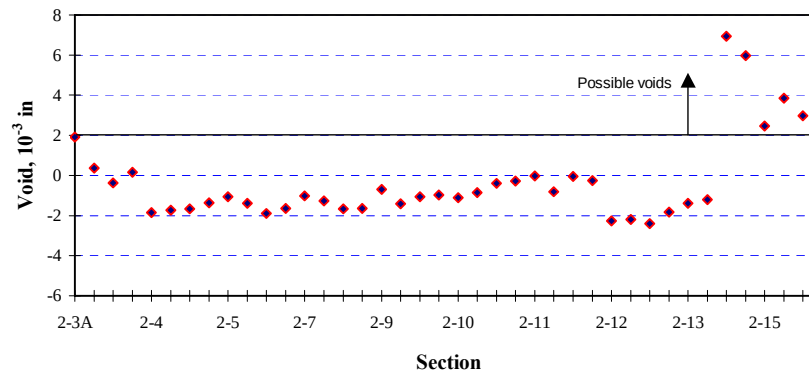
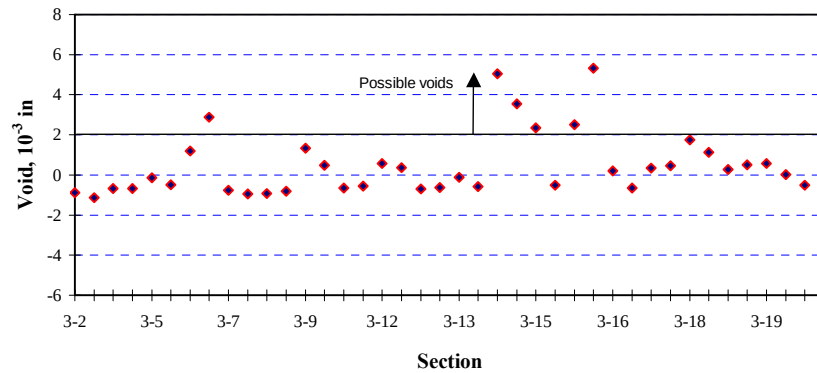
The intercept values from the load-deflection plots are shown in figures A4, A5, and A6. The figures show possible voids under the repairs 1-3, 2-13, 2-15, 3-13, and 3-15, but most joints tested show good support under the joints. These results show that the slabs were not curled up at the time of testing.
