Highway Concrete Pavement Technology Development and Testing: Volume V— Field Evaluation of Strategic Highway Research Program (SHRP) C-206 Test Sites (Bridge Deck Overlays)

PUBLICATION NO. FHWA-RD-02-086

AUGUST 2006

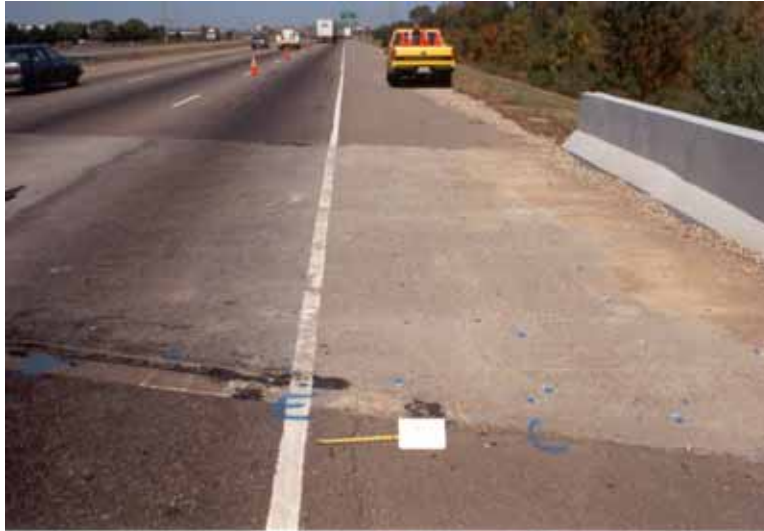
Figure 2. Photograph showing test section on I-270 northbound (1995).

The test sections studied on both spans include the shoulder and travel (outside) lanes. Examination of the deck overlay surface indicated several narrow longitudinal cracks in the shoulder lanes of both bridges. Cracks were more frequent in the travel lanes. The travel lane of the northbound SFC bridge had mostly single nonconnected cracks running in both the longitudinal and transverse directions with very little branching. The travel lane of the southbound LMC bridge had more and longer longitudinal cracks and also more branching of cracks.

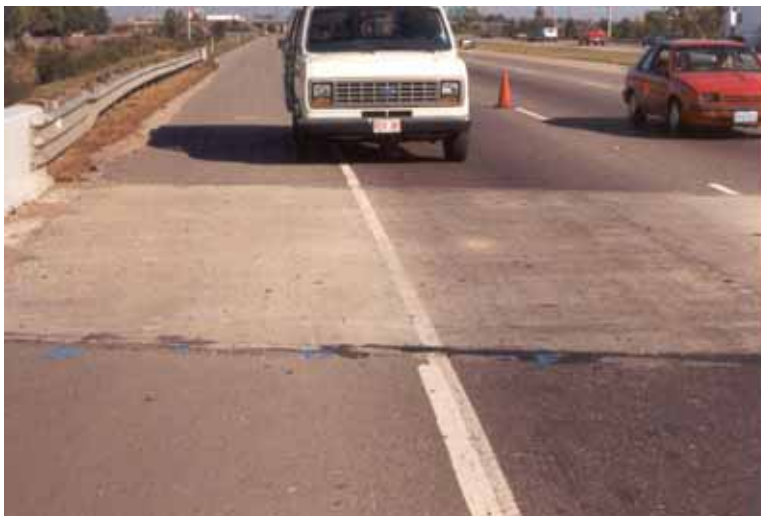
Figure 3. Photograph showing test section on I-270 southbound (1995).

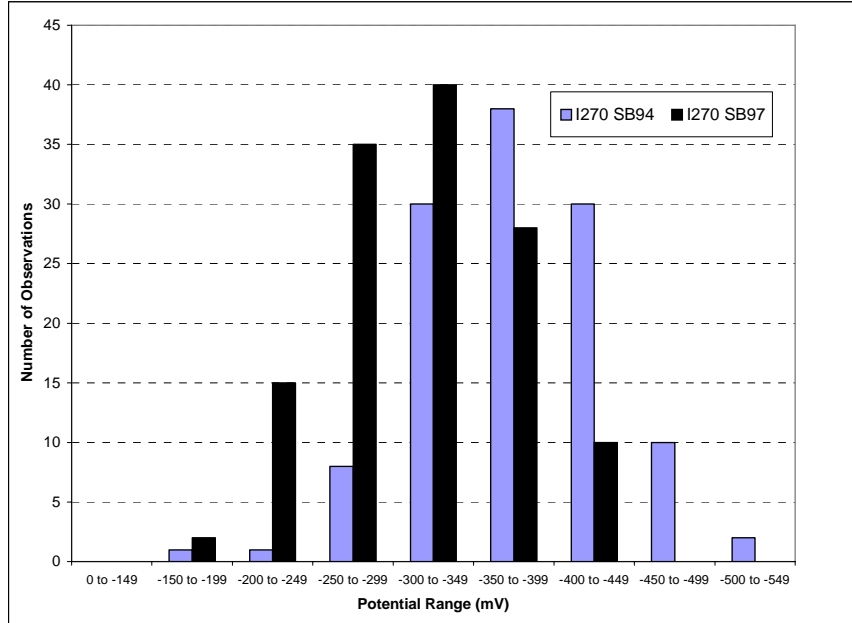
Figure 6. Histogram of half-cell potential readings for the I-270 southbound LMC-III test section for 1994 and 1997.

The half-cell potentials for the southbound LMC span in 1994 range from -188 mV to -540 mV. A cumulative percentage summary of the data is shown in table 6. The data for 1997 is shown in table 7. For 1997 the data ranges from -167 mV to -449 mV. A histogram of the data for the southbound LMC test section for the years 1994 and 1997 is shown in figure 6. The potential generally shift less negative (less corrosion) in 1997 versus 1994.

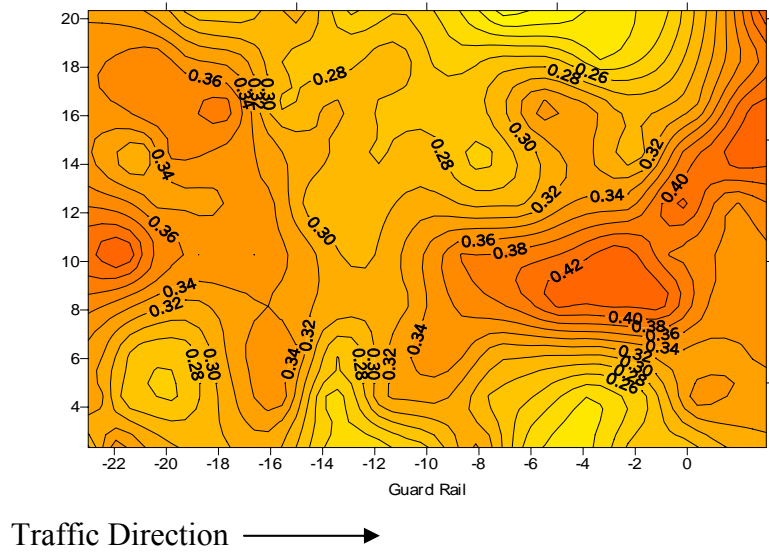
Figure 7. Equipotential map of half-cell potentials for I-270 southbound (latex-modified concrete).

An equipotential map of the half-cell data for the I-270 southbound test section in 1997 is shown in figure 7. The most negative potentials were seen in the areas of the construction joint, the ends of the bridge, and near cracked delaminations. The majority of the readings were more negative than -250 mV. Also, indicative of corrosion in the structure are the relatively large differences in potential across the area surveyed, as indicated by the closely spaced lines on the contour plot. The most negative potentials along the edges of the bridge, the construction joint, and the cracked delamination indicate that the overlay is not providing sufficient protection from water and waterborne chlorides in these locations.

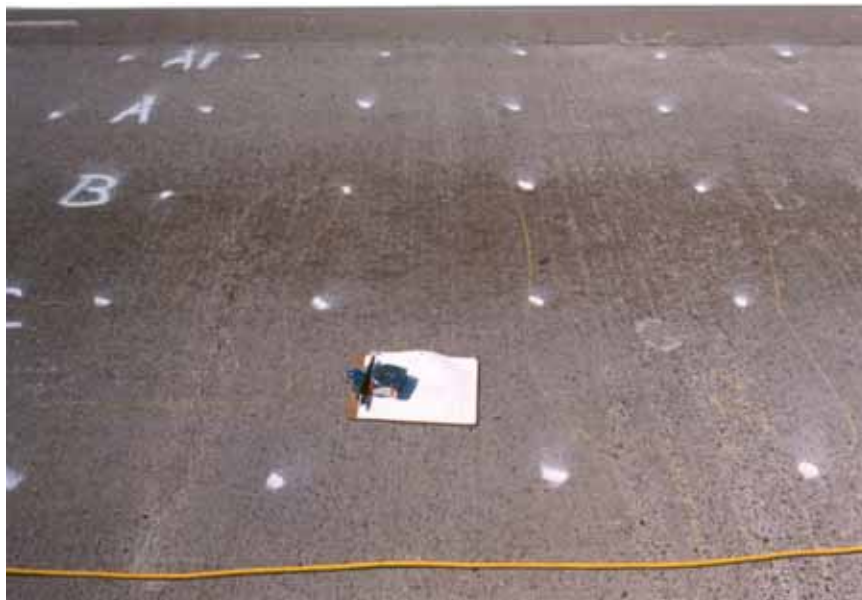
Inspection of the deck surface of the northbound LMC structure indicated the performance of the three spans was quite different, with Spans 1 and 3 exhibiting heavy transverse and longitudinal cracking and Span 2 exhibiting hardly any cracking. Figure 25 shows typical cracking on the northbound deck. Over the last two years of the study the cracking became worse. Several cracks had lengthened or were becoming interconnected with other cracks. The surface of all three spans in the driving lane was heavily abraded compared to that of the passing lane.

Figure 25. Photograph showing typical cracking found in the northbound deck of the U.S. 41 test section LMC.

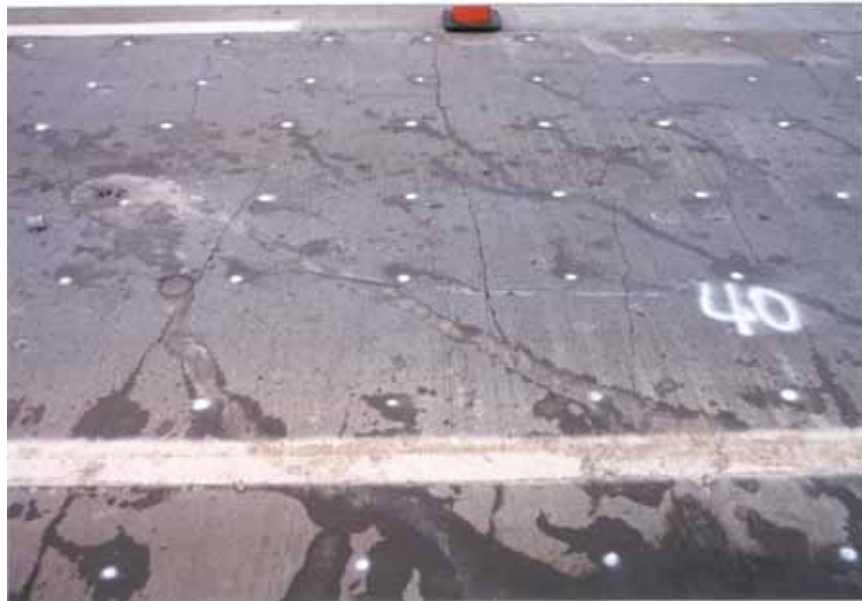
Inspection of the deck of the southbound SFC structure revealed the three spans also performing differently. Span 1 was different than Spans 2 and 3 due to its many large and raveled cracks. Many of the cracks increased in length or joined nearby cracks over the five years of the study. In Spans 2 and 3, many of the newer cracks were longitudinal but a few transverse cracks also developed. Span 3 was more heavily cracked than Span 2. In the last year of the study, many of the cracks in the two spans that earlier were only visible after a rainstorm, were now plainly visible when the deck was dry. Figure 26 shows some typical cracking associated with the southbound test section.

The southbound test section SFC is performing well. No delaminations were found in any of the spans in 1994 or 1995 and the center span had no delaminations found in any year of the study. The total delaminated area of all three areas is 6.59 m² (71 ft²), 3.72 percent of the total area. The northbound LMC test section performed much worse than the southbound SFC section. All three spans of the northbound structure had delaminations in the first year of the study (1994). The center span is performing the best with only 4.46 m² (48 ft²) square meters or 7.55 percent of the area delaminated. The two end spans are performing much worse with 16.40 m² (176 ft²) (27.8 percent) and 11.47 m² (123 ft²) (19.4 percent) of the surface area delaminated.

Figure 26. Photograph showing typical cracking associated with the southbound test section of U.S. 41 SFC.
