# LTPP Pavement Maintenance Materials: PCC Partial-Depth Spall Repair Experiment, Final Report

PUBLICATION NO. FHWA-RD-99-153

OCTOBER 1999

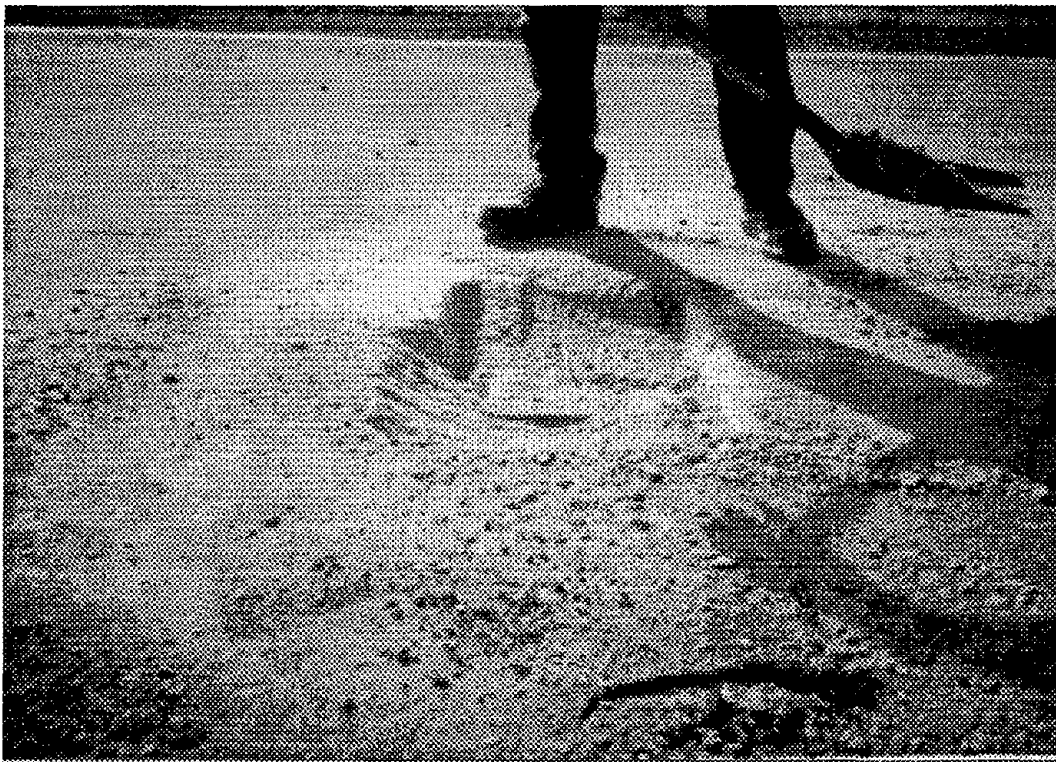
Figure 17. Patch area for milling operation.

The milling machine is very efficient in removing large areas of spalled concrete. With a milling head of 0.3 m, the smallest currently available for this use, the repair area will be a minimum of 0.09 m<sup>2</sup>. Therefore, if the area to be repaired is small, the patch may be larger than necessary. The exposed bottom surface of the concrete created by milling is very rough and very level, as shown in figure 17. The hole created by the operation will tend to be concave, rather than vertical, at the boundaries that are perpendicular to the direction of the milling. The milling operation also caused spalling on the edges of the adjacent pavement. The removed concrete becomes a fine slurry that is easy to wash away. The size of the machine and the location of the milling head in relation to the rest of the equipment affects the efficiency of the removal operation.

The orientation of the concave edges was parallel to the direction of traffic where possible. However, because of traffic constraints, the equipment was not always able to maneuver into such an orientation. It may be desirable in such cases to chisel the edges to form a vertical face. This was done on all but one test section in Arizona. Cementitious materials, in particular, may not perform well when feather-edged.

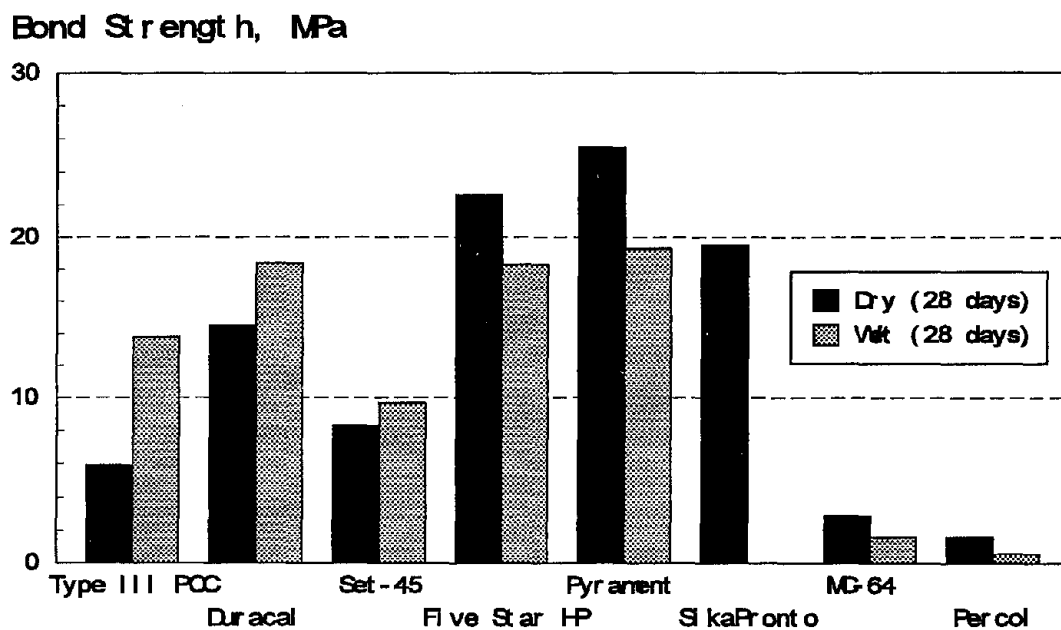
Figure 19. 28-day slant-shear bond strengths of spall repair materials.

Bond strength is thought to be an important factor in determining field performance. The bond strengths of the spall repair materials are shown in figures 19 and 20. It is interesting to note that, in general, the bond strengths of the materials that were specified to be installed wet decreased when tested using a dry substrate, and materials that were specified to be installed dry lost bond strength when tested using a wet substrate.

Several exceptions to that statement should be noted. Percol FL, whose manufacturer claims that the material is moisture-tolerant, lost strength significantly when applied to a wet substrate. Also, Five Star HP and Pyrament 505 manufacturers recommended that their materials be applied to a saturated, dry (SSD) surface. The slant-shear and center-point bond strength tests indicated that the bond strength was weaker when applied to a wet substrate. It can also be seen that some materials were more tolerant of changed conditions than others. A partial listing of the results of the tests for the cementitious and polymeric materials is given in table 11. Table 12 gives the results of the tests on the bituminous materials when tested using a wet substrate.

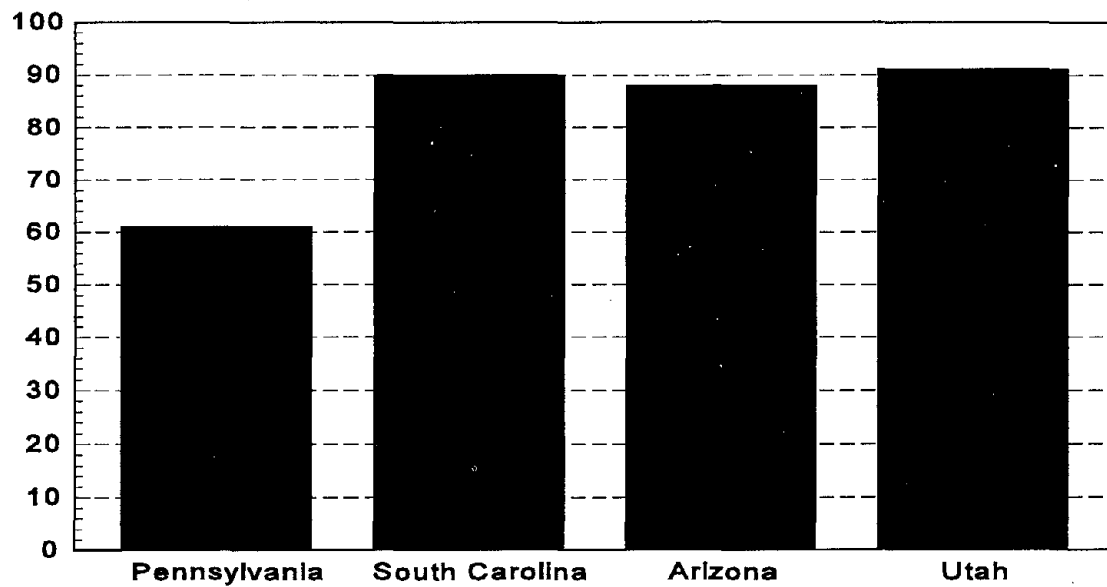
Figure 21. Percentage of surviving patches by test site.

The percentages of surviving patches at the final inspection for each site are shown in figures 21 through 23, grouped by site, procedure, and materials, respectively. It is important to note that these charts do not provide rankings of patch performance, but are simply a means of showing the overall performance percentages. Chapter 5 presents the statistically
