# Long-Term Effects of Electrochemical Chloride Extraction on Laboratory Specimens and Concrete Bridge Components

PUBLICATION NO. FHWA-HRT-10-069

SEPTEMBER 2011

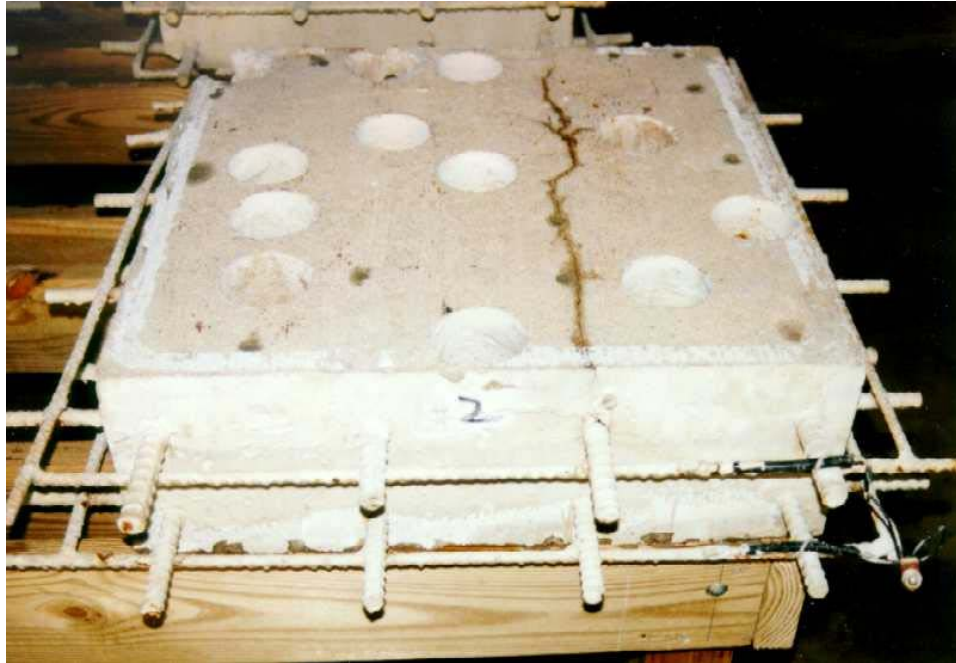
From August 1994 to the last survey in May 1998, additional cracks were observed on the top surface and the sides of the slab. A few hairline cracks were observed in 1995 on the top surface of the slab, which were not associated with any reinforcing steel.

**Figure 4. Photo. Condition of crack on the top surface of slab 2 in August 1994.**

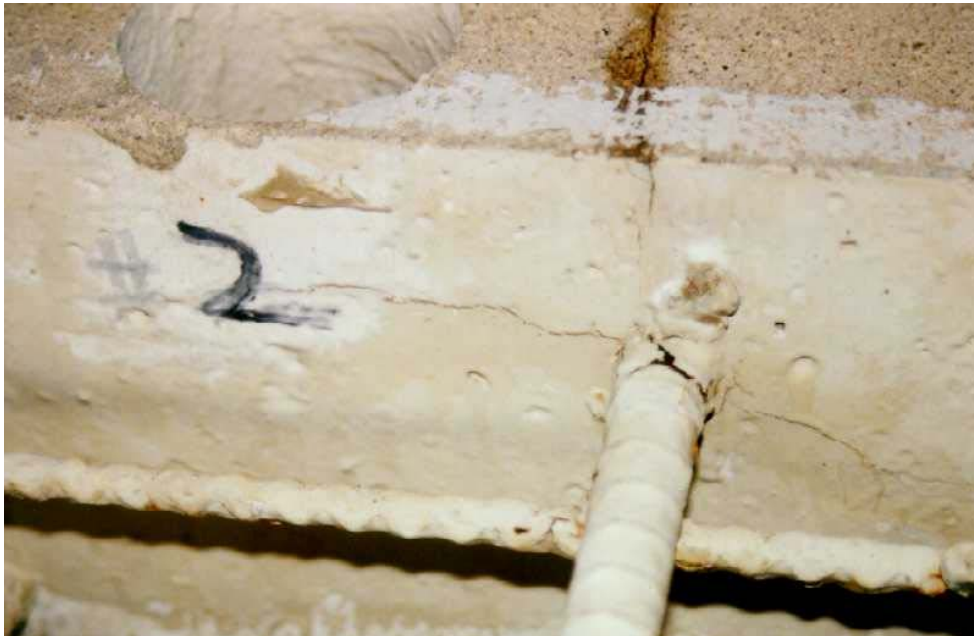
**Figure 5. Photo. Termination of the top crack and other cracks on the front side of slab 2 in August 1994.**

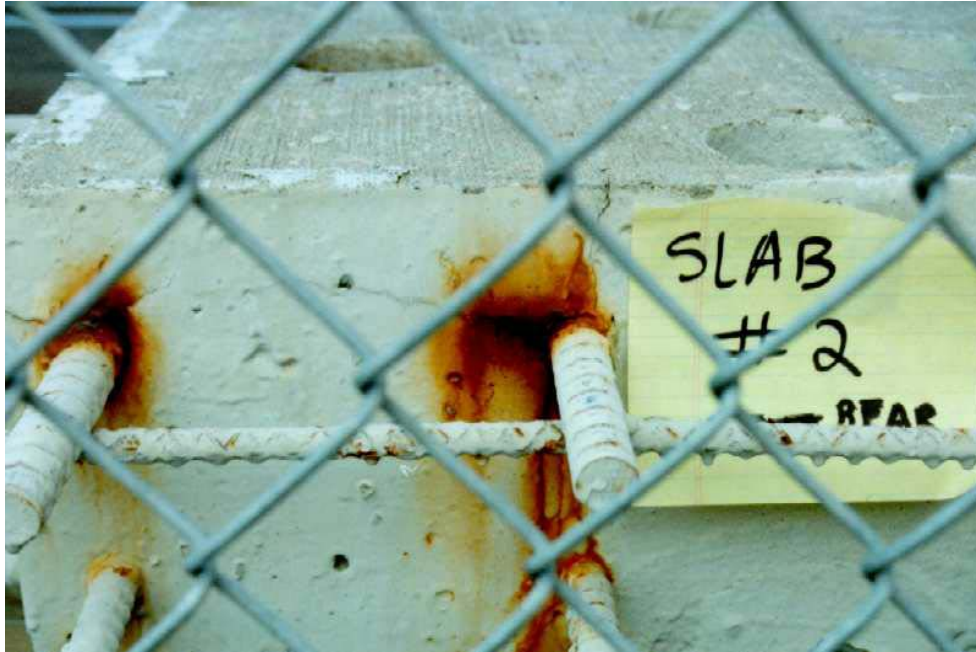
**Figure 6. Photo. Cracks and corrosion products on the rear side of slab 2 in August 1998.**

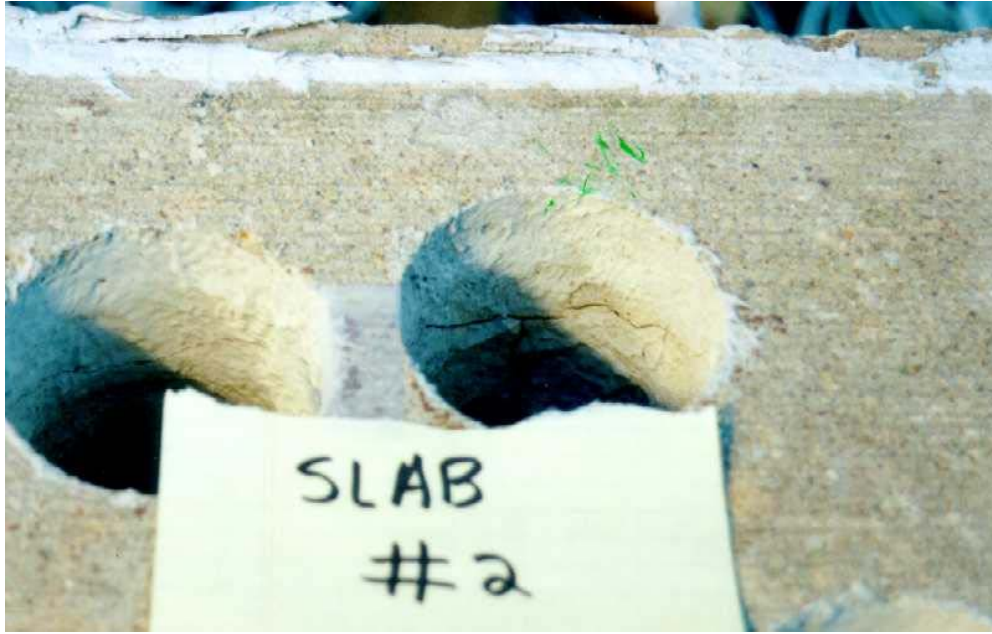
Cracks were also noted on the inside of core holes, and these cracks exhibited rust staining (see figure 7). Cracks in the core holes were determined to be at the level of the reinforcing steel. Corrosion of the ends of the rebars exposed in core holes was also noted (see figure 8). The cracks on the sides of the slabs continued to form and grew wider over time. They primarily originated at the external section of the rebars. On one side of the slab, a crack either connected or just passed over all four rebars protruding out of the concrete (see figure 9). Rust staining was observed on some of these cracks.

**Figure 7. Photo. Cracking and rust staining at the level of reinforcing steel in core holes of slab 2.**

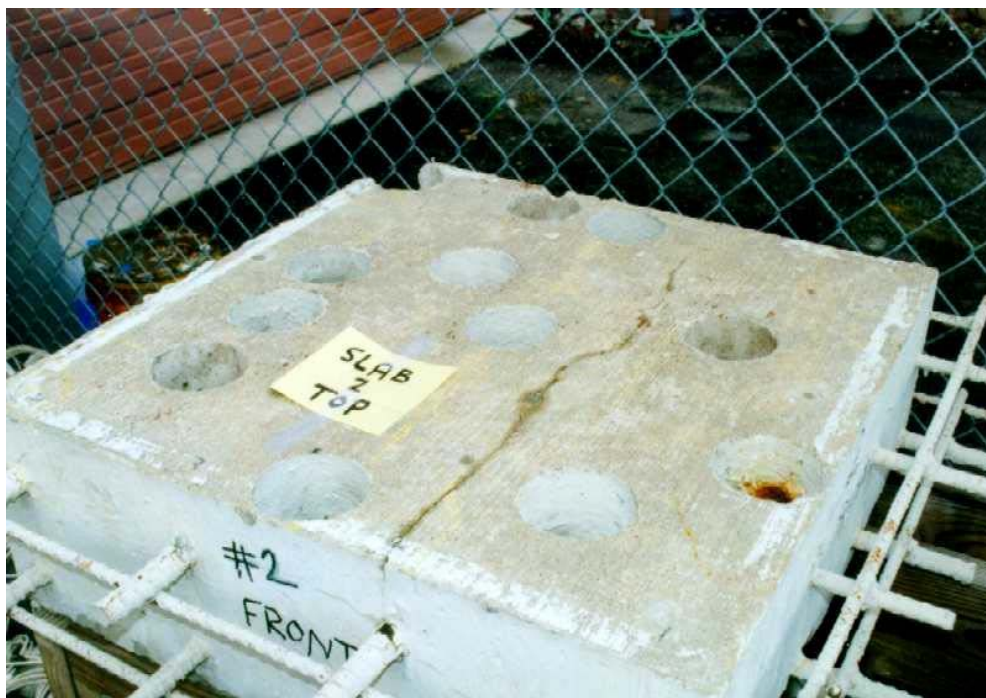
**Figure 8. Photo. Corrosion on the ends of rebars exposed in core holes of slab 2.**

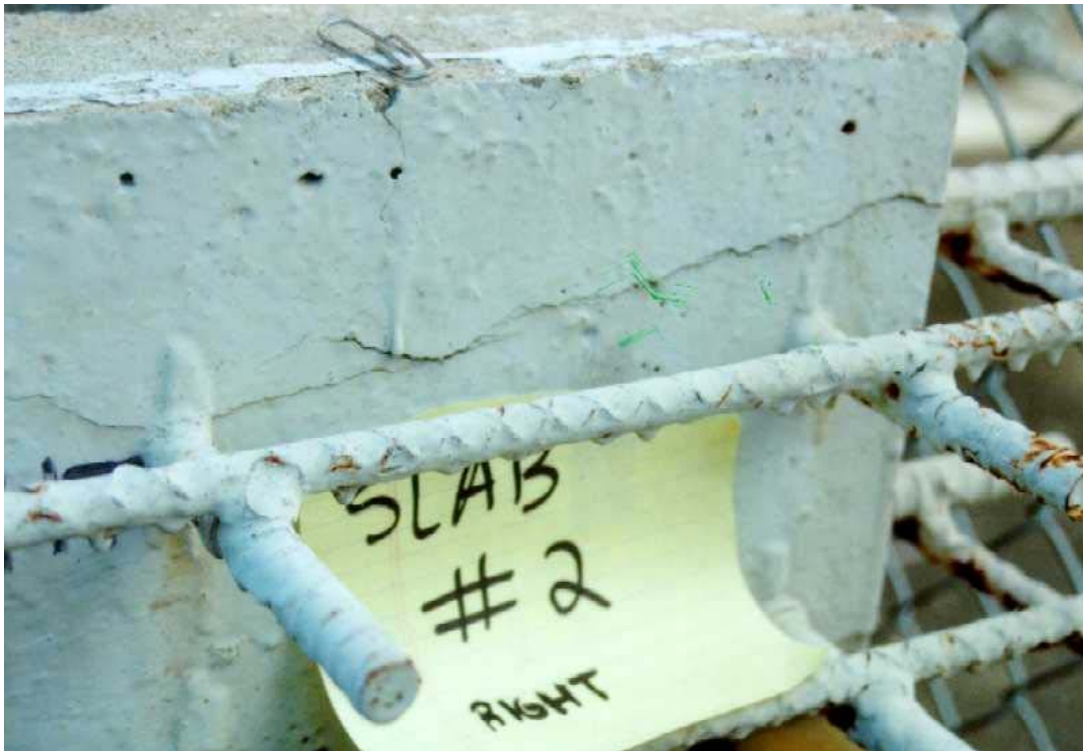
**Figure 9. Photo. Crack on the right side of slab 2.**

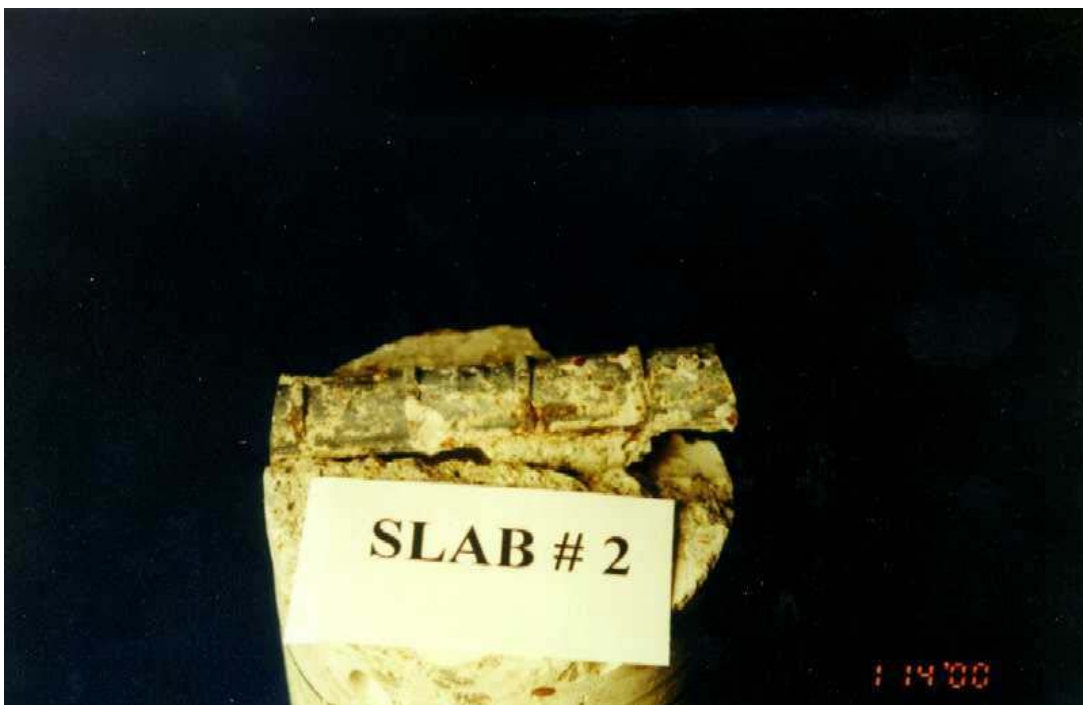
Delaminations detected on the surface of the slab increased, and by the end of the study, approximately 66 percent of the slab surface was delaminated. The presence of the crack along the rebar, cracks in the core holes, and cracks on the sides of the slab correlated with the delaminations that were detected. An autopsy of the single core collected from the slab in December 1999 indicated ongoing corrosion in localized areas of the extracted rebar. Expansive corrosion is shown figure 10.

**Figure 10. Photo. Autopsy of core extracted from slab 2 in December 1999.**

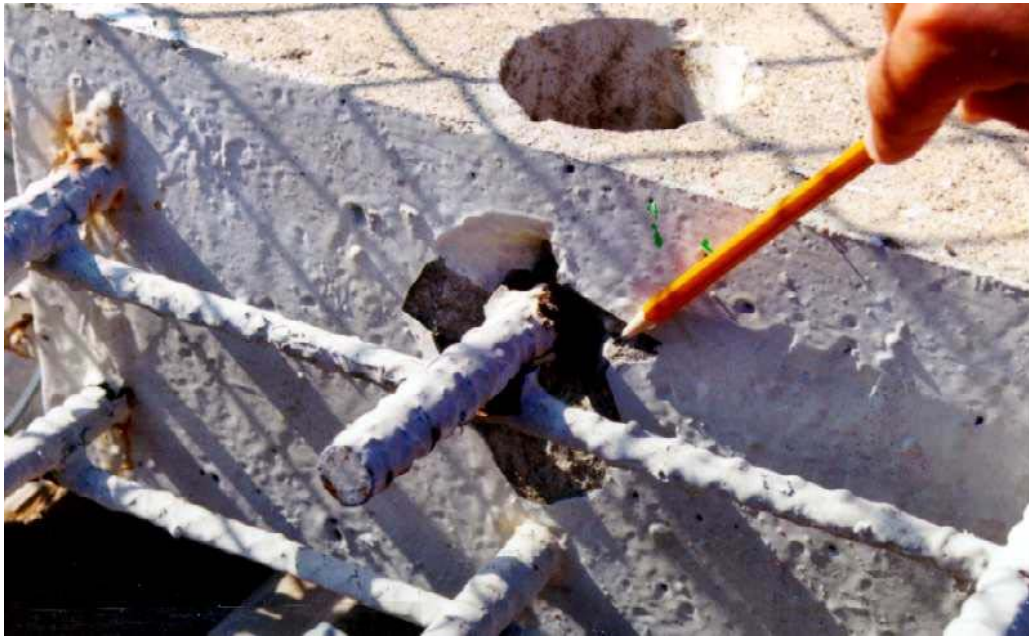
In early 1995, slabs 3 and 4 started showing cracks on the sides, which widened and increased over time. Similar to the cracks on slab 2, many of these cracks originated at the protruding rebars and either connected or passed over them. Corrosion of the rebars just inside the concrete on the side of the slab resulted in a spall on slab 3 by September 1997 (see figure 11). Rust stains accompanied by cracks were observed on the sides of slab 4 as well (see figure 12). Corrosion of the rebar just inside the concrete also resulted in a delamination on slab 3 (see figure 13).

**Figure 11. Photo. Corrosion and spalling on one rebar at the concrete-air interface on the side of slab 3 in September 1997.**

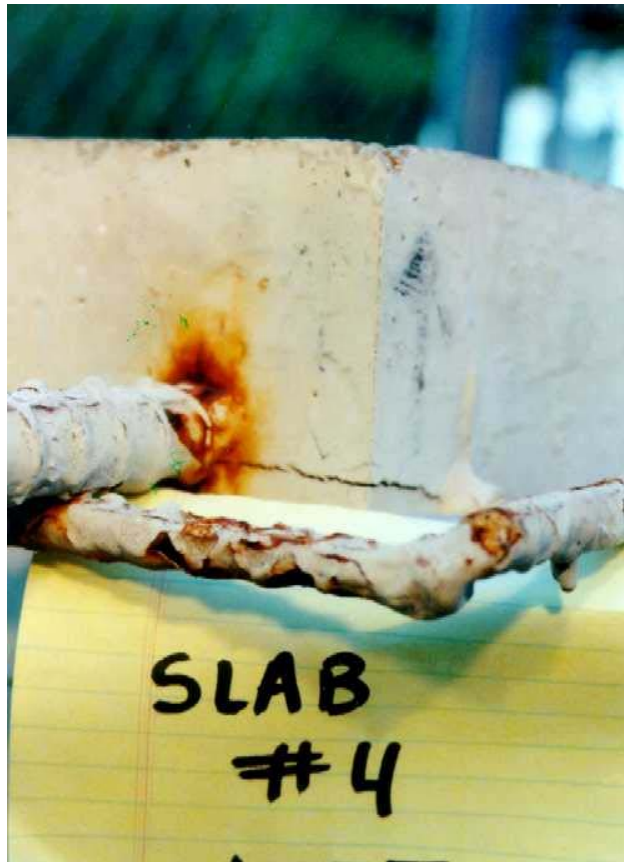
Figure 12. Photo. Rust staining and cracking on the side of slab 4.

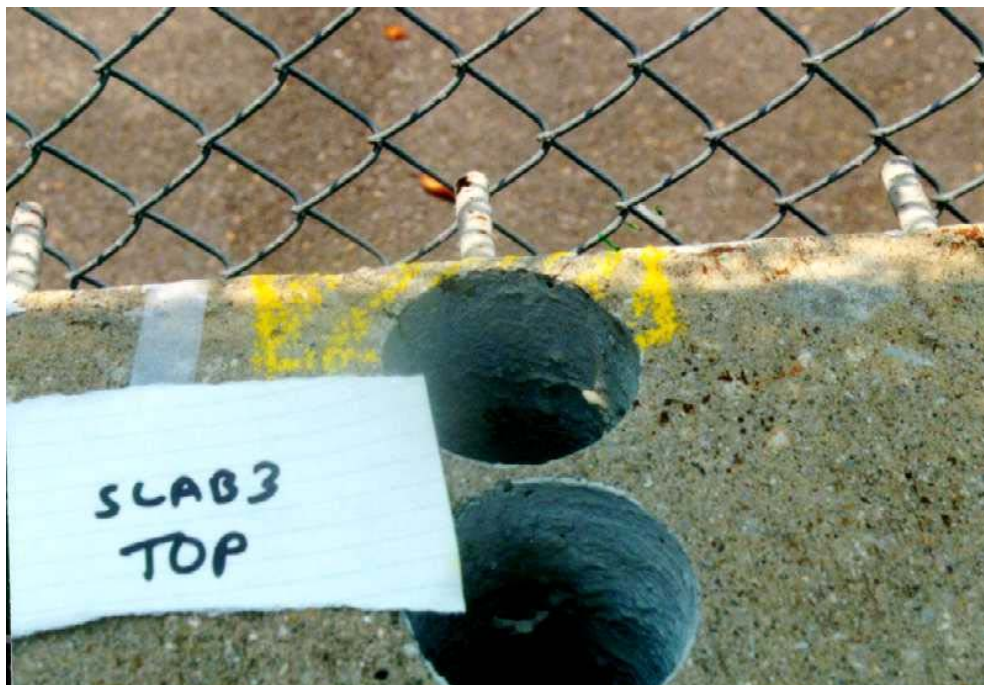
Figure 13. Photo. Delamination (marked in yellow) found on the top surface of slab 3.

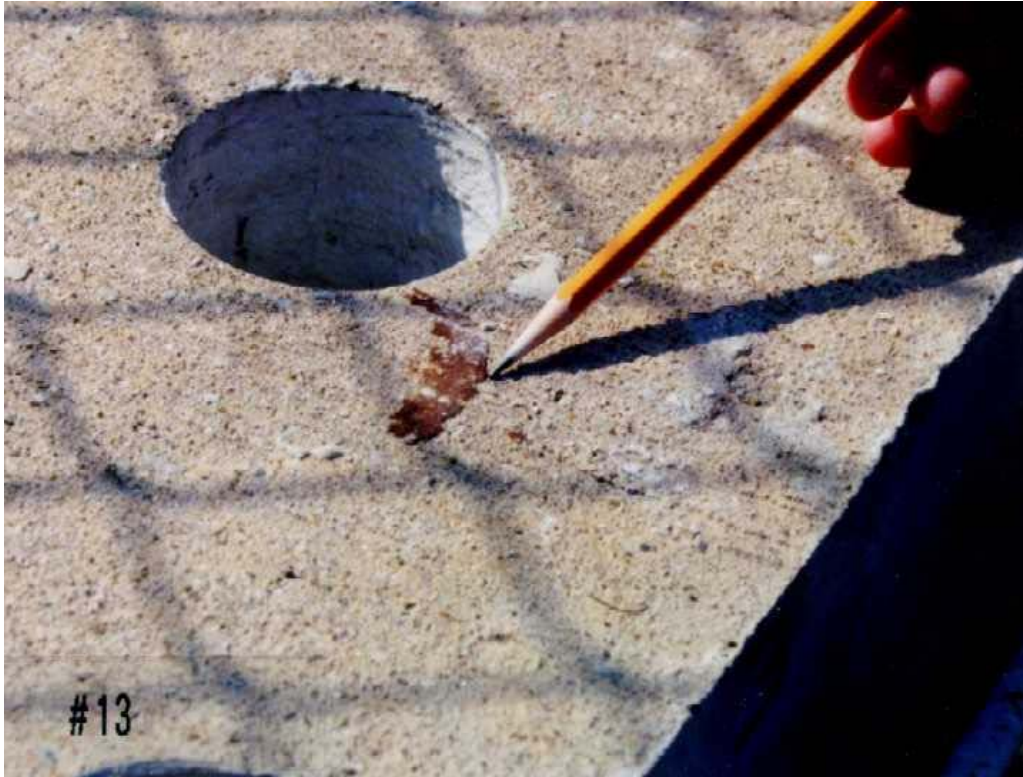
These slabs exhibited hairline cracking on the top surface, and the number of hairline cracks on the top surface increased with time. On both slabs, one crack connected two core holes on the opposite sides of the slab. Many of the hairline cracks initiated at core holes. Rust stains were noted on the top surface of both slabs (see figure 14). Corrosion of ends of rebars and continuity wires in core holes were observed. No ongoing corrosion was detected on the extracted rebar during autopsy of the core collected in December 1999 (see figure 15).

**Figure 14. Photo. Rust staining on the top surface of slabs 3 and 4.**

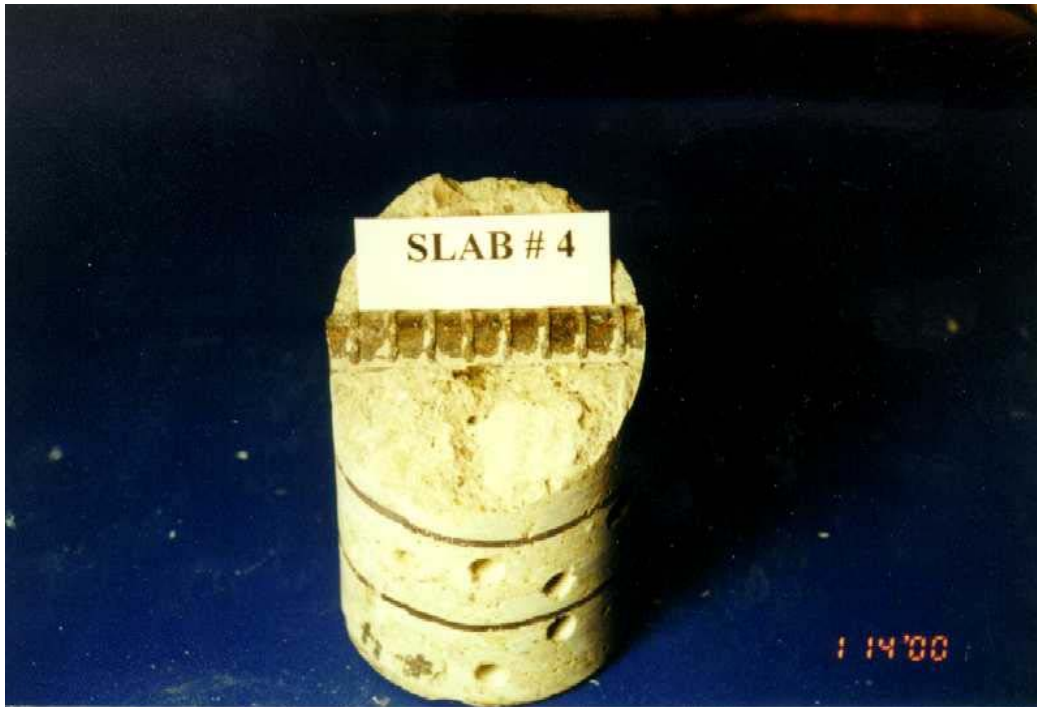
**Figure 15. Photo. Autopsy of core extracted from slab 4 in December 1999.**

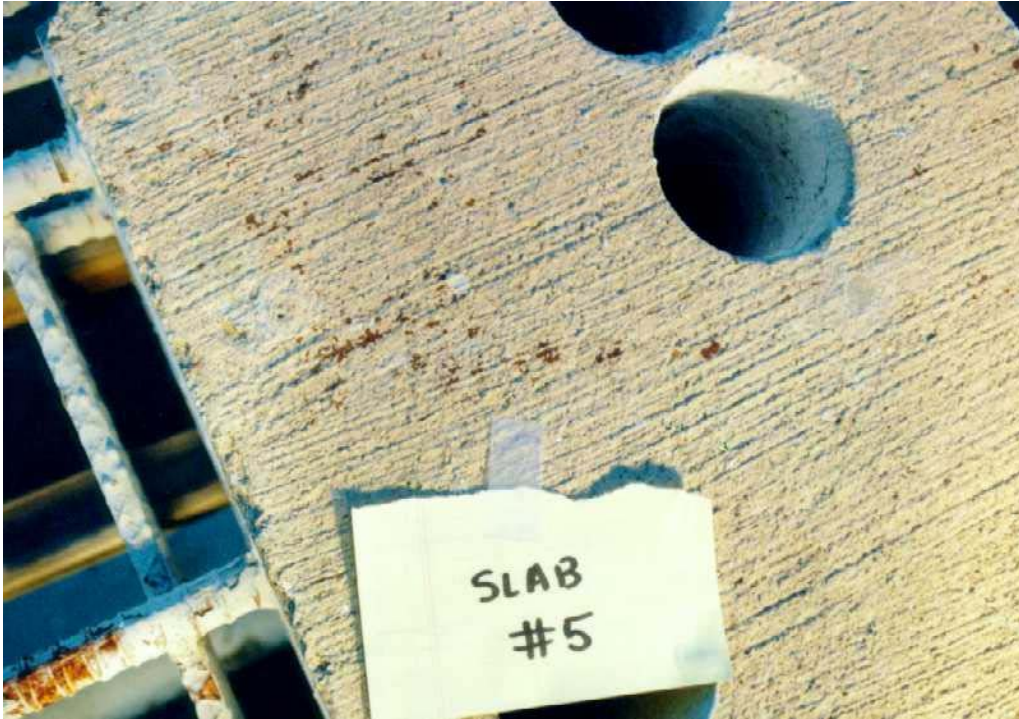
**Figure 16. Photo. Rust stains on the top surface of slab 5.**

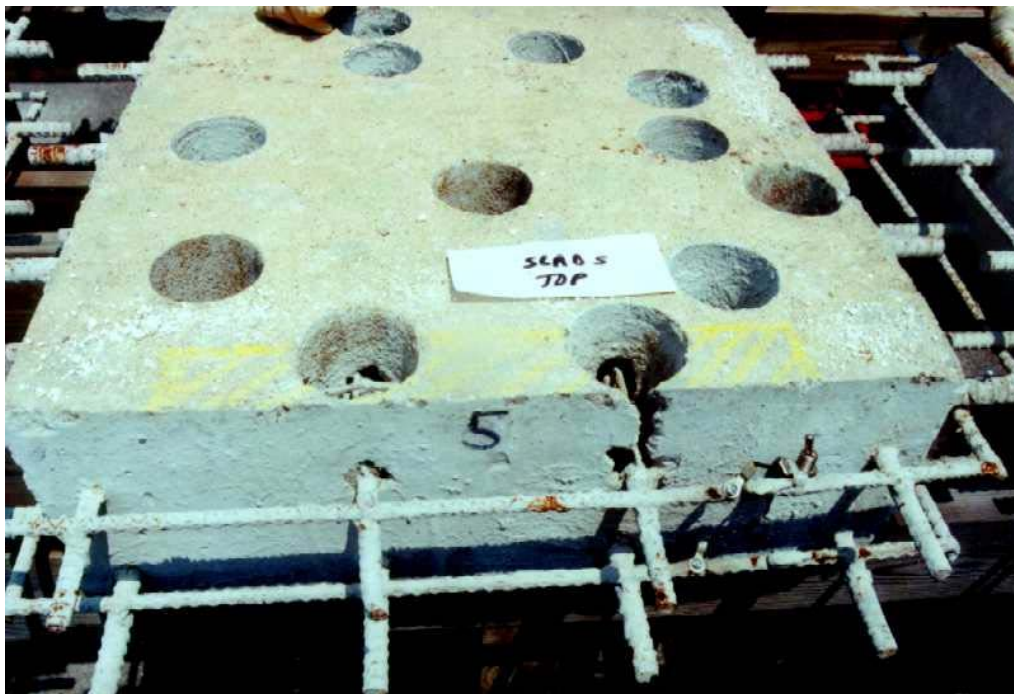
**Figure 17. Photo. Delaminations (marked in yellow) and concrete failure near a core hole on slab 5.**

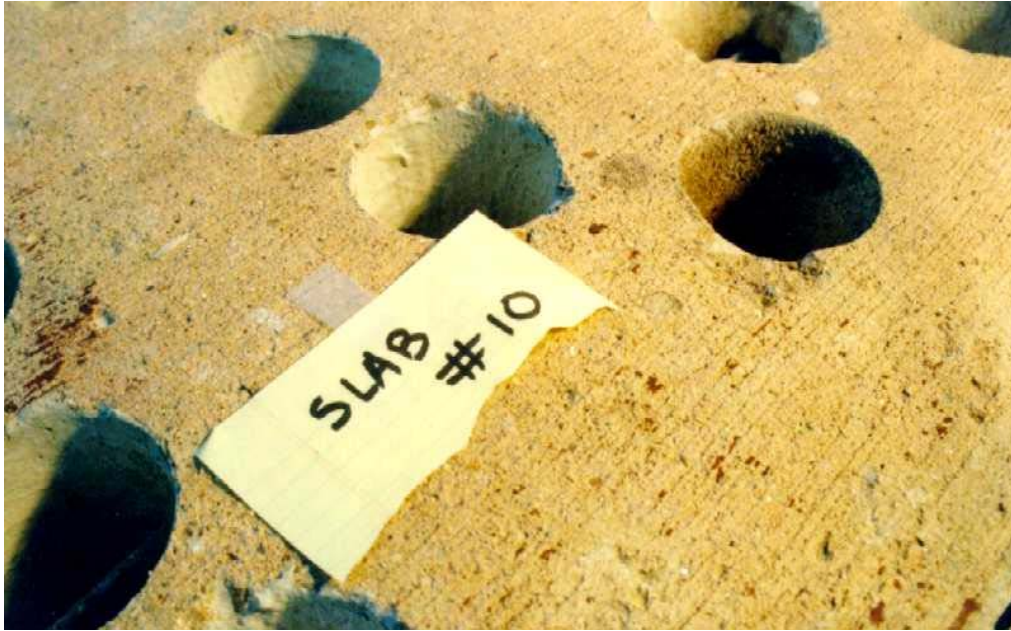
At the inception of this study, only one crack was observed on the side of slab 10. By January 1998, some rust stains appeared on the top surface of the slab, but they were not accompanied by cracks (see figure 18). The number of cracks on the sides of this slab increased with time, and there were rust stains in core holes adjacent to the ends of rebars. In May 1998, a pop-out (i.e., a small piece of pavement broken loose from the surface) adjacent to a core hole was observed.

**Figure 18. Photo. Rust stains on the top surface of slab 10.**

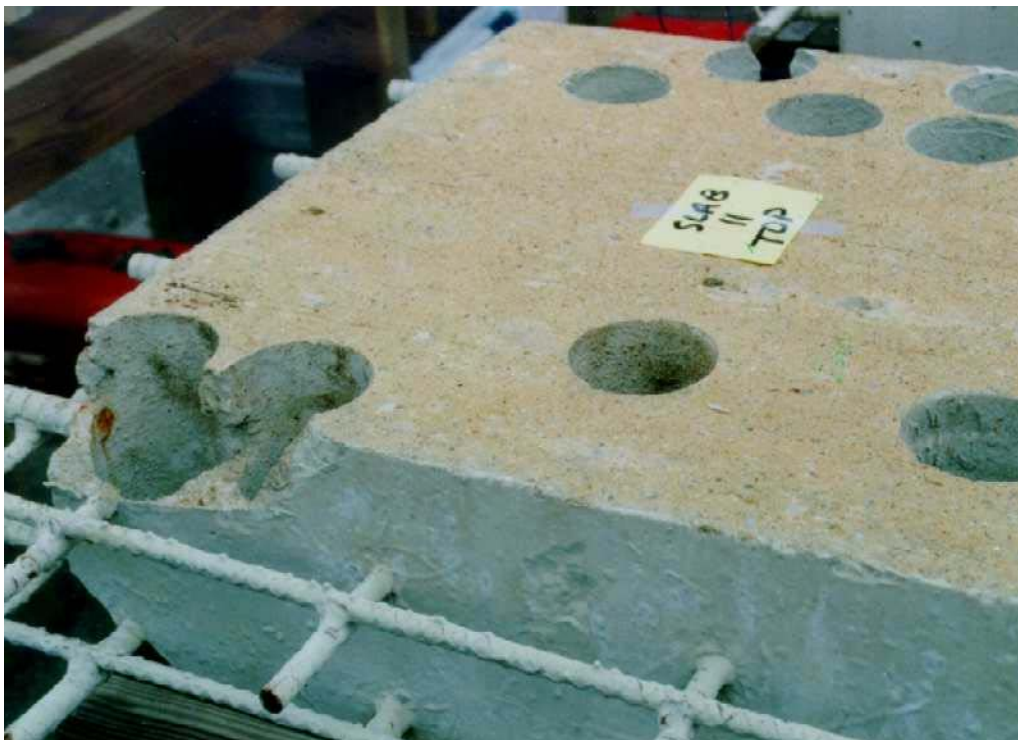
No signs of deterioration were observed until spring 1997. Noncorrosion-related failure of the corner adjacent to a core hole on slab 11 (see figure 19) and failure of a core hole wall on slab 12 were observed. A rust stain appeared on the surface of slab 11, and rust stains were found at external sections of the rebars. By the end of the study, more cracks appeared on the sides of the slabs, and rust stains in core holes increased. An autopsy of the rebar extracted from a core in December 1999 showed no evidence of any corrosion (see figure 20).

**Figure 19. Photo. Noncorrosion-related concrete failure adjacent to core holes on one corner of slab 11 in spring 1997.**

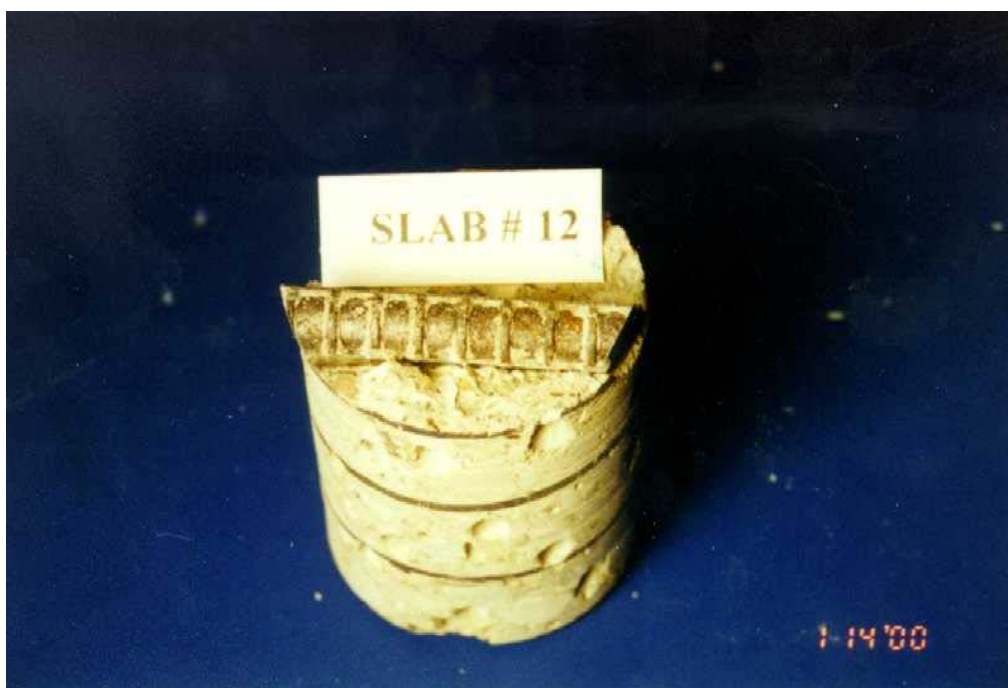
**Figure 20. Photo. Autopsy of core extracted from slab 12 in December 1999.**

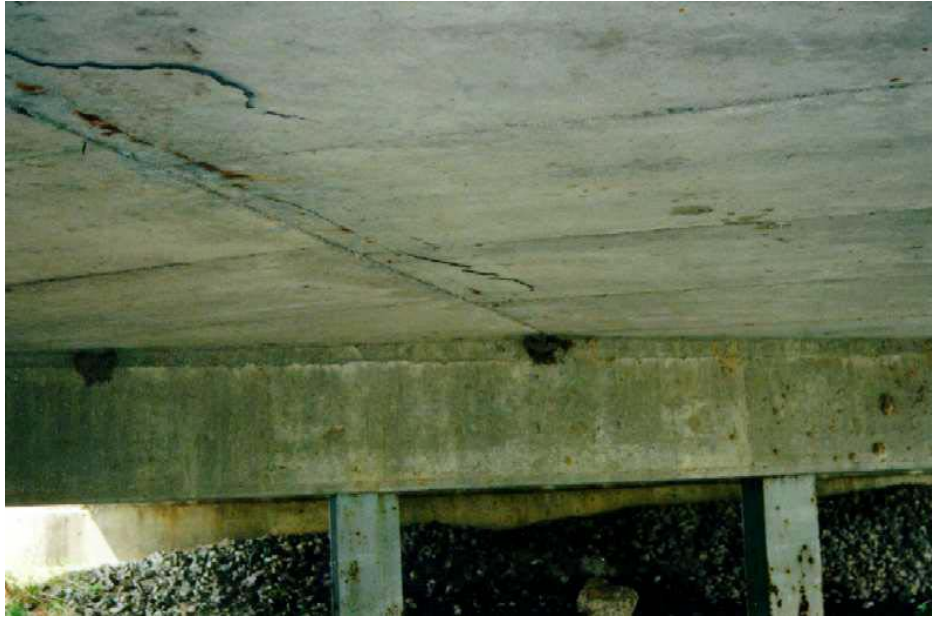
A complete delamination survey was conducted on the entire surface of the bridge deck during each evaluation, and no delaminations were detected. Additionally, a delamination survey was performed on assessable sections of the soffit adjacent to the abutments during the third evaluation. Delaminated area totaling 23.11 ft<sup>2</sup> (2.14 m<sup>2</sup>) was detected on the soffit of the treated section of the deck and on 6.05 ft<sup>2</sup> (0.56 m<sup>2</sup>) on the soffit of the control section of the deck (see figure 29).

**Figure 28. Photo. Cracking, rust staining, and spalling on the soffit of the bridge.**

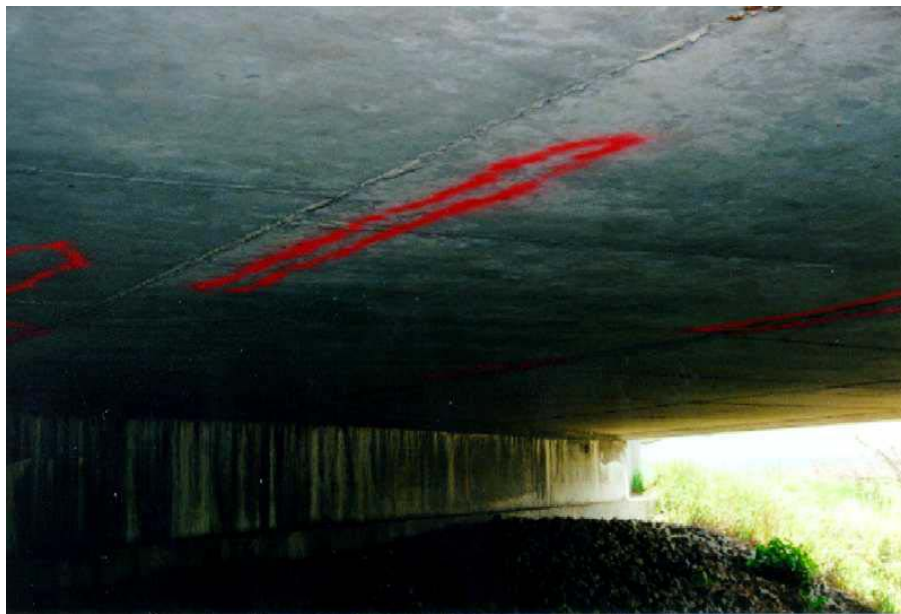
**Figure 29. Photo. Delaminated areas (marked in red) on the soffit of the bridge.**

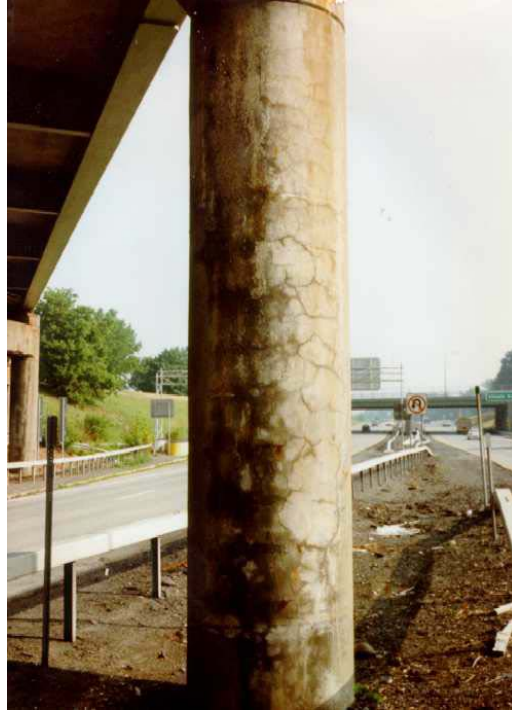
During the first visit, patched areas on all columns were identified, and cracks were observed in all patched areas (see figure 37). A majority of cracks in patched areas were considered to be shrinkage cracks and did not exhibit signs of ongoing corrosion. During the second trip, a significant increase in cracking was observed, and many of the cracks inside and outside patched areas exhibited rust staining (see figure 38 through figure 40). Further increases in cracking and rust staining were observed during the third visit. Total cumulative crack length for cracks outside patched areas is presented in table 5.

**Figure 37. Photo. Cracking on the patched areas on one of the columns of the Campus Loop Bridge in Albany, NY, during the first evaluation in 1995.**

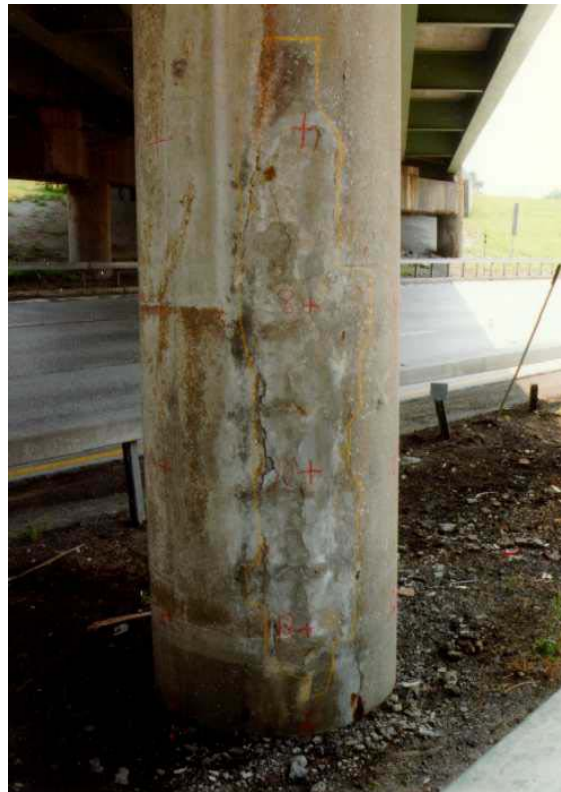
**Figure 38. Photo. First view of cracks and rust staining in patched and nonpatched areas of the columns of the Campus Loop Bridge in Albany, NY, during the second visit in 1996.**

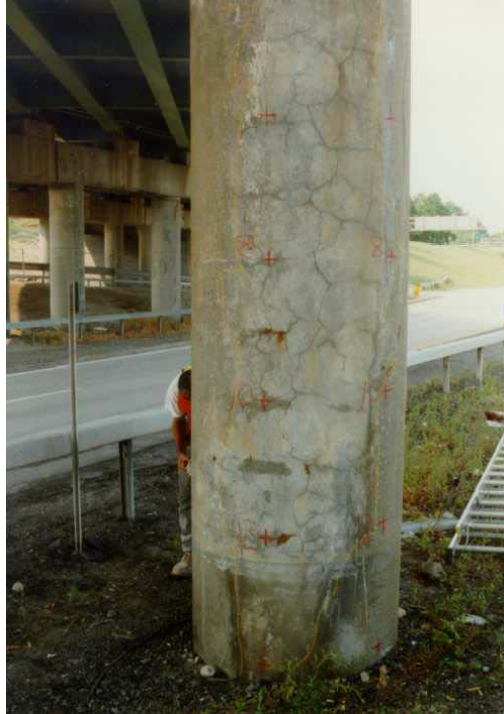
**Figure 39. Photo. Second view of cracks and rust staining in patched and nonpatched areas of the columns of the Campus Loop Bridge in Albany, NY, during the second visit in 1996.**

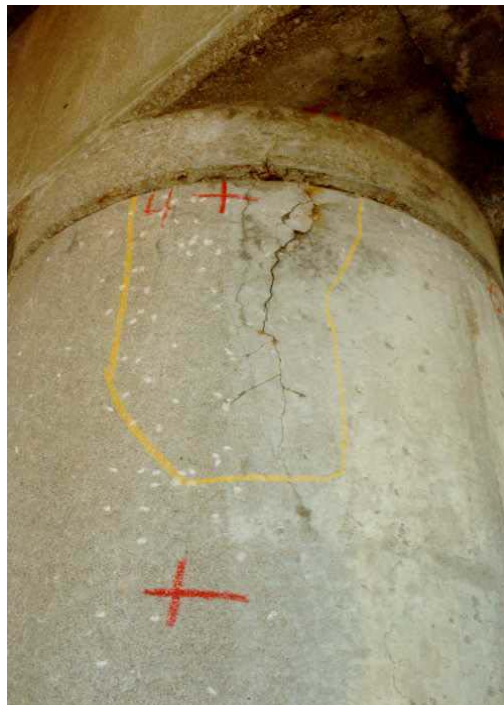
**Figure 40. Photo. Cracks and rust staining in a nonpatched area of a column of the Campus Loop Bridge in Albany, NY, during the second visit in 1996.**

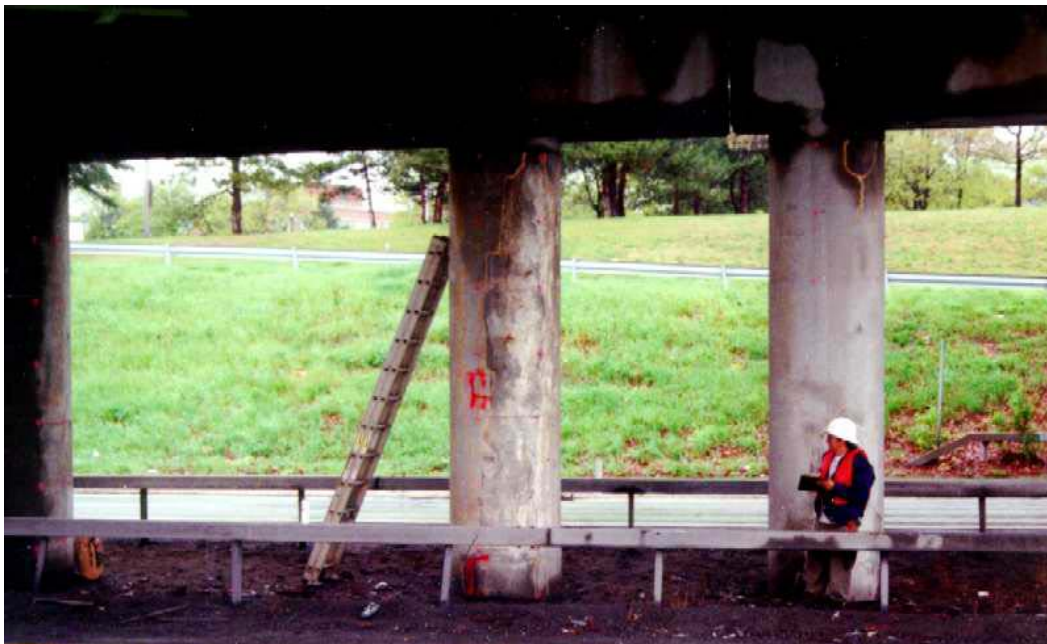
Joints in the bridge deck were leaking, and water was flowing down the pier caps and the columns (see figure 41). The water flowing through the leaking joints in winter was probably contaminated with deicing salts. It can be concluded that chloride ions from the contaminated water were introduced into the column concrete. Shrinkage cracks were observed in the patched areas immediately after the completion of the ECE treatment. It was suspected that chloride contaminated electrolyte may have entered the patched areas through these cracks and deposited chloride ions.

**Figure 41. Photo. Water flowing down the pier caps and columns through leaking joints.**

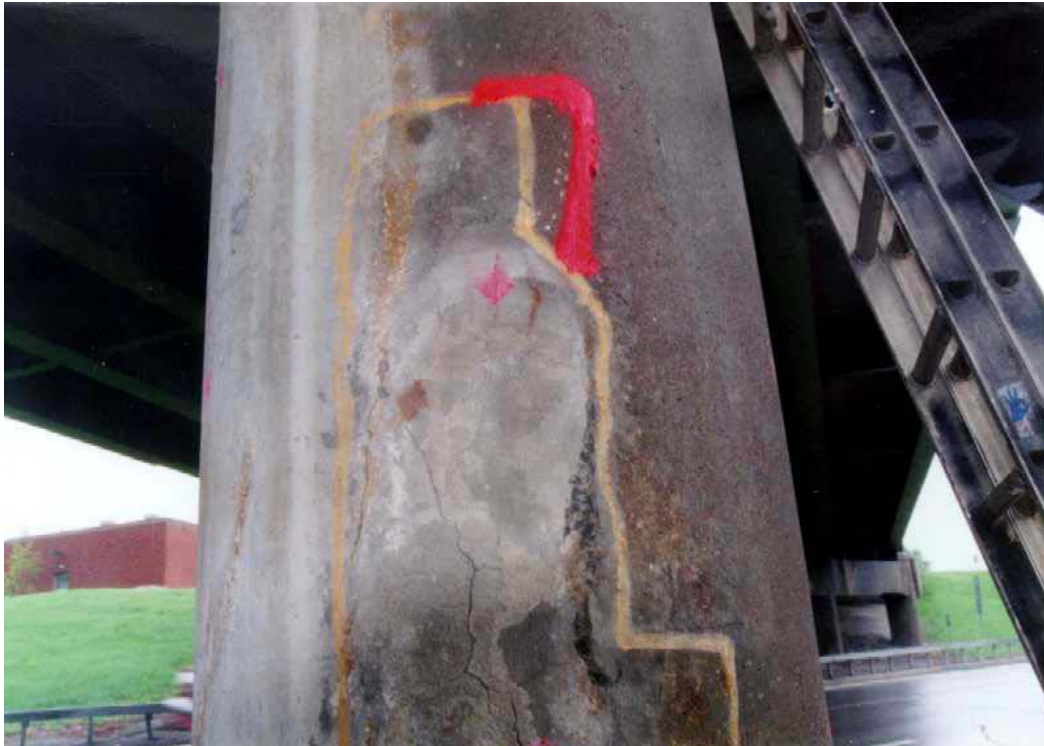
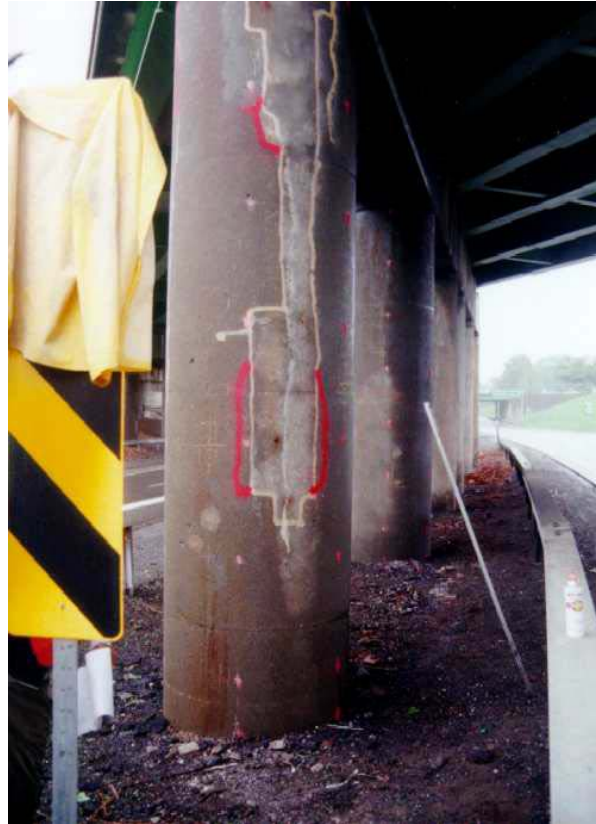
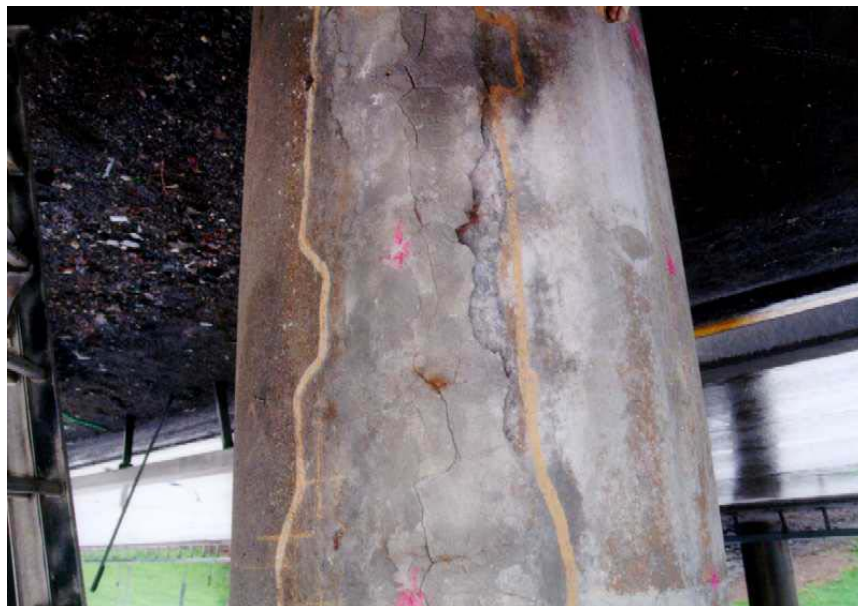
A delamination survey was performed on each column during each evaluation. By 1995, all patches on all columns were completely delaminated (see figure 42 through figure 44). In 1996, delaminations extended from the patches into the original concrete. Delaminations not associated with any patches were also detected. Cumulative percent delaminations as a function of time are presented in table 6.

**Figure 42. Photo. First view of a completely delaminated patch (marked in yellow) on a column of the Campus Loop Bridge in Albany, NY.**

**Figure 43. Photo. Second view of a completely delaminated patch (marked in yellow) on a column of the Campus Loop Bridge in Albany, NY.**

**Figure 44. Photo. Third view of a completely delaminated patch (marked in yellow) on a column of the Campus Loop Bridge in Albany, NY.**
