FORENSIC EVALUATION

LTPP SPS-5 Project (040500)

*I-8 Eastbound
Casa Grande, Arizona*

DRAFT REPORT

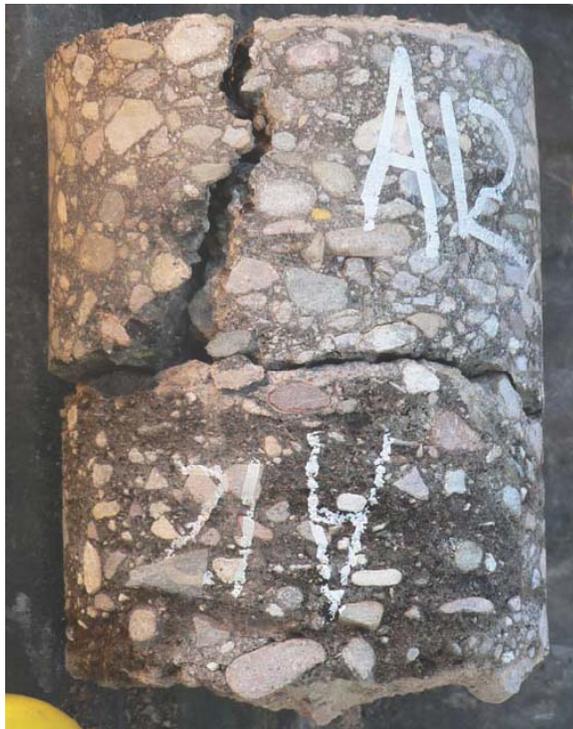
In addition, the core samples were used to determine the location of the crack starting point and to check whether the crack extended completely through the bound surface layer. This was also performed to determine whether the crack mechanism was primarily top-down or bottom-up cracking. The AC core samples were visually inspected before destructive testing was conducted. Photographs were taken for each core sample (Appendix B). Most of the recovered core samples were intact, while some of the cores extracted over the cracks were fragmented. In general, the core samples exhibited medium to high severity cracks initiated at the pavement surface and extending to the inlay layer, showing a top-down cracking pattern. A typical top-down crack is shown in Figure 9 for a core sample recovered from test section 0509. Similar crack patterns were generally observed for other test section core samples.

Figure 9. Top-Down Cracking; Section 0509, Core No. A12.

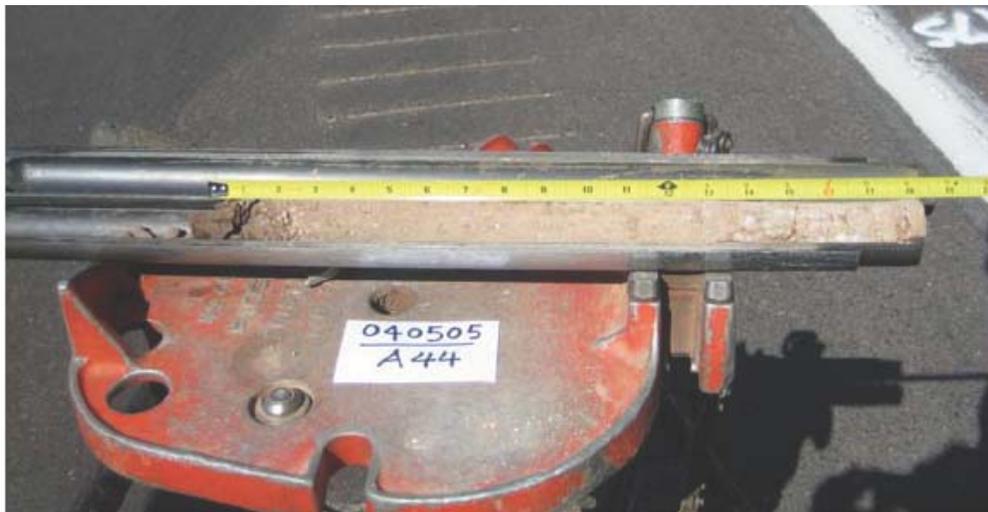
The SPT-N values for each of the test sections are presented in Table 10. These values correspond to stiff granular materials. This indicates the pavement subsurface soil materials are in good condition and can resist traffic vehicle loading. The materials extracted from the sample were also visually inspected. The undisturbed and disturbed SPT samples for test section 0505 are shown in Figures 13 and 14, respectively. In general, uniform soil materials were observed for each of the test sections.

Figure 13. Undisturbed SPT Sample; Section 0505, Core No. 44.

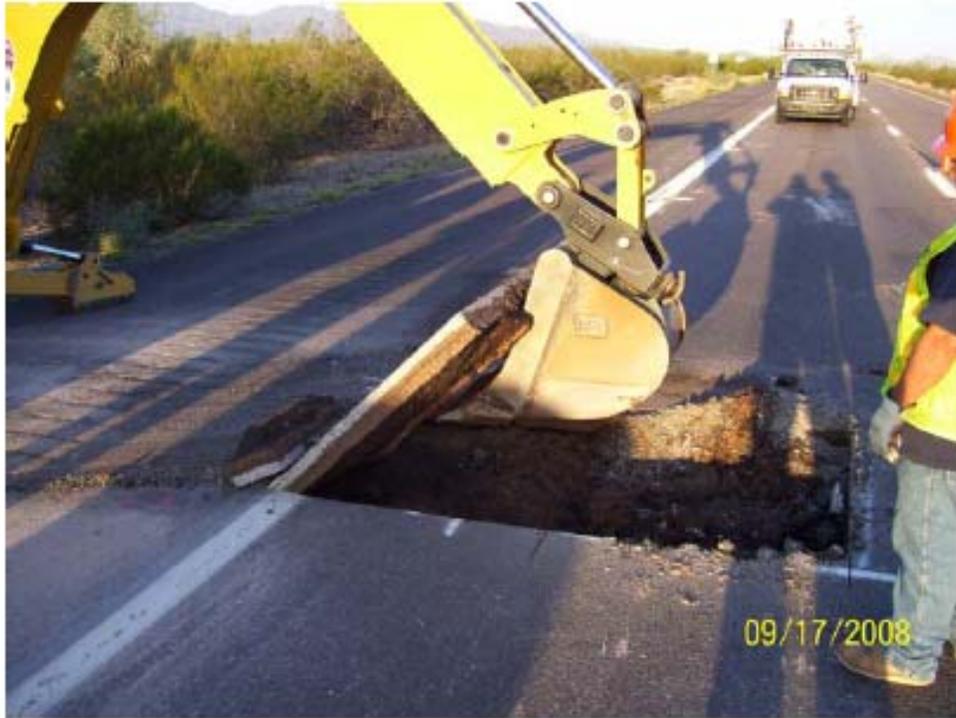
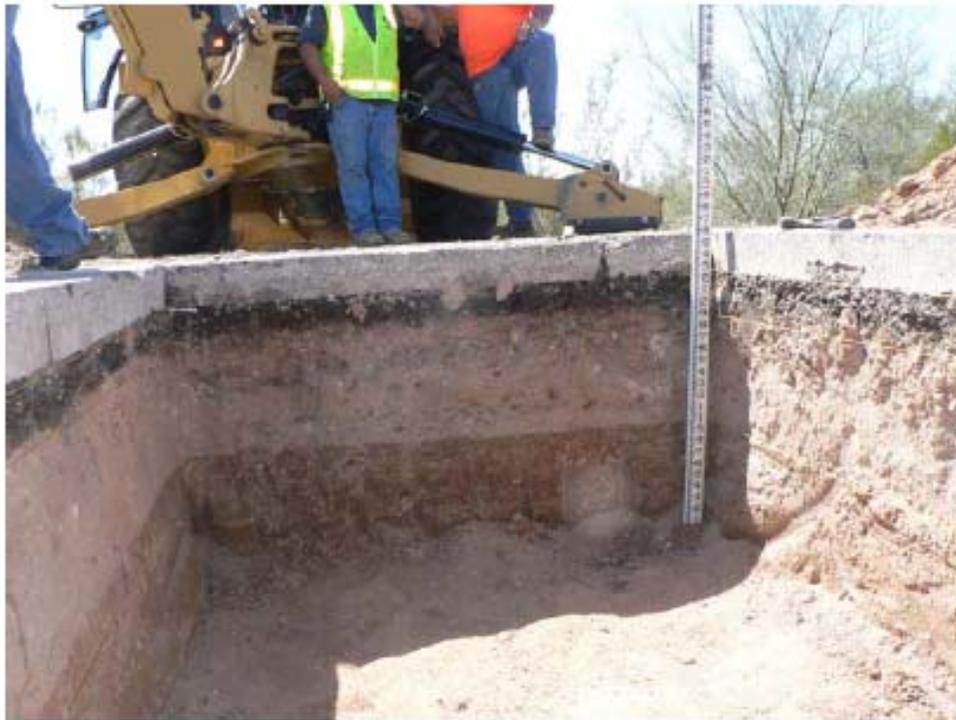
The trench cutting was laid out with spray paint, and the trenches were cut with a diamond saw (the trench excavation operation is shown in Figure 16). For both of the test sections, the saw cut was deep enough to penetrate through the AC layers. Nails and string lines were used to delineate each pavement layer, and the pavement layer interfaces were clearly identified. Following excavation, a visual assessment was made at the exposed layers and photographs were taken throughout the operation. No reflective cracks (i.e., cracks from underlying pavement layers propagating to surface layers) were observed at the bottom of the AC slab layer, reconfirming the crack mechanism as top-down cracking.

Figure 16. Trench Excavation.

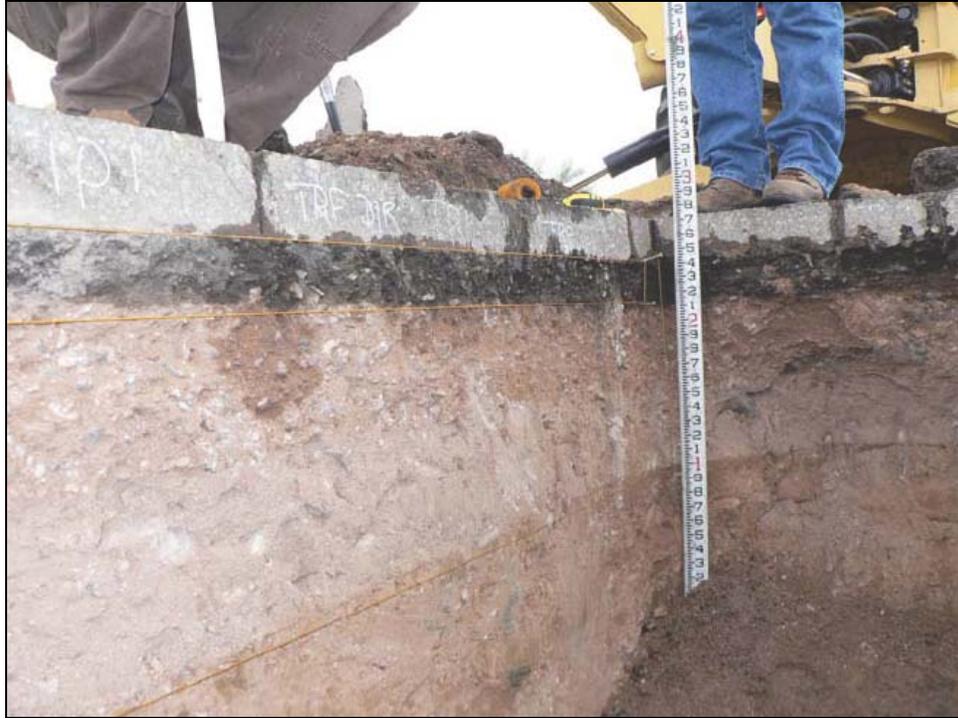
As per the LTPP recommendation, layer thickness profiles were collected at 1 ft (0.305 m) intervals with a standard tape measure along the length of the trench. For consistency, the same person measured all layer thickness profiles. The layer thickness profiles for test section 0509 and 0506 are presented in Tables 11 and 12, respectively. The subsurface profiles measured in these test sections are shown in Figures 17 and 18, respectively. The layer profiles show the rutting contributed by each layer (Figure 19 and 20). Close-up views of the surface layer along the wheel paths are shown in Figures 21 and 22, respectively. It is clearly shown that rutting was mainly in the top AC layer and virtually no rutting was detected in the lower layers (AC inlay and base layer). Similar observations were found using downhill subsurface profiles.

Figure 19. Trench Profiles; Section 0509.

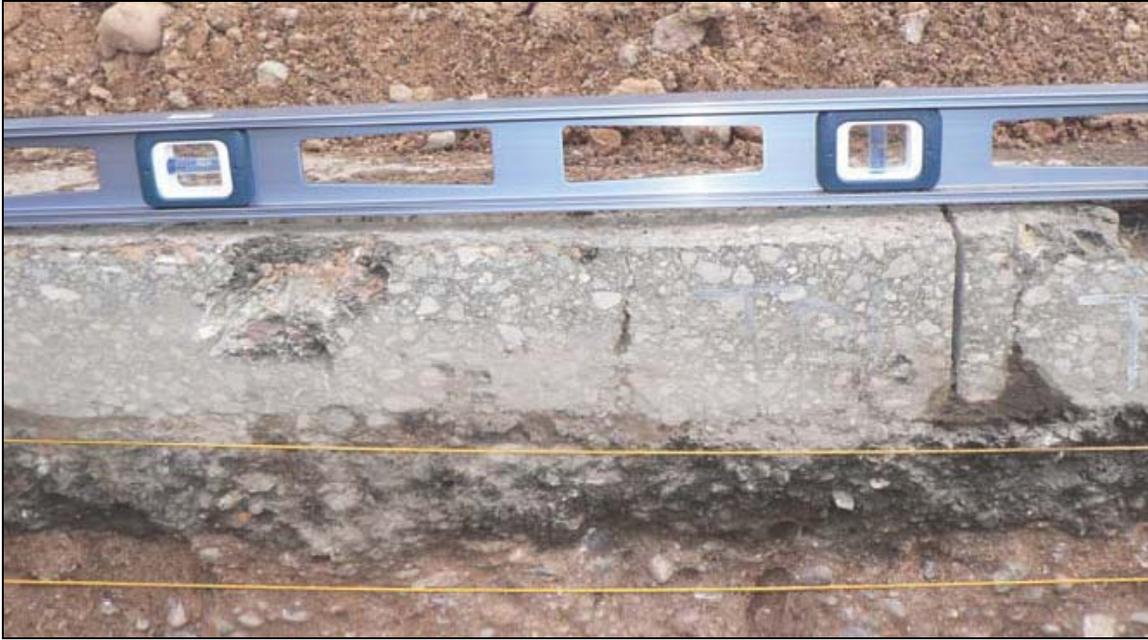
Figure 21. OWP Rutting; Section 0509.

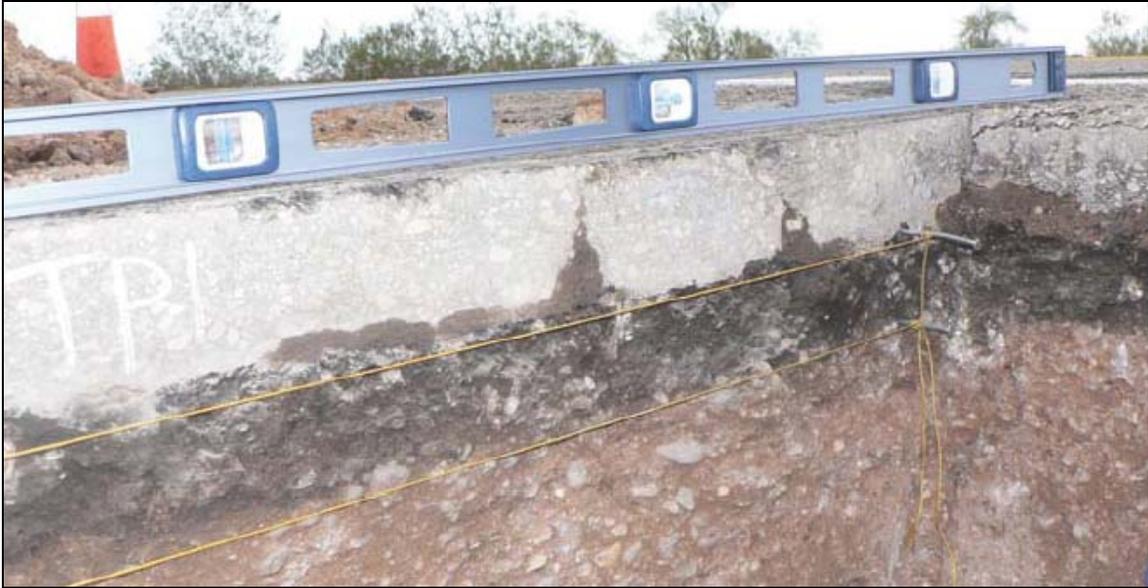
Figure 22. IWP Rutting; Section 0506.

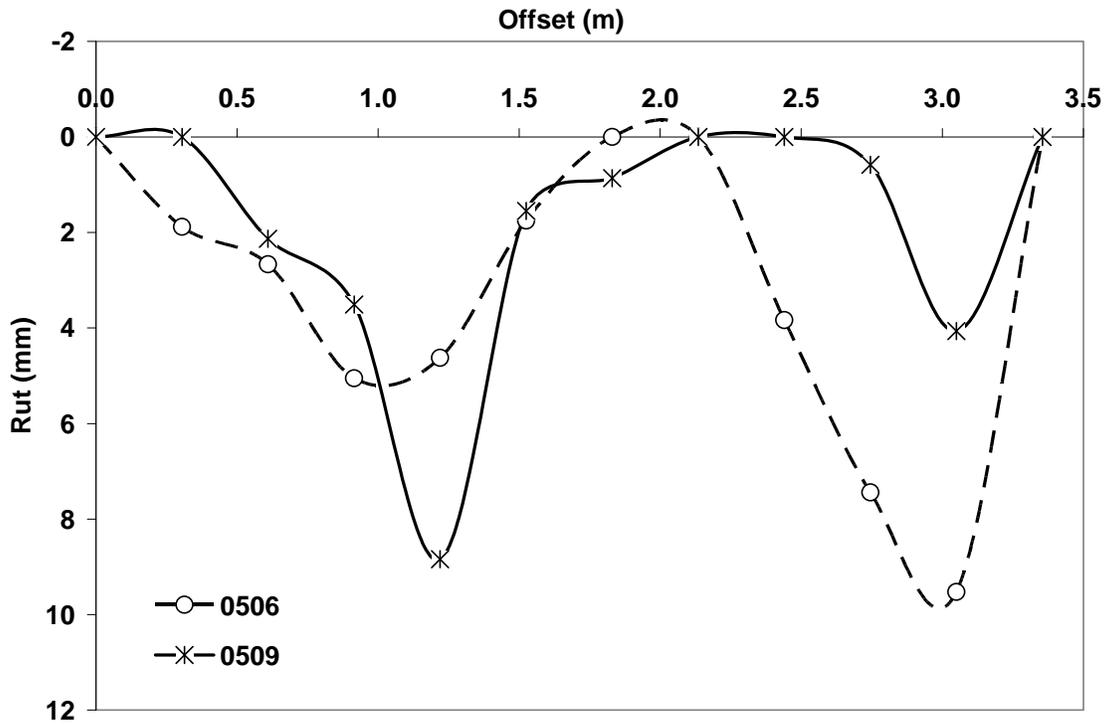
Figure 23. AC Surface Rut Depth.

The rut depth progression for the test sections along IWP and OWP during their monitored period are presented in Tables 20 through 23. In these tables, routine maintenance activities (i.e., fog seal coats) contributed to a decrease in average rut depth are represented by star (*). The historical average rut depth is shown in Figures 31 through 34. The rutting performance of the test sections after four and eighteen years of service are presented. It is evident that the test sections' rutting increased over time, especially for test sections 0502, 0505 and 0509. The rutting progression for test section 0506 is very minimal.

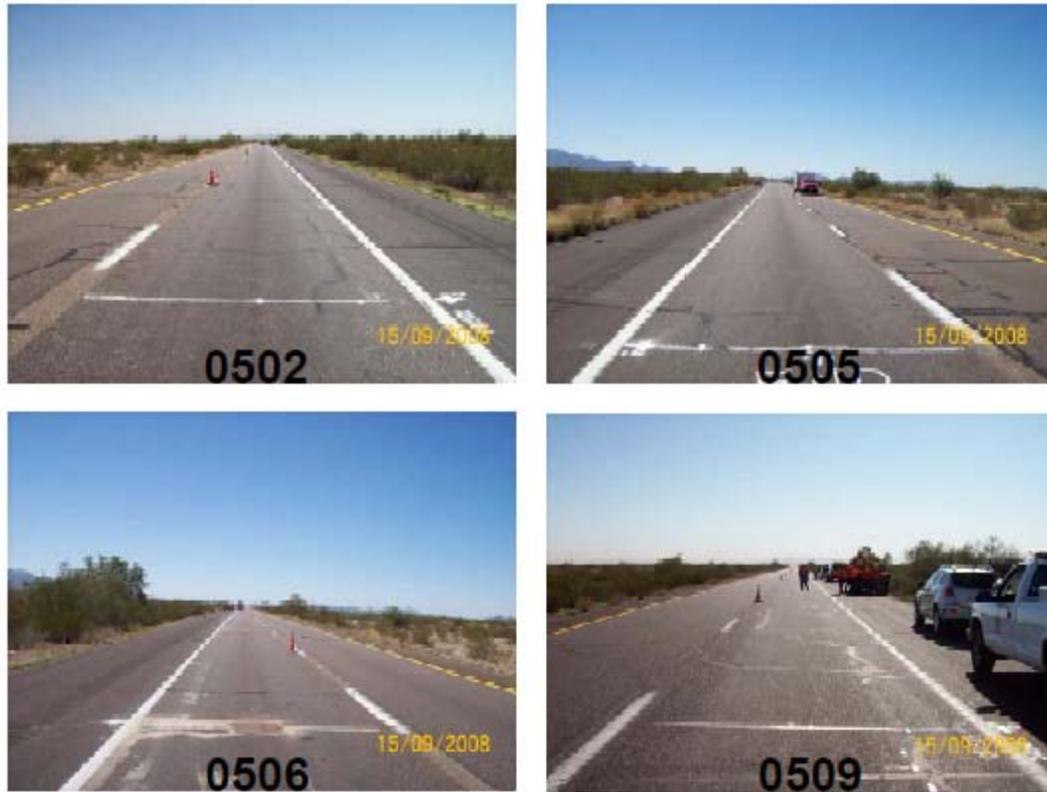
Pavement distresses at the test sections were recorded and summarized in Table 19 in accordance with the LTPP Distress Identification Manual [4]. The pavement distress maps are provided in Appendix D. Typical snapshot view of the test sections are presented in Figure 25. The predominant distresses identified in the test sections included rutting, fatigue cracking, longitudinal cracking, transverse cracking, and pumping.

Fatigue cracking is caused by repeated traffic loading. High severity fatigue cracking was observed for test sections 0502 and 0505. Low to high severity transverse and longitudinal cracking were observed for test sections 0505, 0506, and 0509. Neither transverse nor longitudinal cracking was rated on test section 0502 because of the extent of block and fatigue cracking. Low severity block cracking was observed in test section 0505. Based on the visual assessment, the patterns of the non-wheel path longitudinal cracking consistently occurred at the mid-lane. Low to moderate severity patch deterioration was observed in section 0506. Pavement distress in the form of pumping was also noticed in each of the four test sections, particularly in sections 0502 and 0505.

Figure 25. Pavement Conditions at Selected SPS-5 Test Sections.

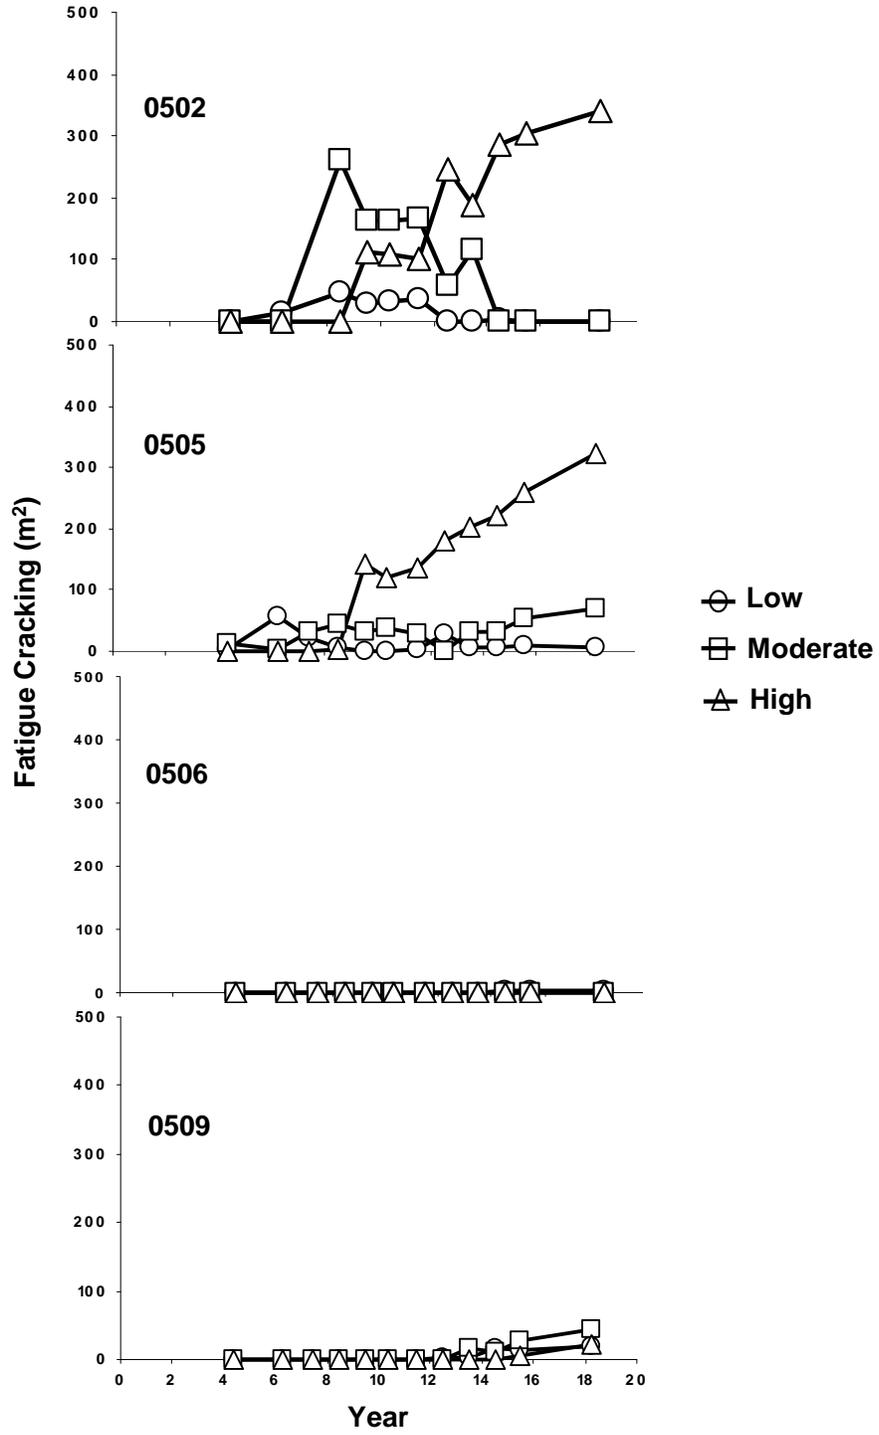
Historical development of fatigue cracking, transverse cracking, and pumping are plotted in Figures 26 through 28. The growth of these distresses increased over time for each of the test sections. Comparatively, the extent of fatigue cracking and transverse cracking is minimal for test sections 0506 and 0502, respectively. Maintenance activities (fog seals and crack sealing) appear to have reduced the severity level of fatigue and transverse cracks. However, after the maintenance operations, an increase in transverse cracks is still apparent for test sections 0506 and 0509. Upon pavement degradation, some portion of high severity transverse cracks in test sections 0502 and 0505 were converted into fatigue or block cracks and therefore the transverse cracking in these test sections is masked.

Figure 26. Fatigue Cracking Progression.

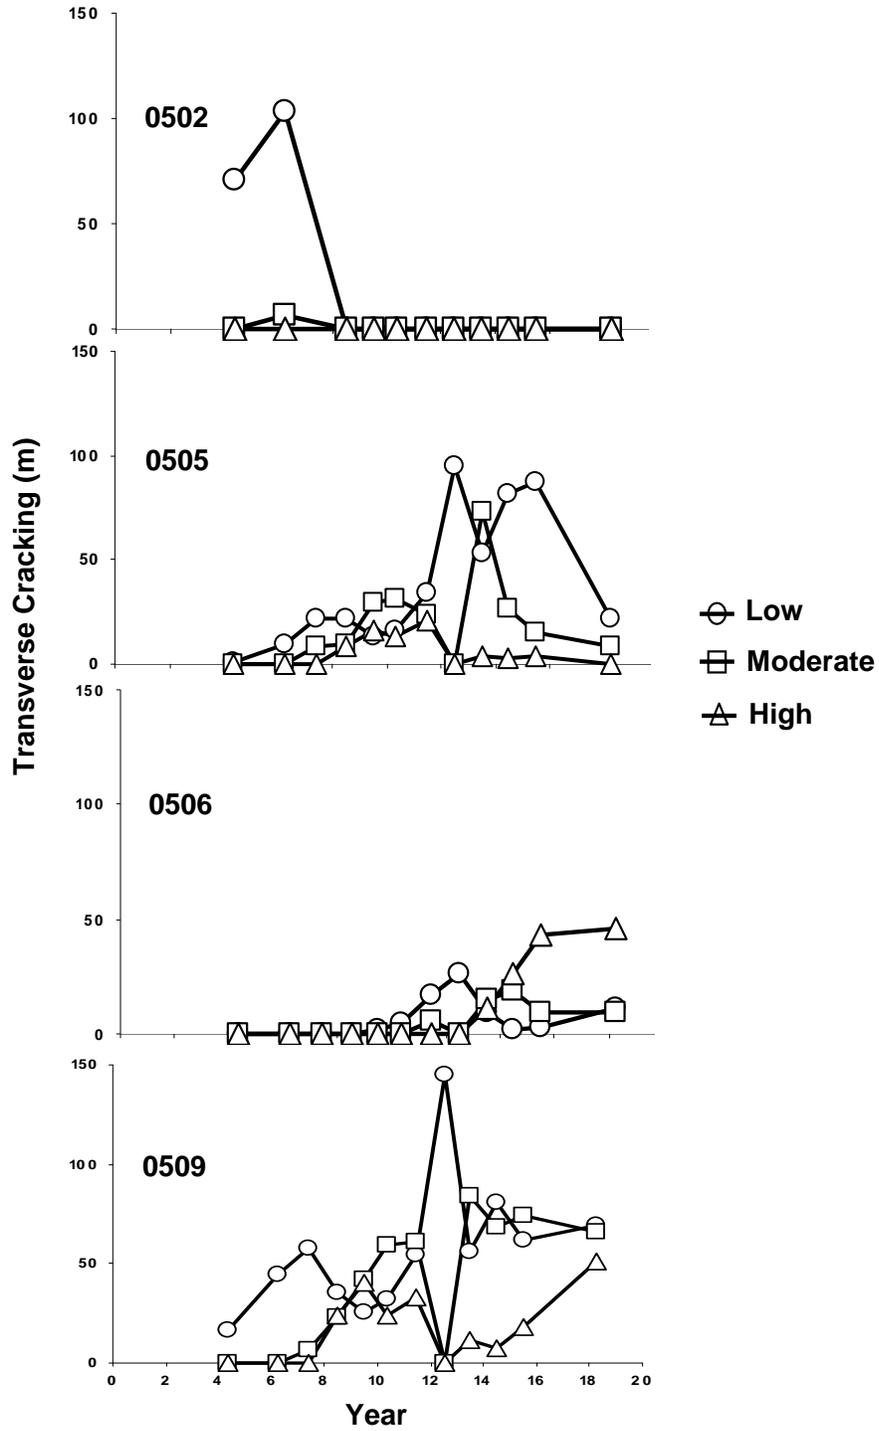
Figure 27. Transverse Cracking Progression.

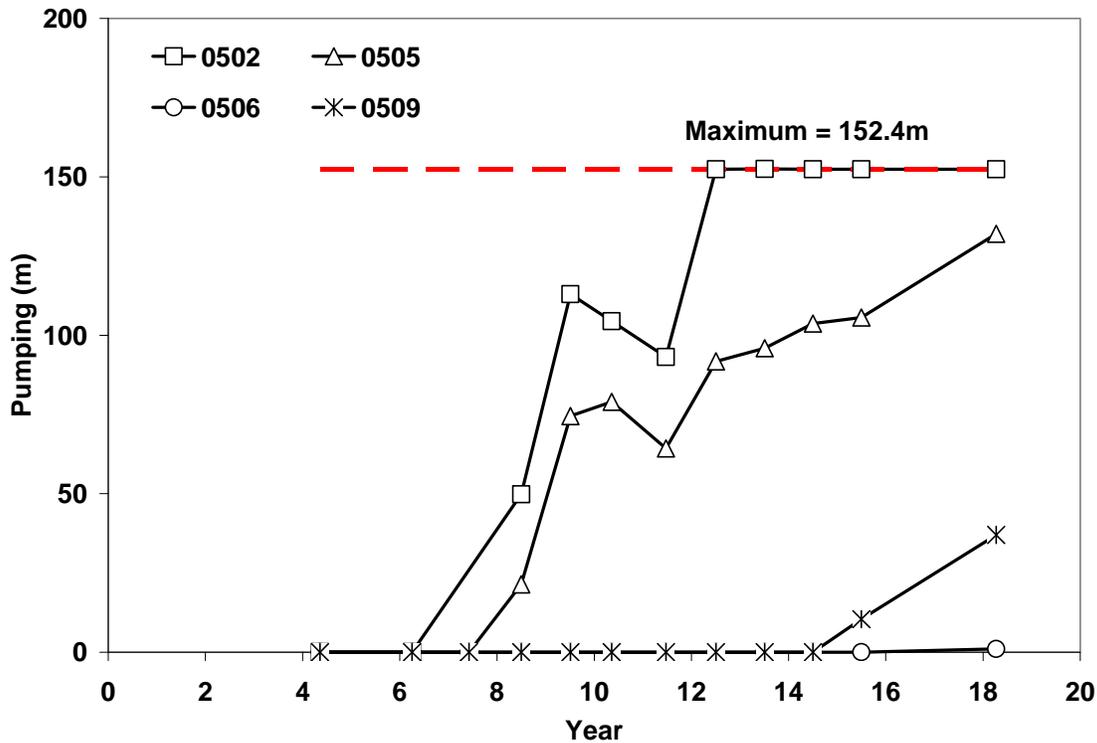
During the September 2008 visit, disintegration and loss of AC materials were also noticed in some locations of the test sections. In most cases, the transverse cracks covered the entire width of the lane. Section 0502 exhibited low severity transverse cracks over the monitored history. In addition, the extent of water bleeding and pumping increased over time for test sections 0502 and 0505. Since 2004, an increase in the pumping level was observed in test section 0509. Test section 0506 demonstrated very little pumping over time.

Figure 28. Pumping Progression.
