# FORENSIC INVESTIGATION REPORT ON THE LTPP TEXAS SPS-5 PROJECT

Submitted by Fugro Consultants, Inc.  
FHWA-LTPP SPS-5 PROJECT 48A500  
US 175 Eastbound, Kaufman County, Texas  
Date Prepared: July 2009

**FHWA LTPP SPS-5 PROJECT 48A500**  
*US 175 Eastbound Kaufman County, Texas*  
*Date Prepared: July 2009*

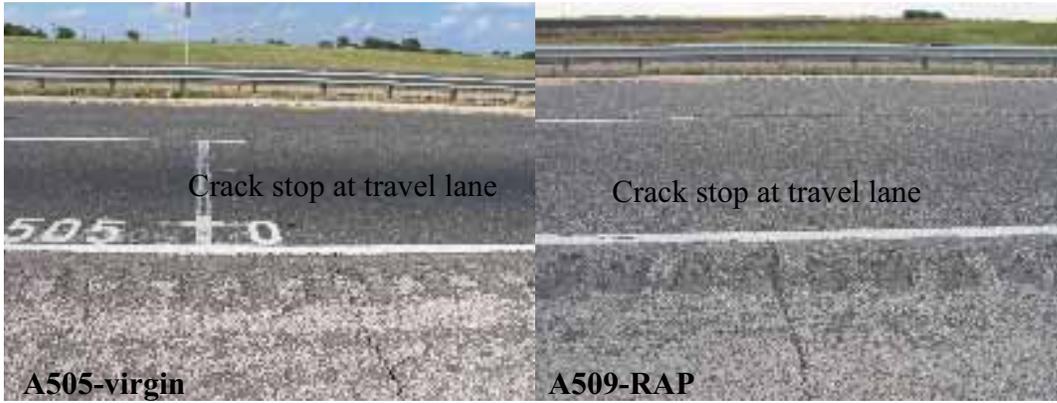
Fig. 1 Pictures Were Taken in 2004 after 13 Years of Service for Site A505 (virgin) and A509 (RAP)

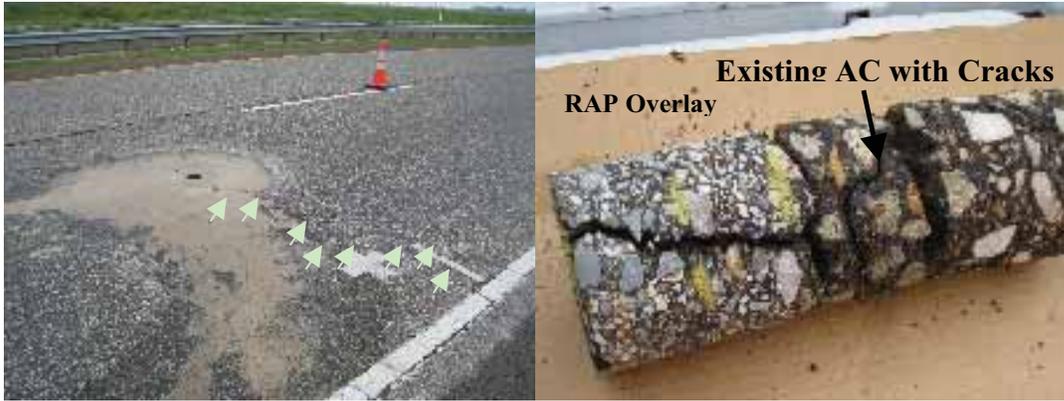
Fig. 6 Core showing Reflective Transverse Crack (2008) from Site A509 after More than 17 Years of Service

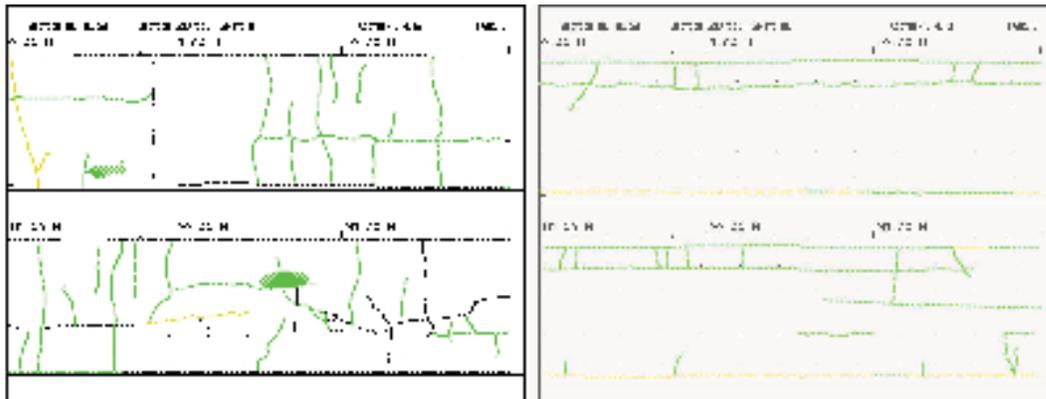
Crack Maps for Pre (1991) and After (2003) Rehab Condition for Site A508

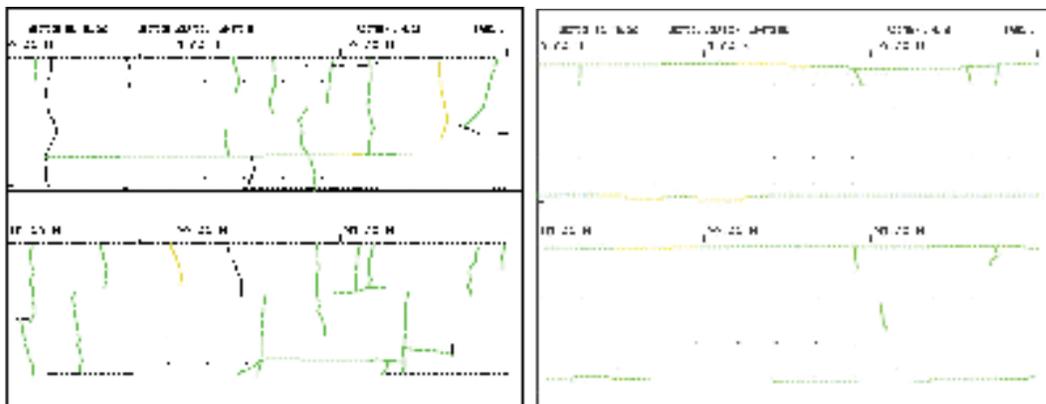
Crack Maps for Pre (1991) and After (2003) Rehab Condition for Site A505

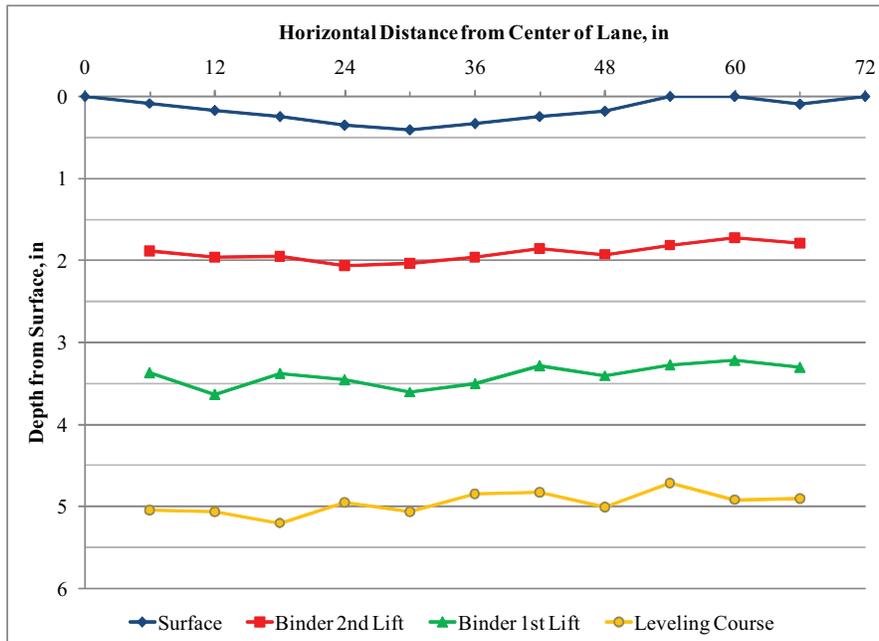
From these figures, it would appear that the rutting in section 48-A0508 is confined to the surface RAP layer, with a maximum of 0.25 in. Immeasurable rutting was found within the lower layers of the RAP overlay. For section 48A507, rutting has occurred within the surface layer of the virgin HMA with a maximum of about 0.2 in. centered in the wheel path, and continues into the bottom of the binder layer (leveling lift) to a magnitude of about 0.2 in. As noted previously, the lower lift of the virgin mix for binder layer or leveling course was reported to have tensile strength ratios (TSR) lower than the minimum required value of 0.70. Some of this rutting in the leveling course could be associated with moisture damage within that layer. The TSR values reported for the RAP mixtures all exceeded the minimum value of 0.70 and no measurable rut depths were found within that layer from the trench in section 48-A0508.

**Figure TX-10. Section 48A507 Virgin HMA Overlay**

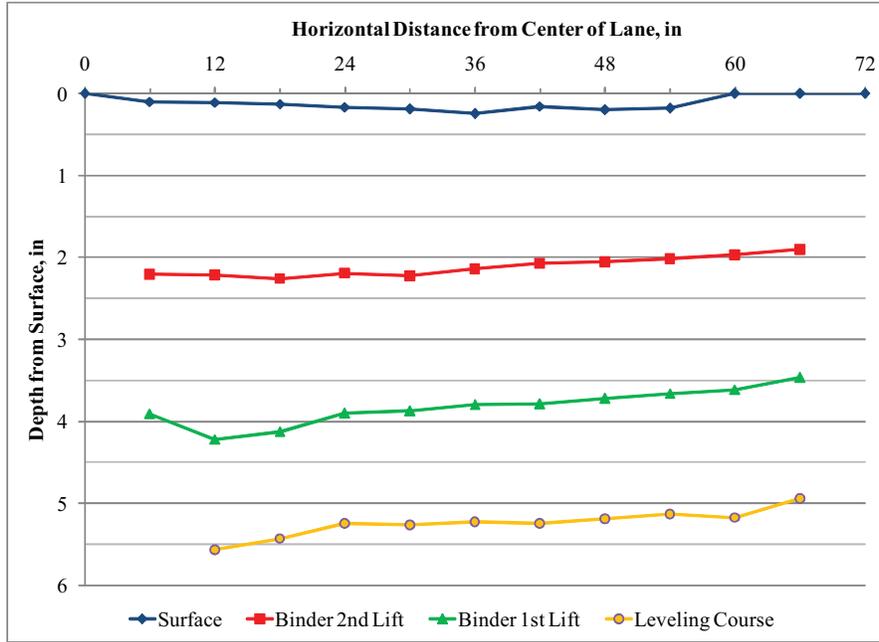
Figure TX-11. Section 48A508 RAP Overlay
