FHWA/LTPP Monitoring Program

**Forensic Study - Specific Pavement Study
(SPS) Sections 360801 and 360802, Lake
Ontario State Parkway, Hamlin, NY**

Report No. FHWA-TS-09-36-01

November 2009

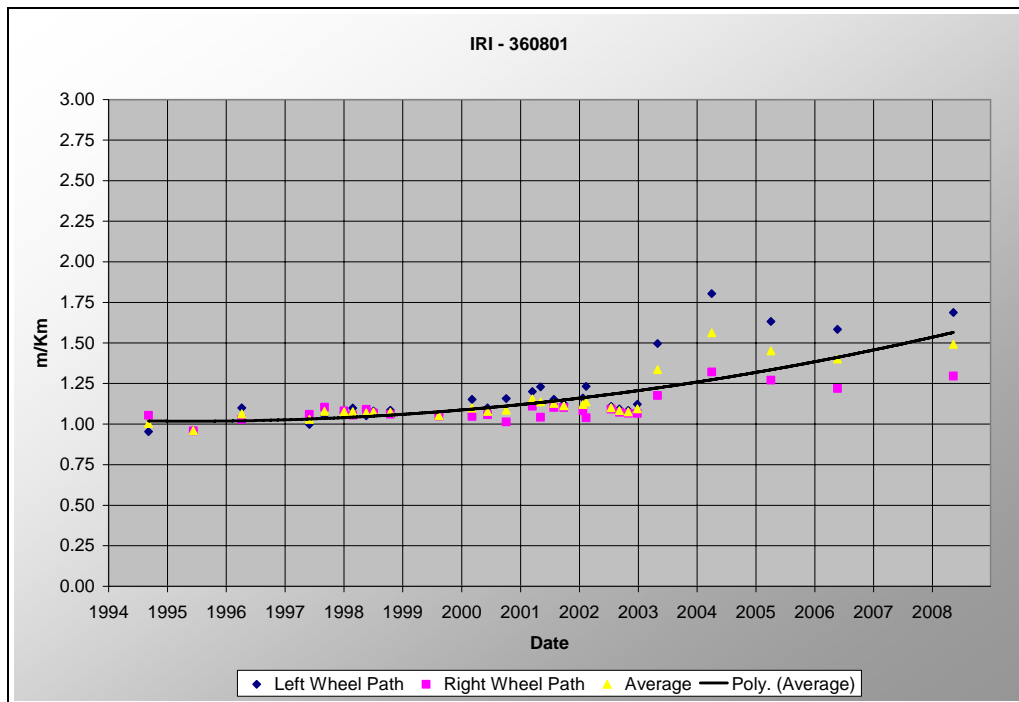
Figure 4: Historical Trend in IRI

distortion on a section with practically no longitudinal grade. At the time of the final survey, profile data was collected on the passing lane, which had significantly less distress than the monitored lane, and an average IRI over the same section length of 1.27 m/km or 15% less than the monitored lane. Seasonal variations in ride quality were notable on this section which could be related to the ‘active’ silty sand subgrade that could become unstable during the freeze/thaw cycles. Based on these results the ride quality can be considered acceptable with no near term intervention required, although due to the high and increasing levels of distress the long term preservation of this pavement section could require some remedial intervention.

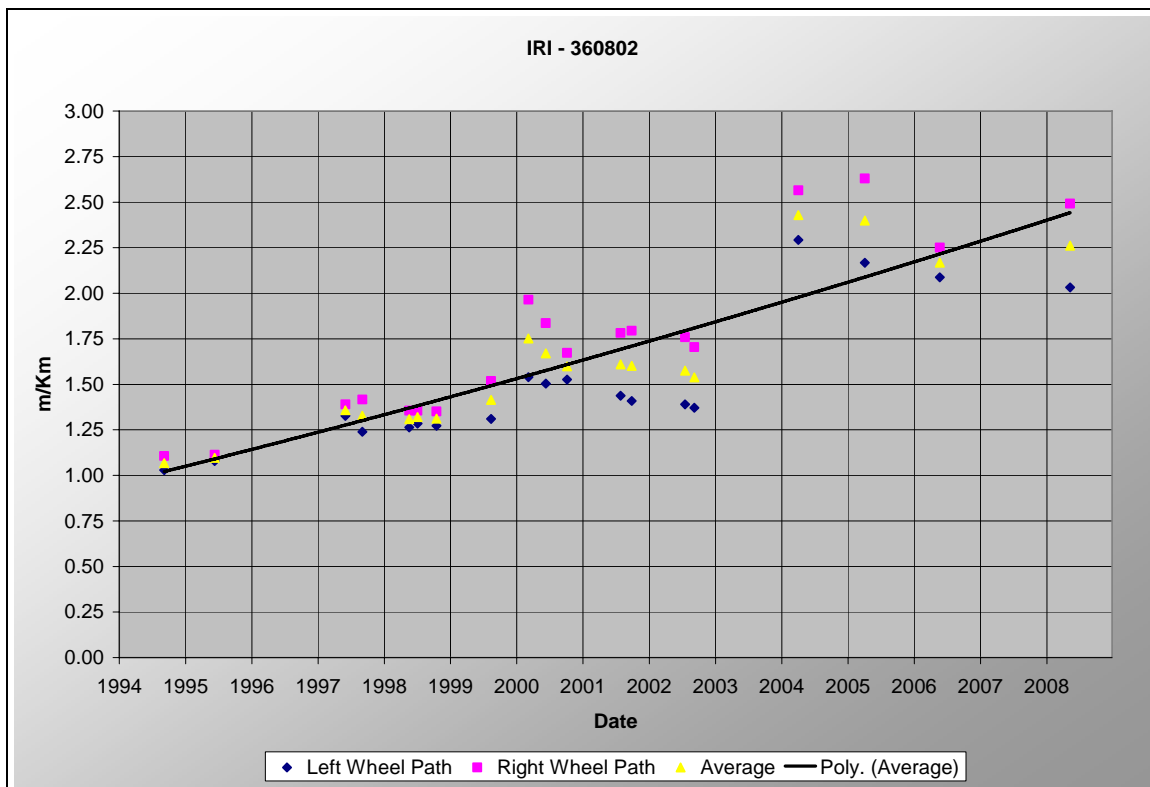
Figure 9: Historical Trend in IRI

Figure 9 provides the historical IRI data for section 360802. A review of the historical IRI shows a substantial change in roughness over time. Although there is less distress on this section when compared with 360801 it is considerably rougher. The initial IRI for this section was also slightly higher than 360801. Again, there is a high seasonal variability. The results indicate the IRI for this section is approaching the design limit and near term corrective action should be considered.

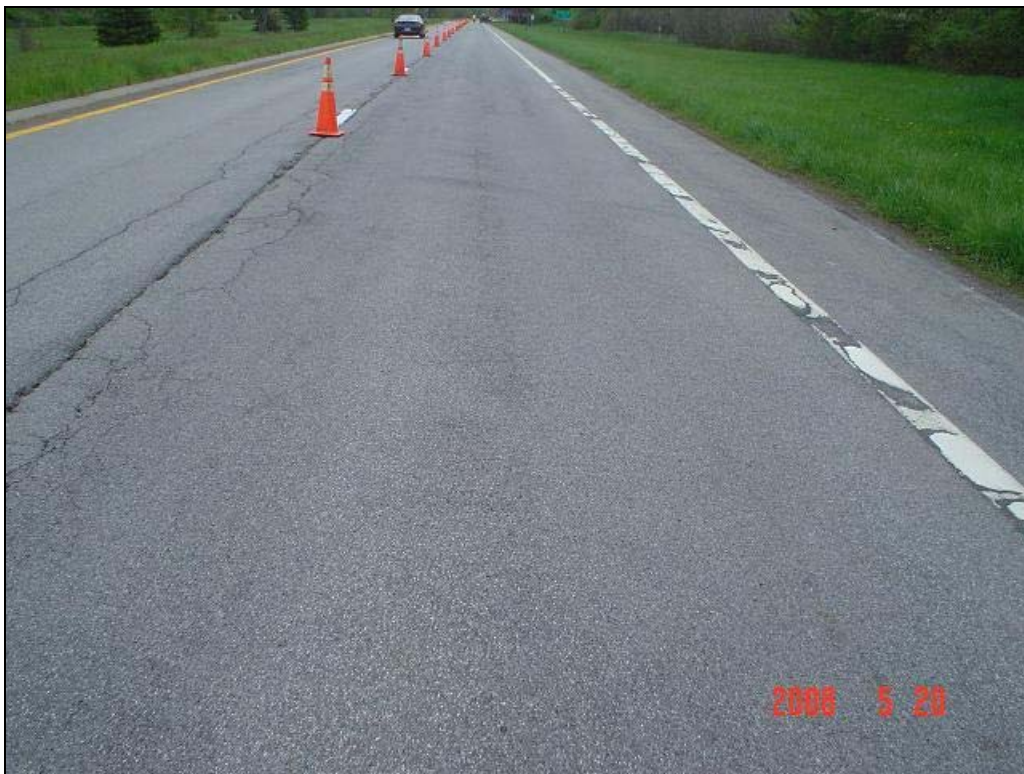
Figure E-2: Photo of High Severity Centerline Longitudinal Crack with Associated Cracking (360801)

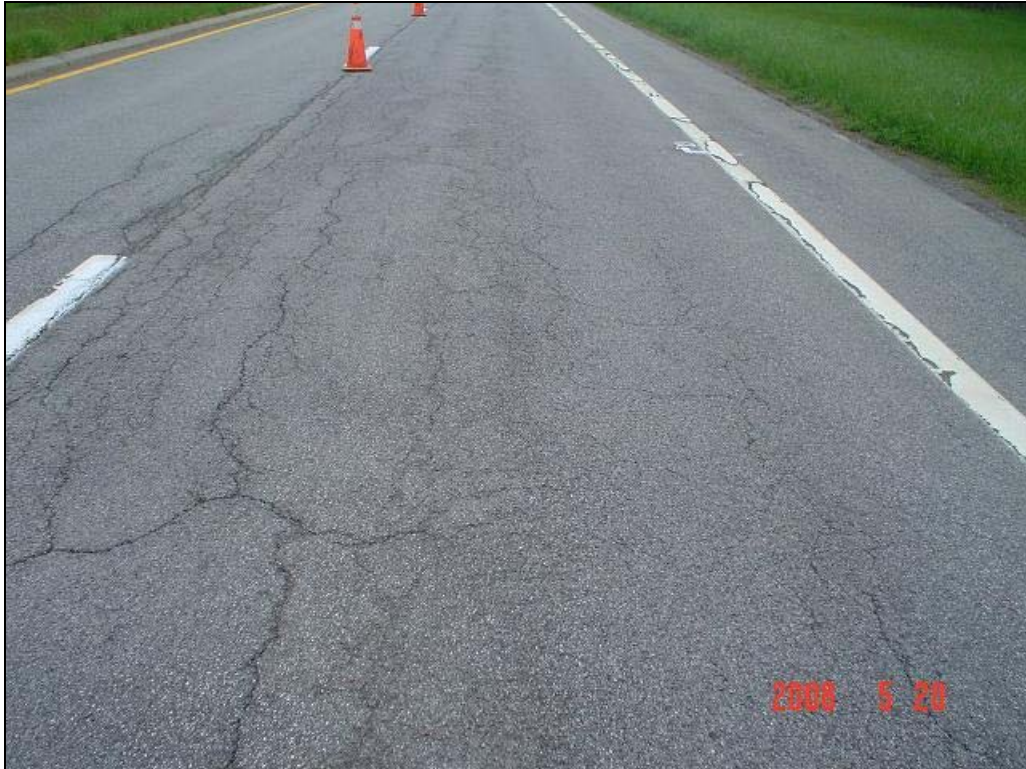
Figure E-3: Photo of Multiple Cracks in Vicinity of Station 1+00 (360801)

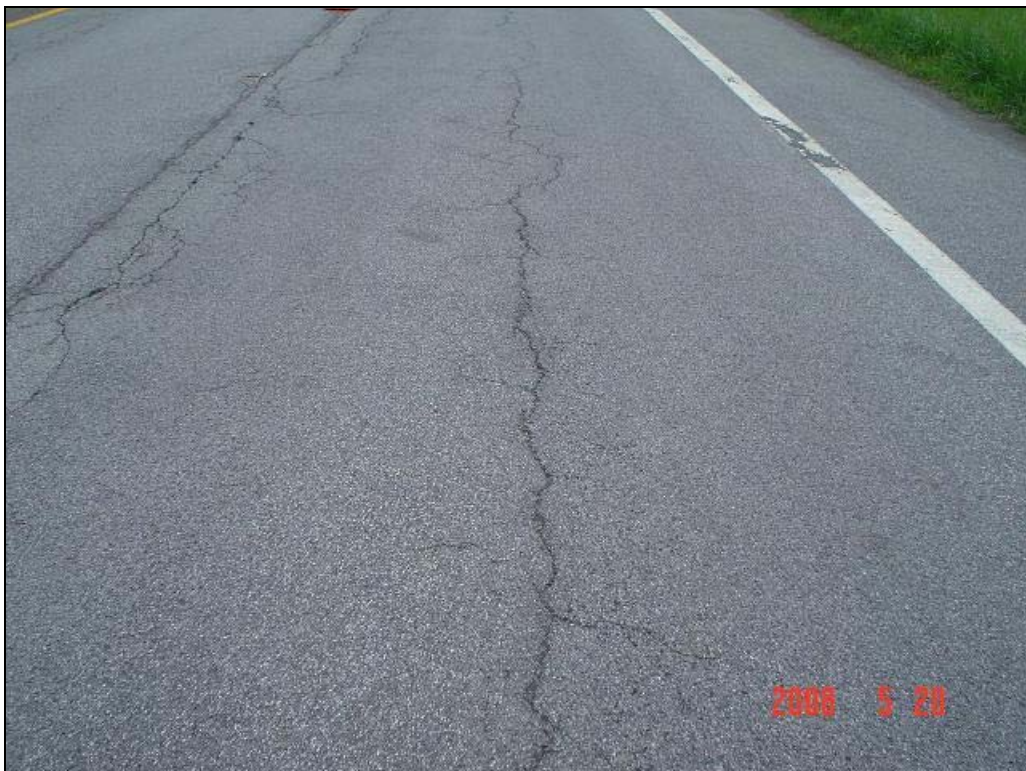
Figure E-4: Photo of Mid-Lane Longitudinal with Associated Cracking (360801)

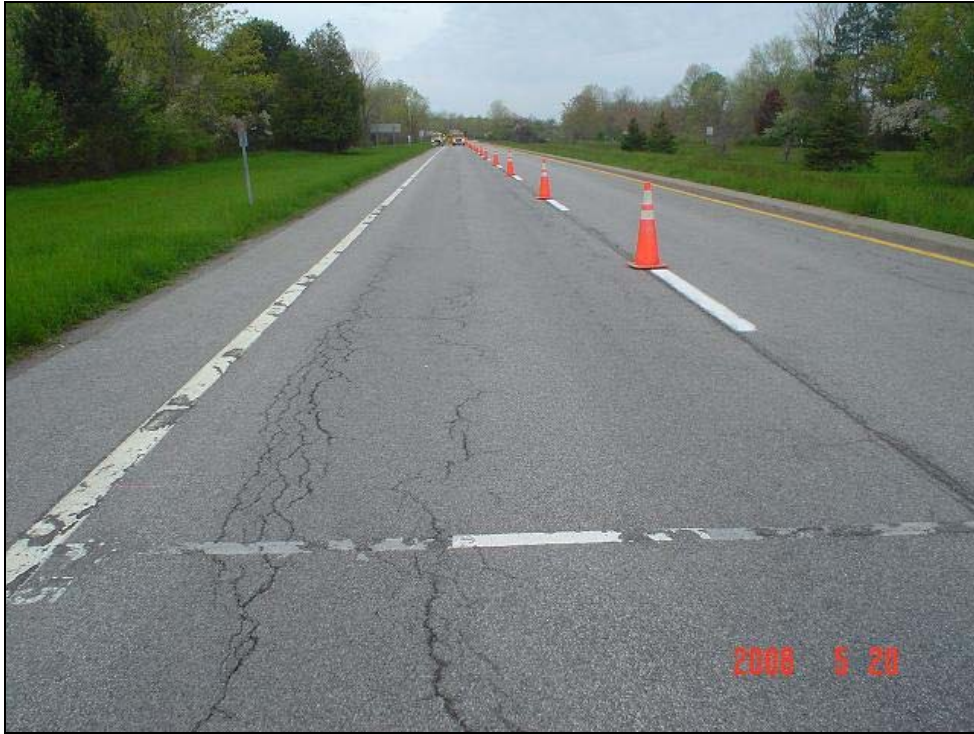
Figure E-5: Photo of Moderate Severity Alligator Crack in Outer Wheel Path (360801)

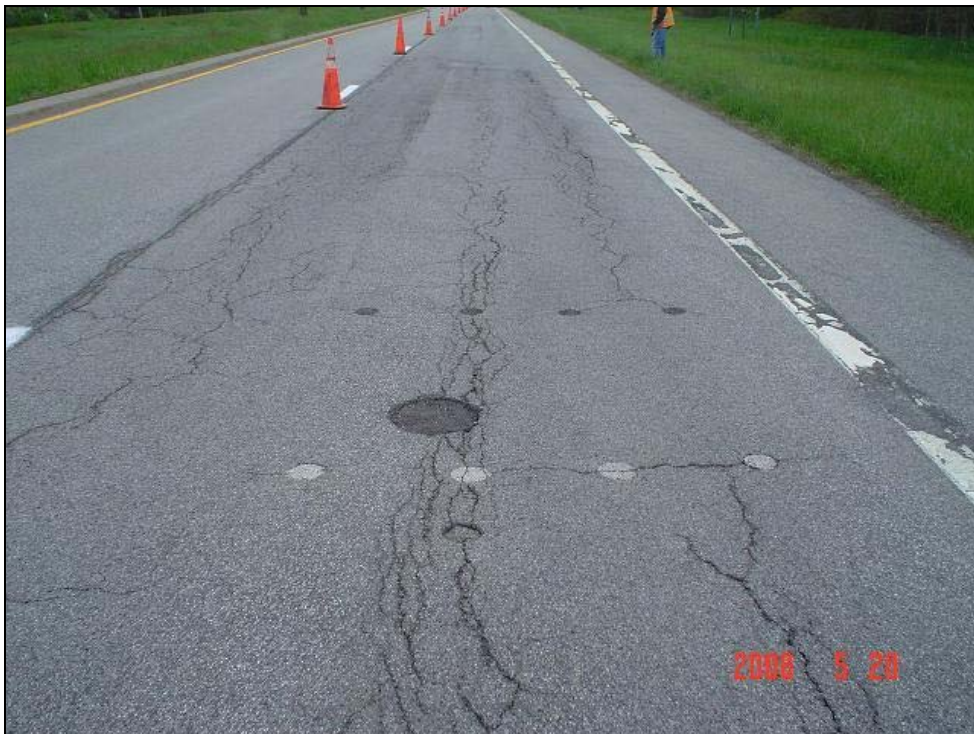
Figure E-6: Photo of High Severity Distress between Section 360801 and 360802

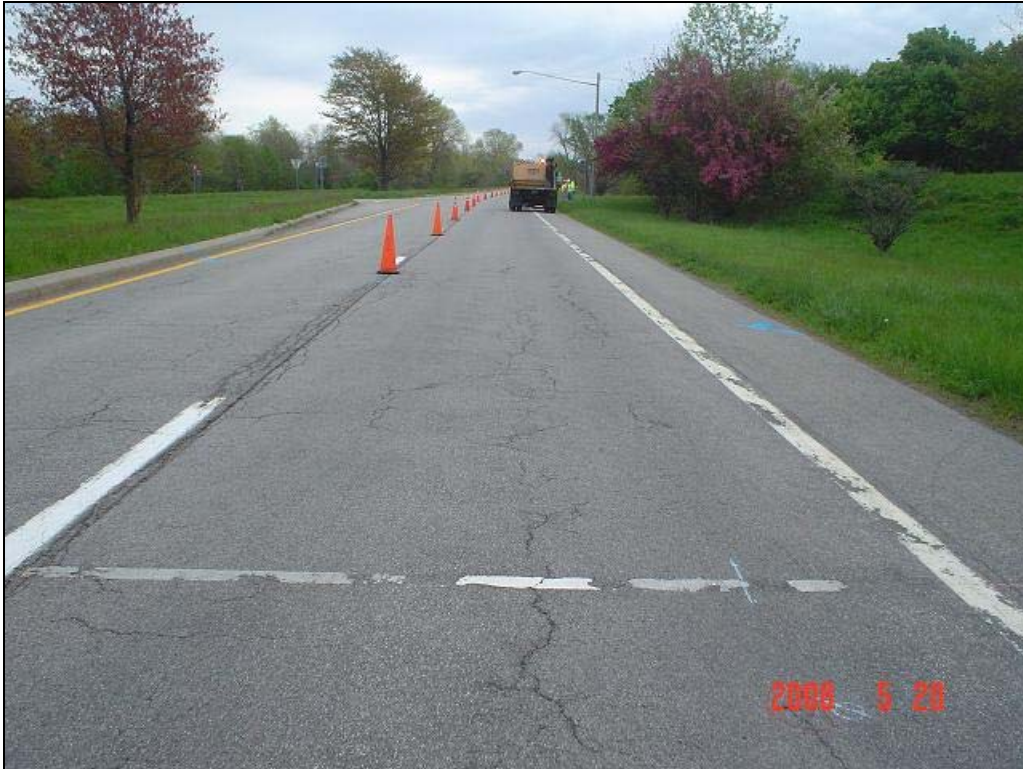
Figure E-7: Photo of Multiple Random Cracking at Station 0+00 (360802)

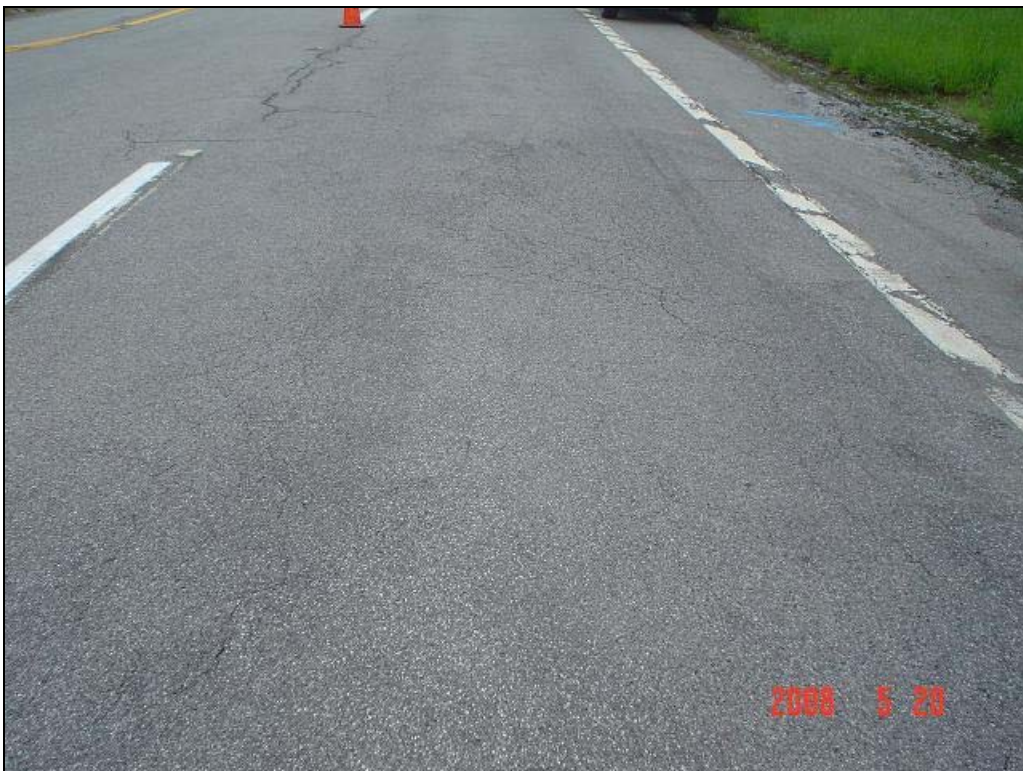
Figure E- 8: Photo at Location of Water Utility – Signs of Leakage (360802)

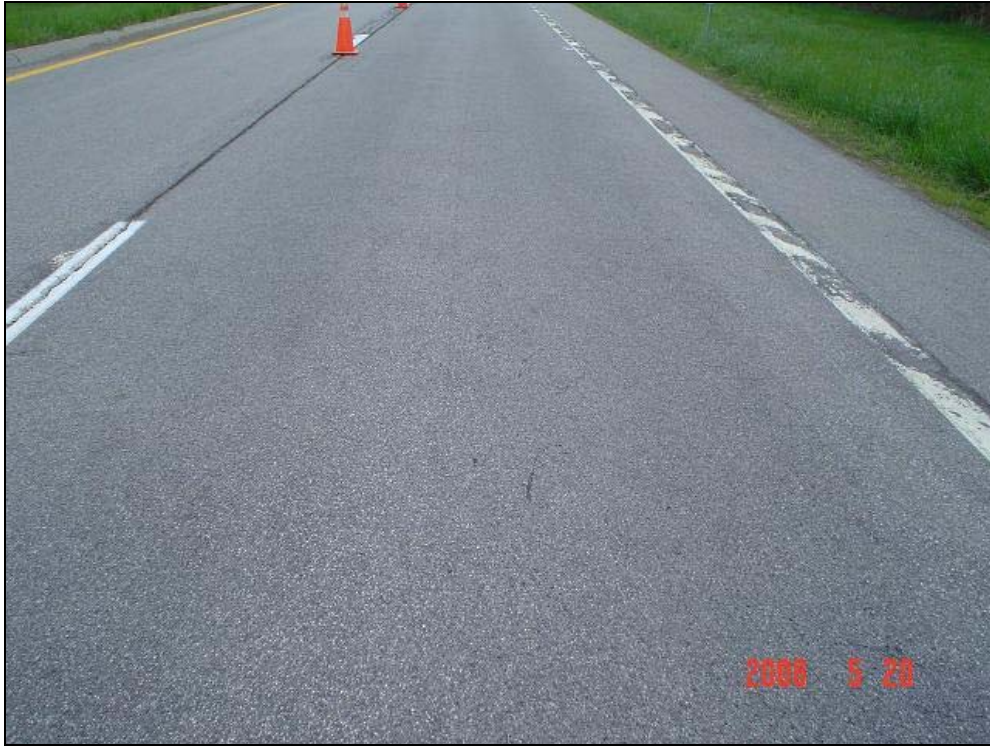
Figure E-9: Photo of Low Severity Alligator Cracks in Wheel Paths (360802)

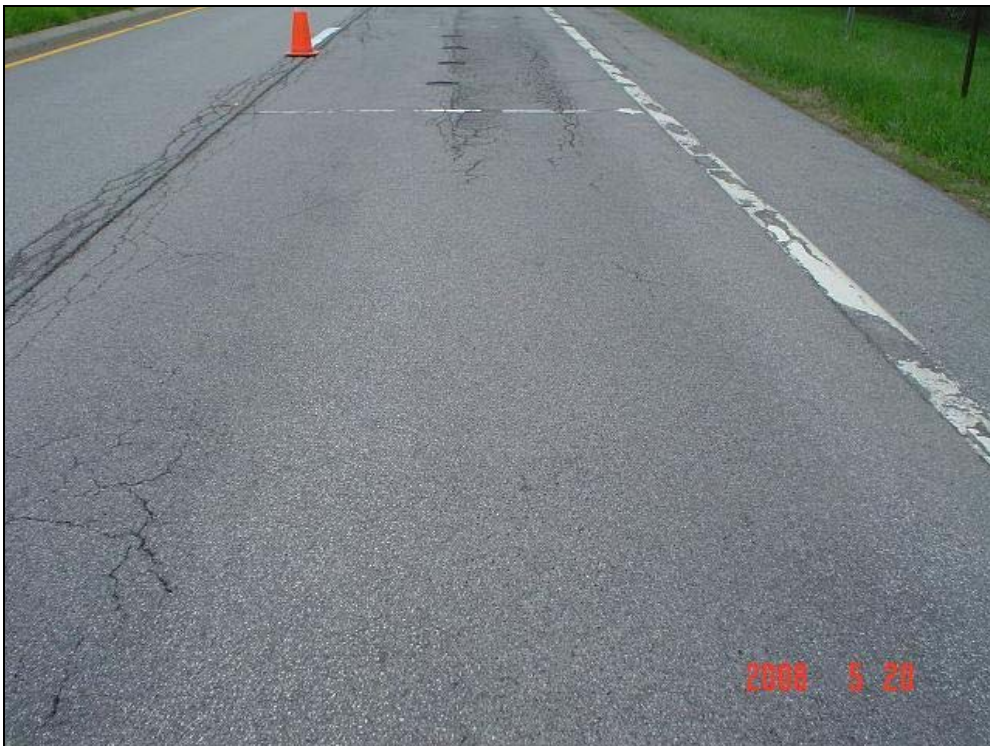
Figure E-10: Photo of High Severity Cracking/Ravelling from End of Section towards Core Sample Locations Station 5+00 (360802)

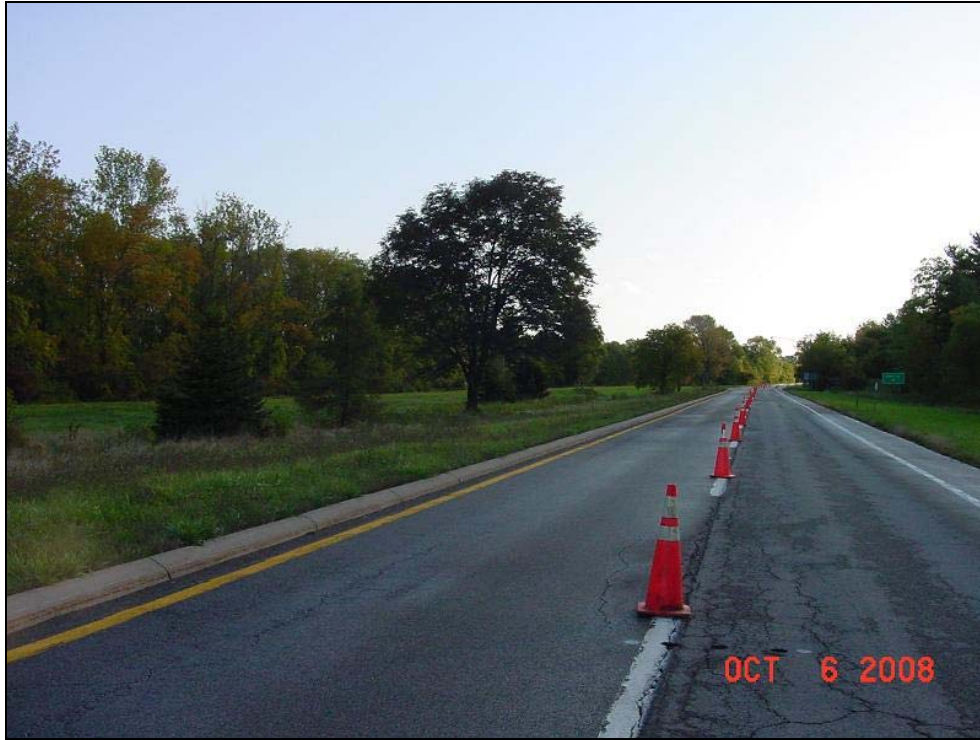
slope for the right lane could accelerate the runoff. Between the shoulder edge and just off the shoulder there is an increase in elevation for a portion of the section which could impede the runoff of the moisture from the pavement. These results are consistent with those observed during the site review and as evident in the photo provided in Figure E-11 and E-12, Appendix E.

Figure E-11: Photo of Median, Curb and Left Lane Pavement (360801)

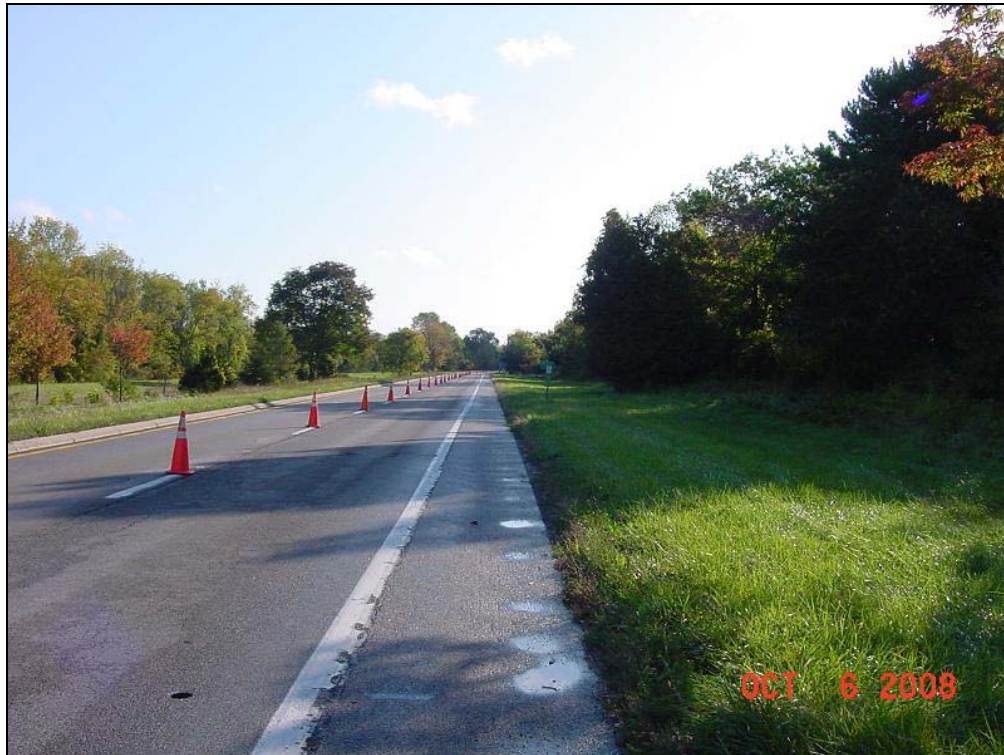
Figure E-12: Photo of Shoulder with Turf Grade Higher Than AC (360801)

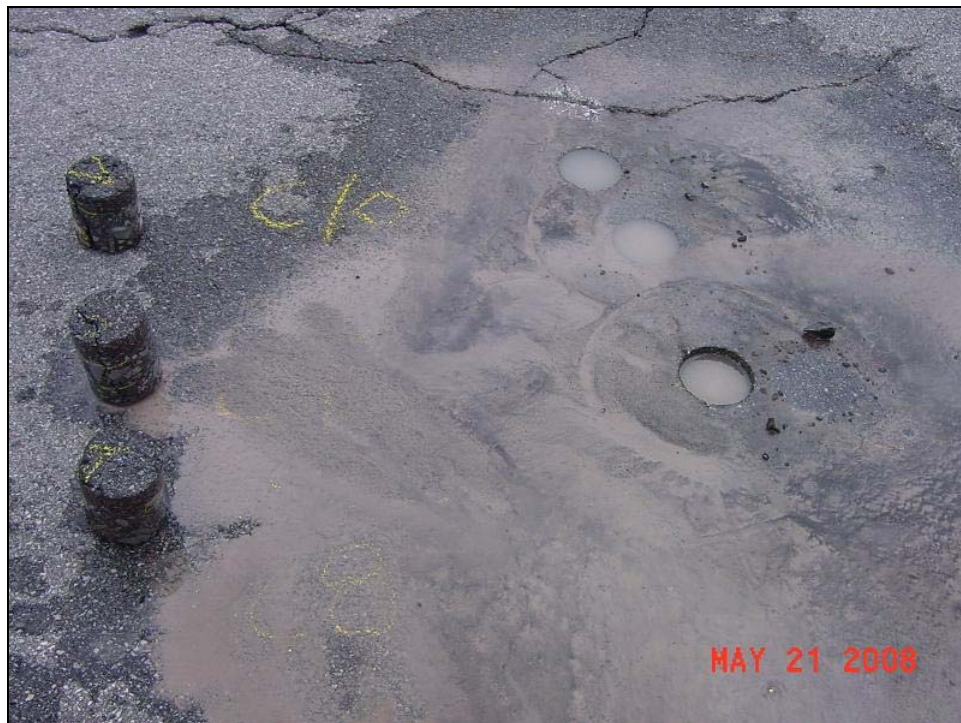
Figure F-4: 100mm Cores at Partial Transverse Crack (360801)

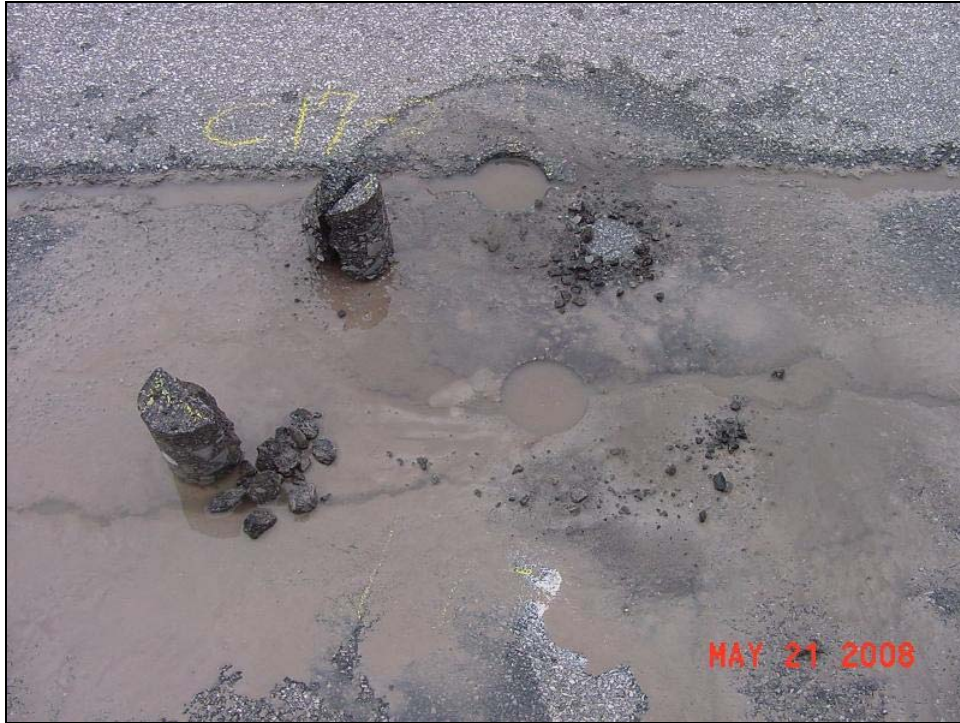
Figure F-5: 100mm Cores at Multiple Inner Wheel Path Longitudinal with Associated Cracking (360801)

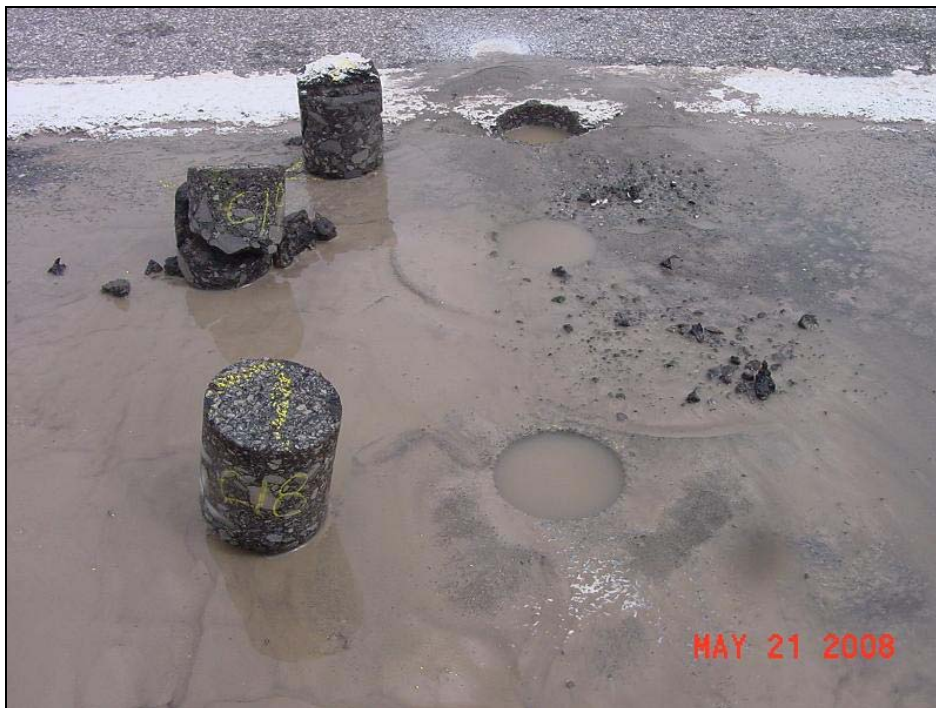
Figure F-6: 100mm Cores at Alligator Cracking from Centerline towards Inner Wheel Path (360801)

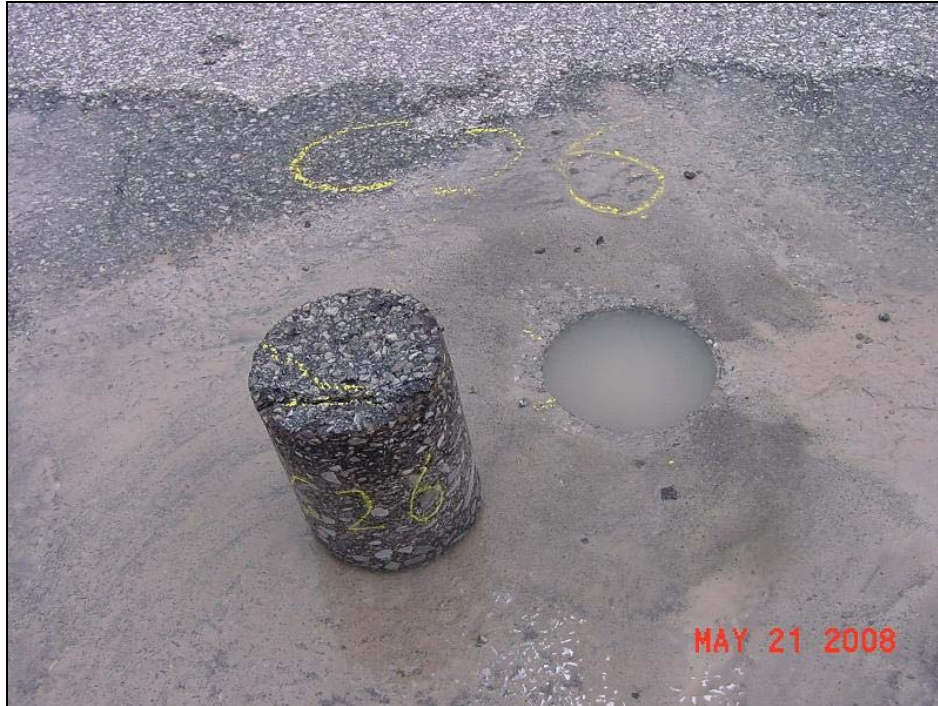
Figure F-7: 100mm Core at Low Severity Longitudinal Crack in Midlane (360801)

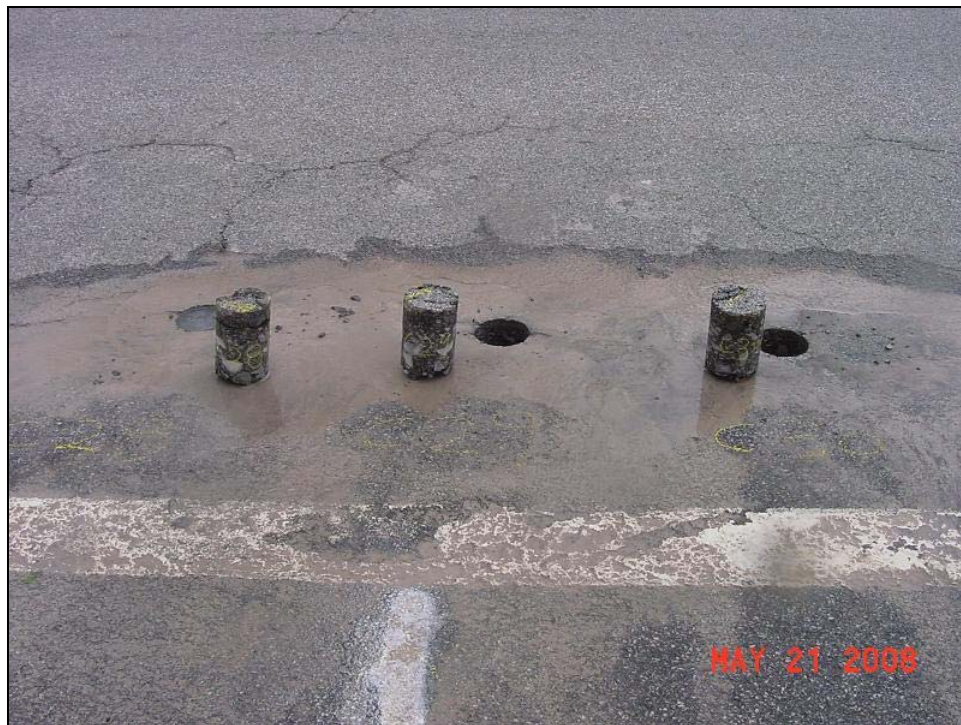
Figure F-8: 100mm Cores at Alligator Cracks in Outer Wheel Path (360801)

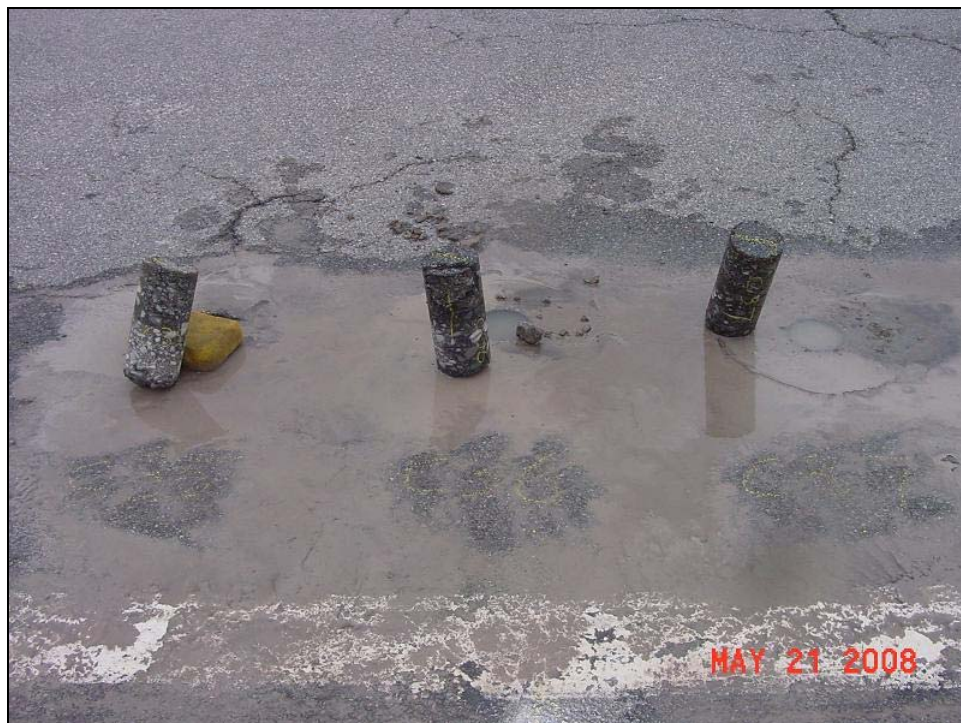
Figure F-10: 100mm Cores at Location of Wheel Path Longitudinal and Associated Cracking (360802)

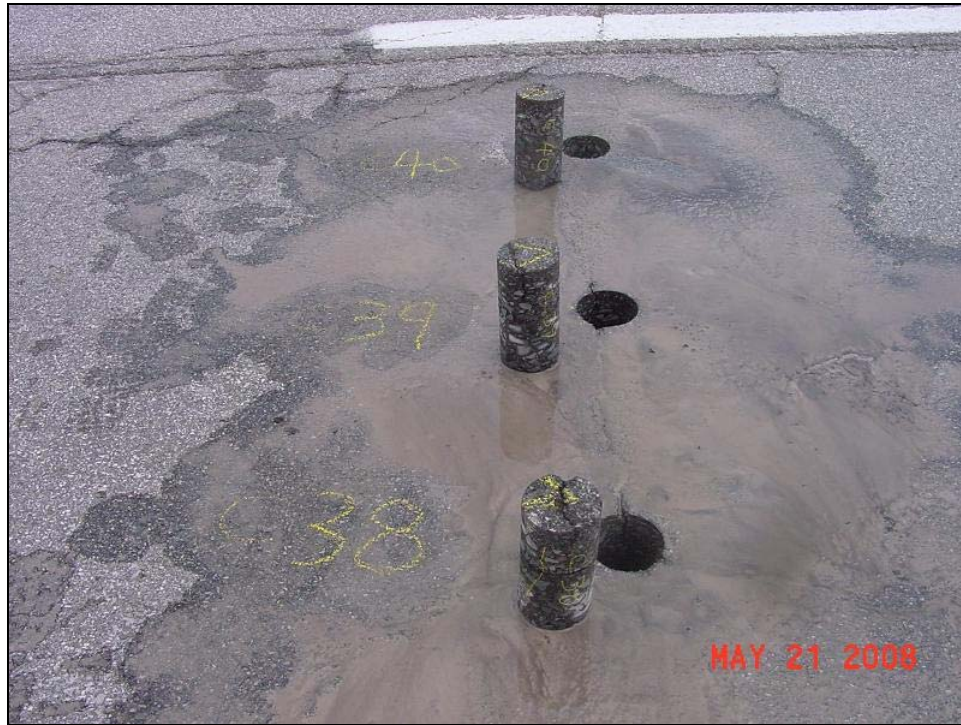
Figure F-11: 100mm Cores at Transverse Crack (360802)

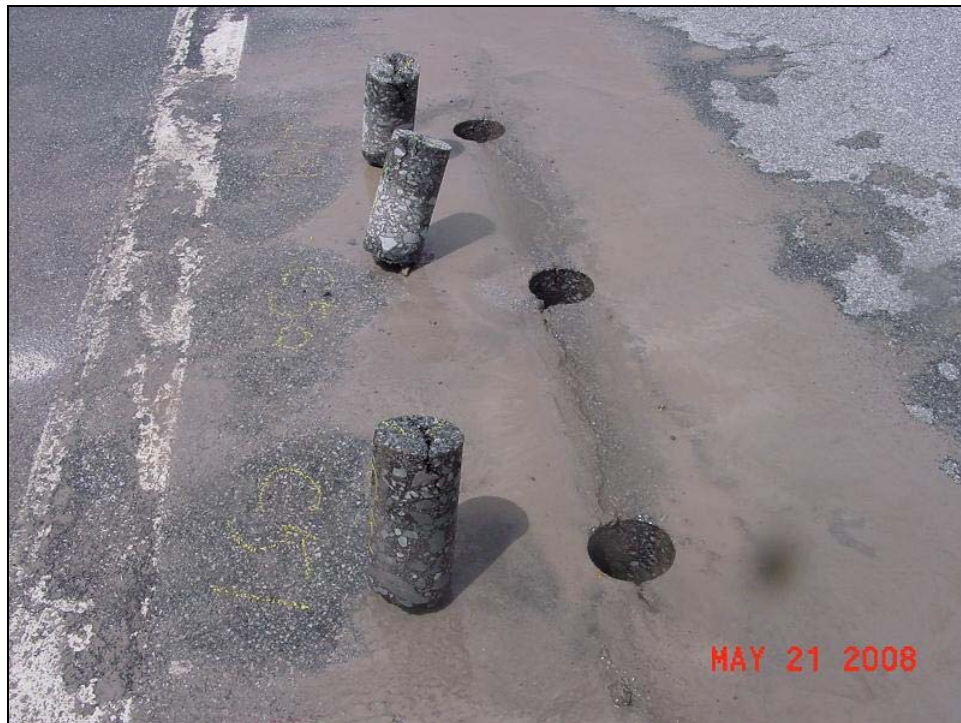
Figure F-12: 100mm Cores at Low Severity Longitudinal Crack in Wheel Path (360802)
