August 25, 1997  
File: 800.12.6.8.13

**RE: Dismantle of SMP Site 161010 Near Idaho Falls, Idaho**

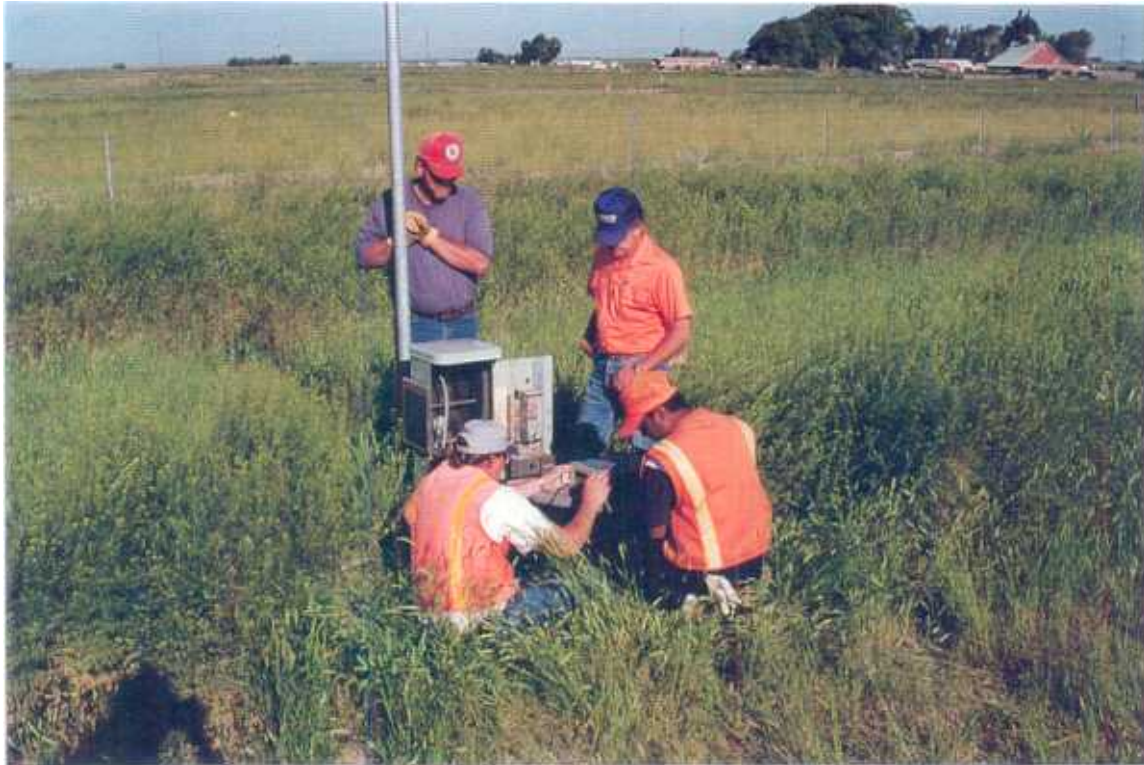
Final set of data collection in progress before dismantle of 161010 site

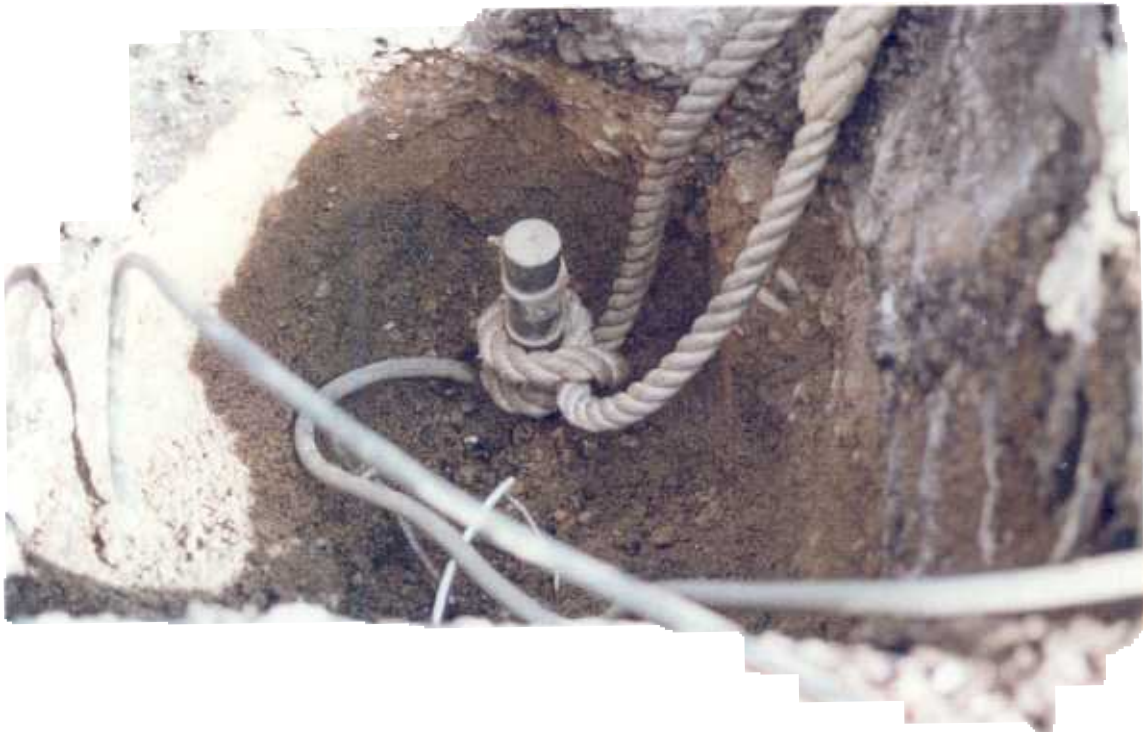
The resistivity probe with clove hitch

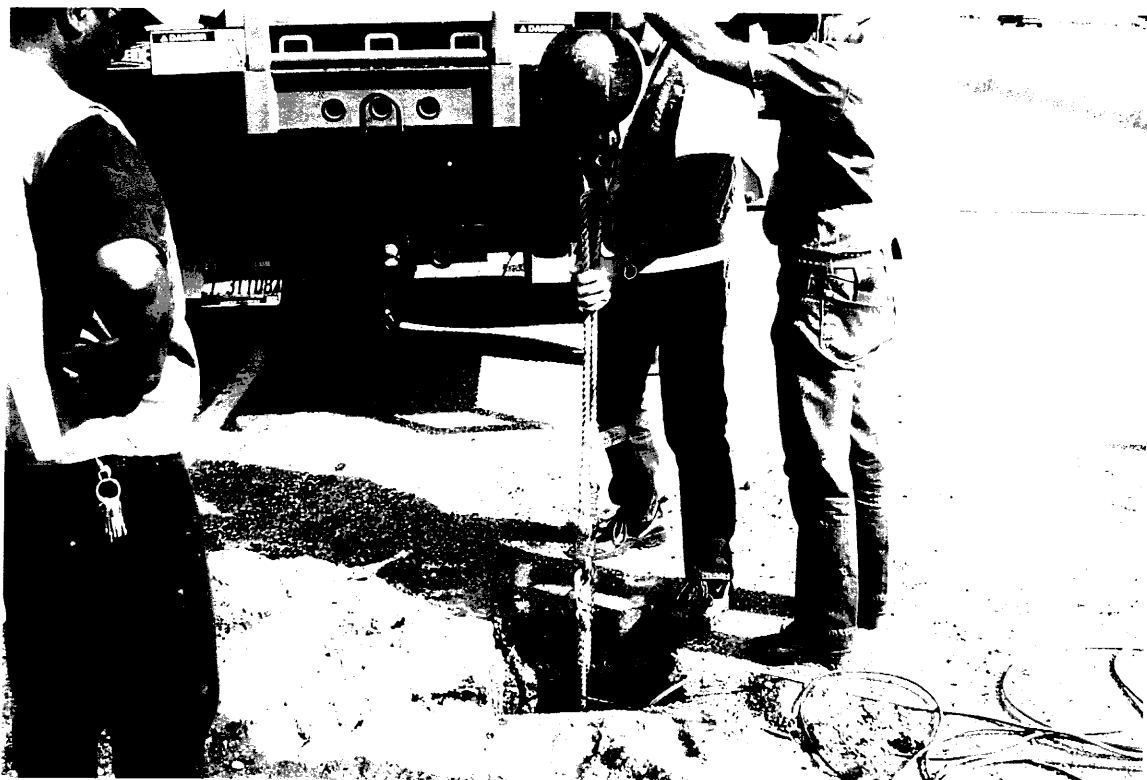
The hoist and rope attachments used in attempting the resistivity and MRC probe recovery.

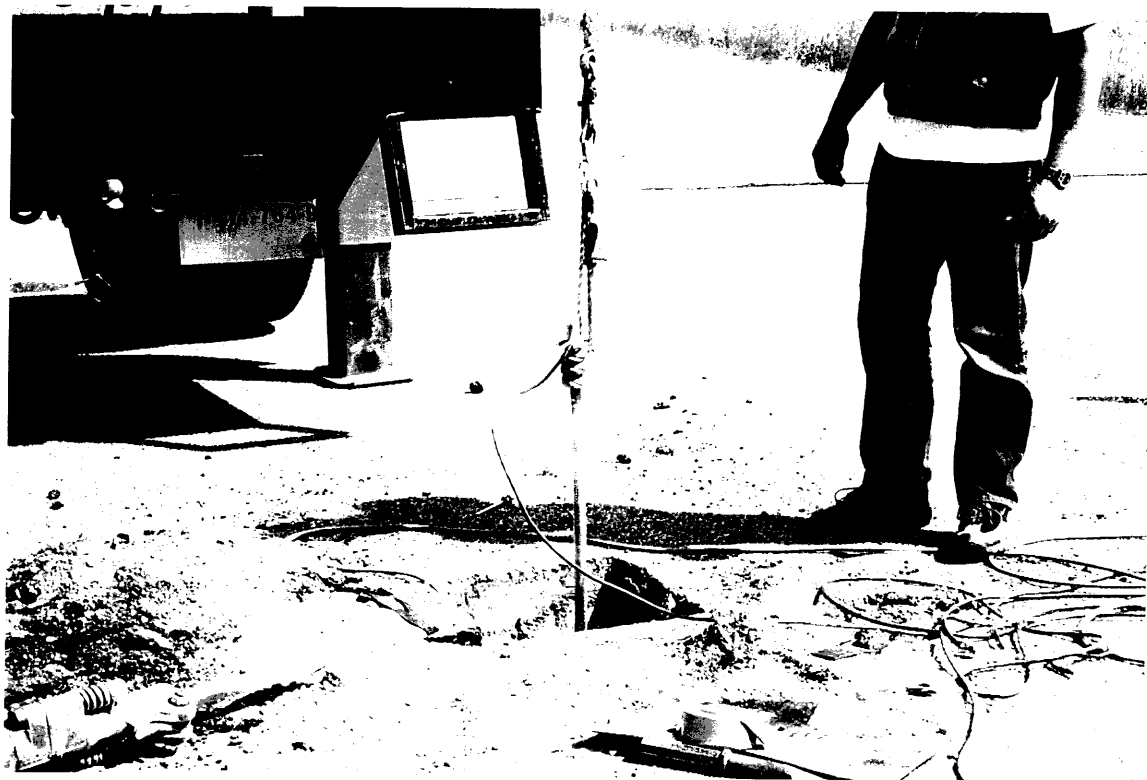
The MRC probe being recovered from the instrument hole.
