## Site Monitoring Suspension Status Draft Final Report for GPS Section 183002 (18A) Lafayette, Indiana

August 1996

1. Report No. <b>FHWA-</b>		2. Government Accession No.		3. Recipient's Catalog No.	
4. Title and Subtitle <b>LTPP Seasonal Monitoring Program Site Monitoring Suspension Report Status for GPS Section 183002 (18A) Lafayette, Indiana</b>				5. Report Date <b>August 30, 1996</b>

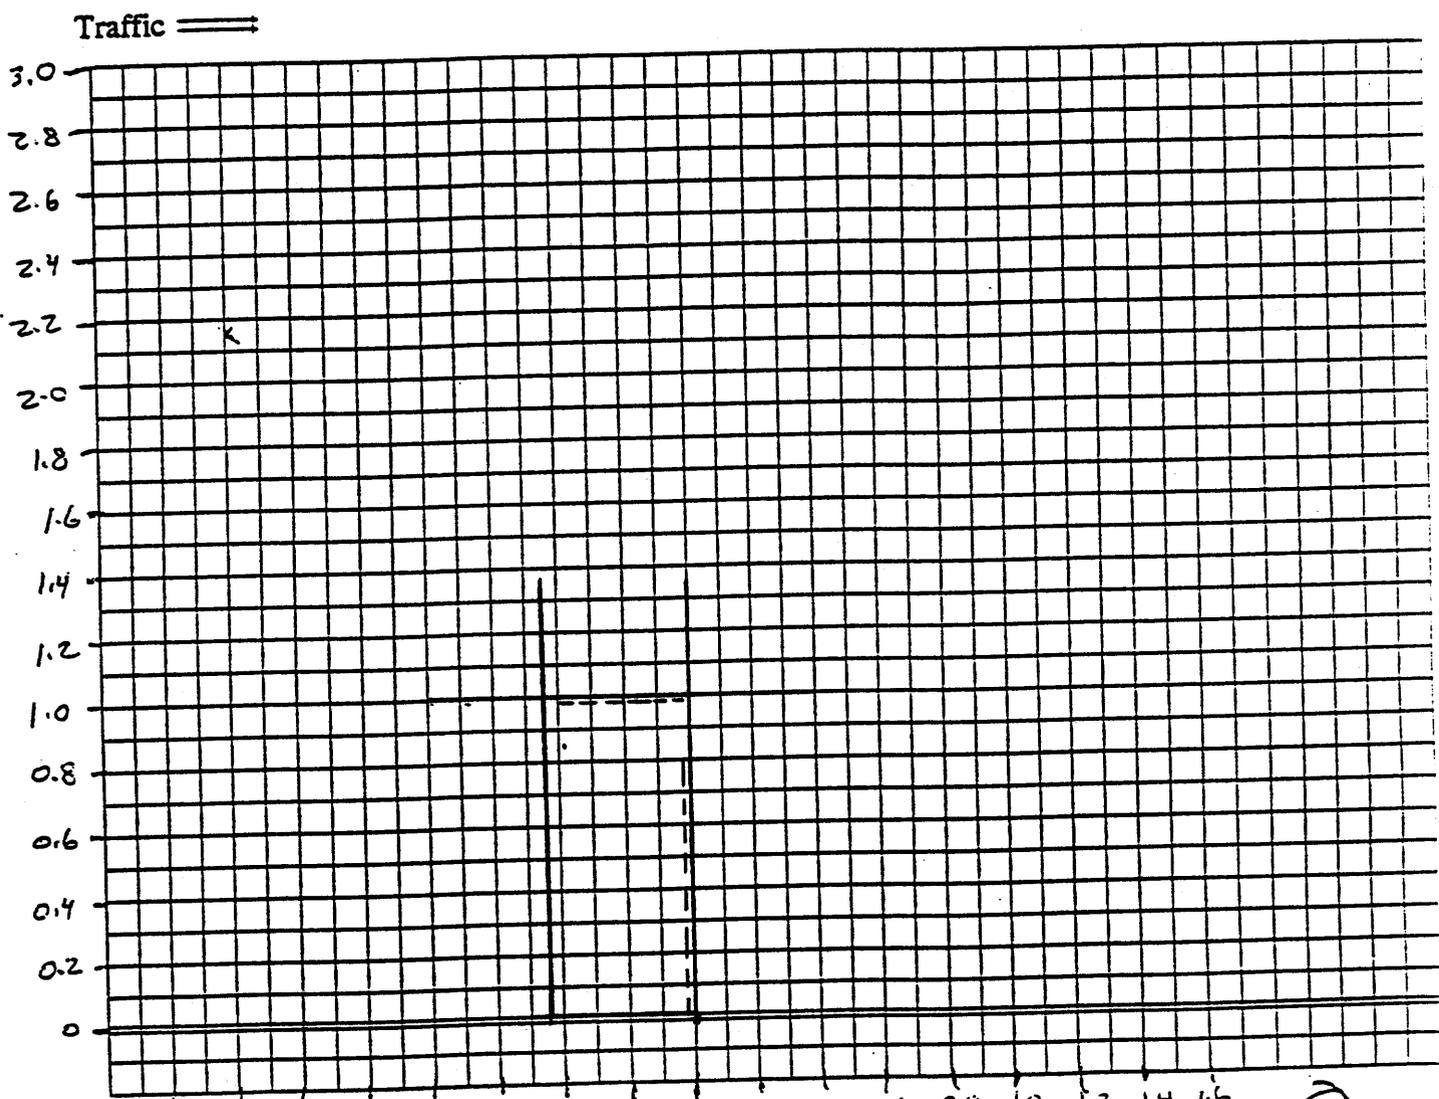
List any repairs (type and extent) done since instrumentation installation and/or last survey of instrumentation area: Previously resealed joints along edge of instrumentation ~~installation~~ block. Some areas of the resealed joints failed and were resealed as part of site closing activities. One of the three low severity cracks in trench to instrument block sealed. Photos taken.

Additional Comments: Settlement of instrument block has not progressed since last measurement.

Location	Settlement, mm			
	Location 1	Location 2	Location 3	Location 4
Instrumentation block/hole	<u>14.0.</u>	<u>16.0.</u>	<u>13.0.</u>	---
Trench	<u>11.0.</u>	<u>07.0.</u>	n/a	n/a

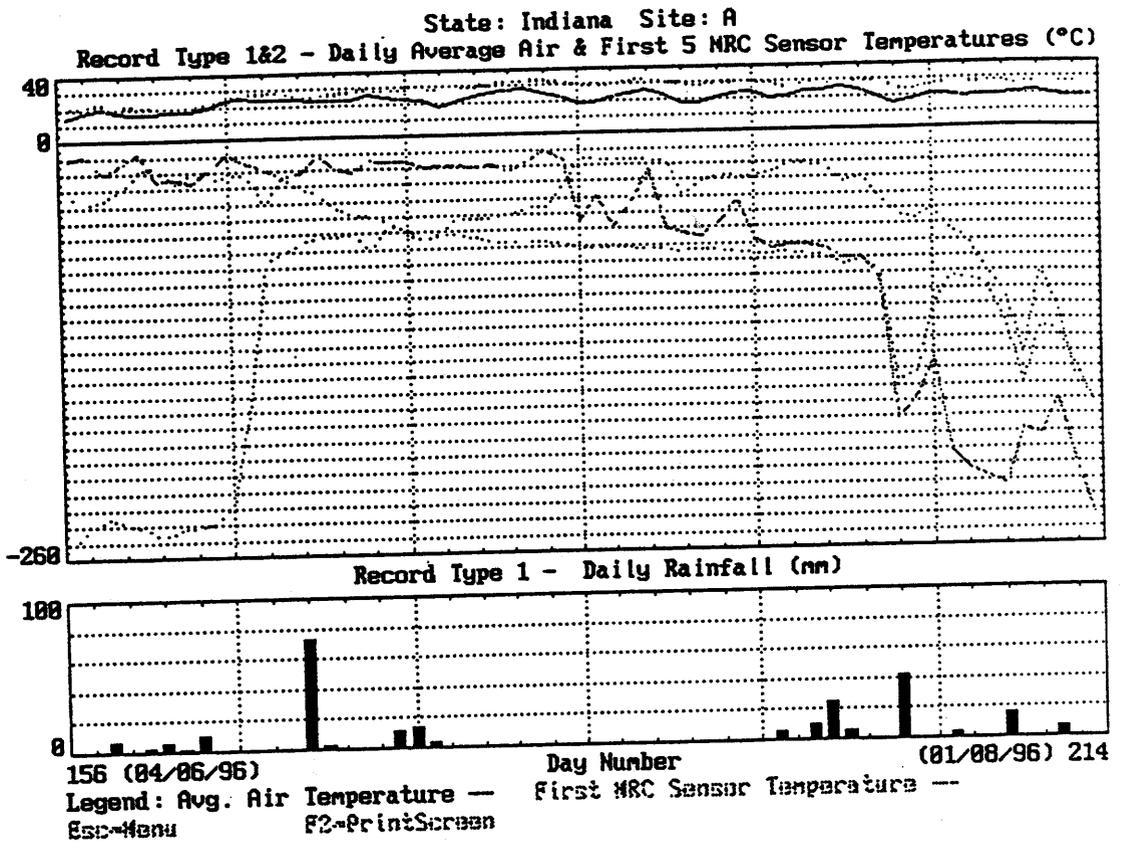
Figure D-1. Profiles for the first 5 MRC sensors for test section 18SA for the period of June 4, 1996 to August 1, 1996.

A review of the onsite data collected during this visit indicated that MRC sensors 1, 2, and 3 are not functioning as expected. As can be seen in the plots presented figure D-1 in appendix D, the temperature recorded by MRC sensors 1, 2, and 3 in the summer from June 4, 1996, through August 1, 1996, were all below 0 °C. The problems with the MRC sensors were first reported on November 20, 1995. At this time, no effort is directed at repairing these sensors, which are located in the pavement. The temperature recordings from the remaining MRC sensors and air temperature measuring sensor appear reasonable and typical of temperatures at this time of the year.

The precipitation data recorded by the datalogger in figure D-1 appears reasonable, suggesting the rain gauge is functioning as expected. No obvious problems were noted from the data recorded from June 4, 1996, through August 1, 1996.

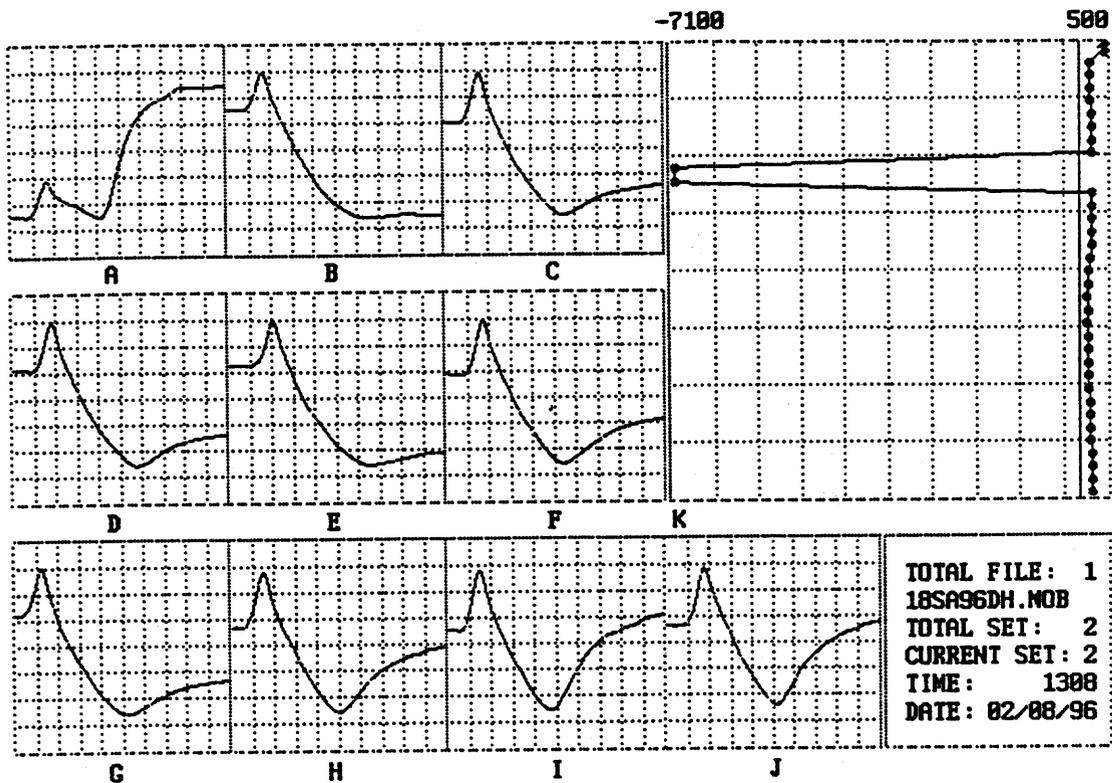
Figure D-3. TDR traces for test section 18SA recorded at 1:08p.m. on August 2, 1996.

A review of the data from the mobile datalogger indicates that the TDR sensors are functioning as expected. All the TDR traces, which can be found in figures D-2 and D-3 in Appendix D, had the maximum and minimum points on the traces that enable analysis. However, in the same figure, plot K indicates potential problems with the mobile unit, possibly the CRREL multiplexer. As can be seen in plot K, a value of -6999 was noted for locations 10 and 11, suggesting potential problems at these locations in the mobile unit. A review of data from previous visits indicates that this problem existed as early as March 11, 1996.

Problem with  
CRREL on  
position K/11.

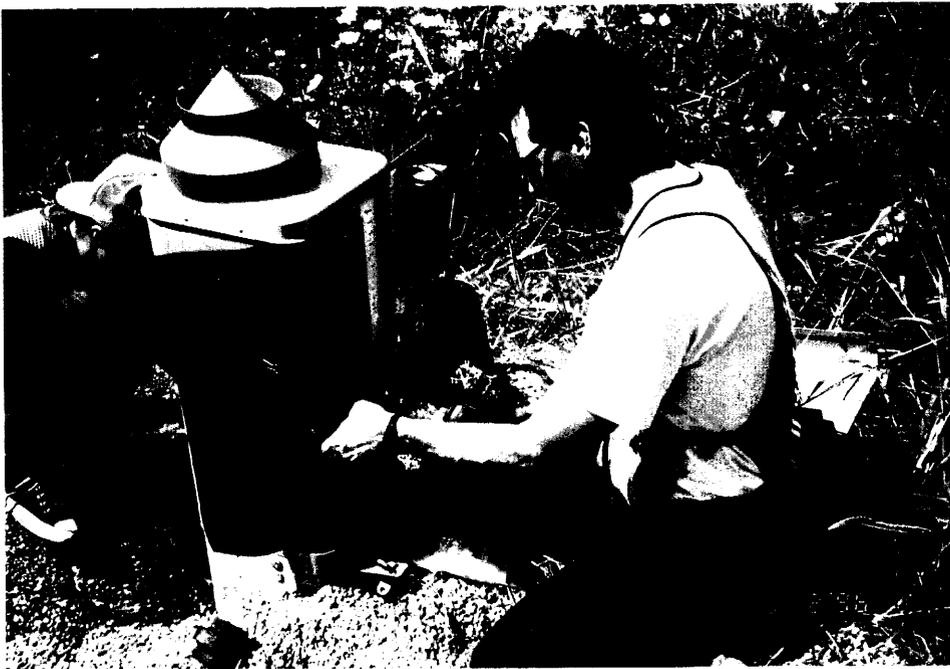
Photograph # 2

- Application of an electronics quality, anti-corrosion compound to the TDR and BNC connectors, electrical resistivity connector, and MRC temperature lead wires, as shown in photograph number 2 in appendix E.
- Disconnection and removal of the panel board containing the Onsite CR10, power supply, terminal strip, and relay. A desiccant pouch with all wires and connectors was sealed in a plastic bag. The wires were secured as high as possible in the cabinet, as shown in photograph number 3 in appendix E.
- Locked cabinet as shown in photograph number 4 in appendix E.
- Painted the units used to protect Indiana DOT benchmark red for easy identification, as shown in photograph number 5 in appendix E.

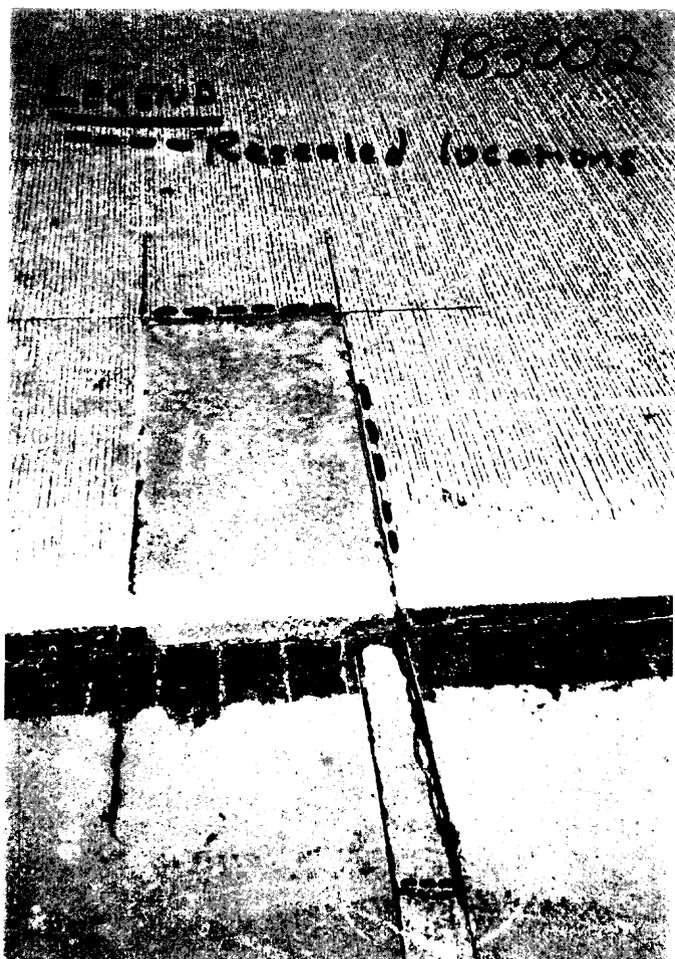
⇐ Photograph # 6

- Resealed edges of the instrumentation block and a crack in the access trench, as shown in photograph number 6 in appendix E.
