LTPP Seasonal Monitoring Program

Site Monitoring Suspension Status Draft Final Report for GPS Section 204054 (20A) Enterprise, Kansas

September 1996

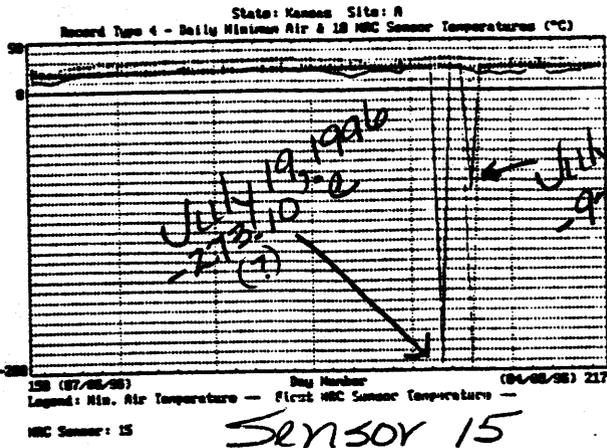
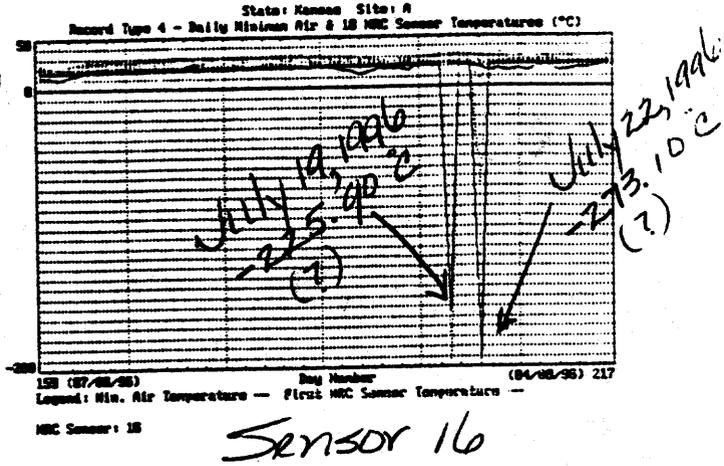
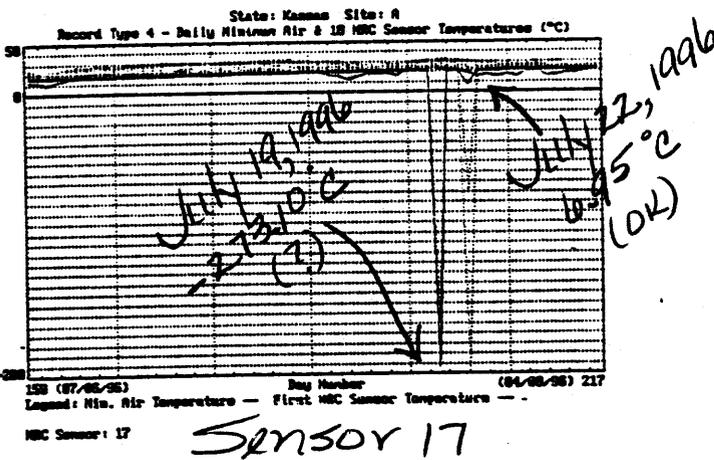
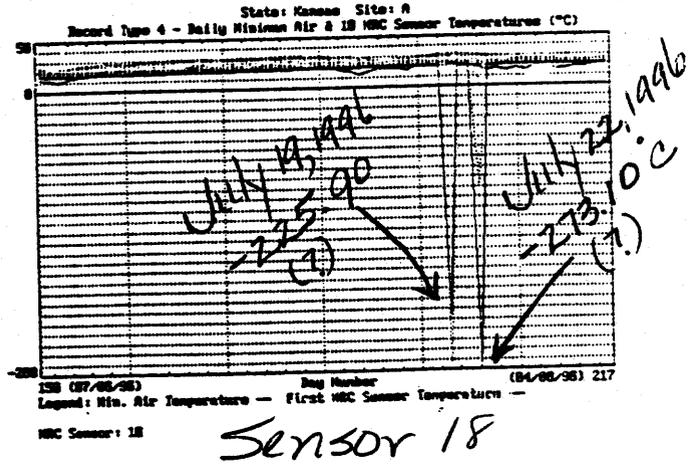
Figure D-1. Profiles for MRC sensors 15, 16, 17 and 18 for test section 204054 (205A) for the period of June 07, 1996 to August 04, 1996.

A review of the onsite data collected during this visit indicated that MRC sensors 15, 16, 17, and 18 did not function as expected on July 19 and 22, 1996.

As can be seen in the plots presented in figure D-1 in appendix D, two spikes were noted in the temperatures recorded by MRC sensors 15, 16, 17, and 18, for July 19 and 22, 1996. The temperatures recorded in these days in summer were below 0 °C, indicating potential equipment problems. For sensor 17 only the temperature recorded on July 19, 1996, was below 0 °C. Similar problems with the MRC temperature recordings attributed to intermittent failure of the relay were reported in the site installation report (1). The temperature recordings from the remaining MRC sensors and air temperature measuring sensor appear reasonable and typical of temperatures at this time of the year.

- MRC Nos. 15, 16, 17, and 18 failed on July 19, 1996 - Temperature readings between -225°C and -273°C .
- MRC Nos. 15, 16, and 18 failed on July 22, 1996 - Temperature readings between -97°C and -273°C . Reading for sensor 17 was 6.95°C which is considered reasonable.

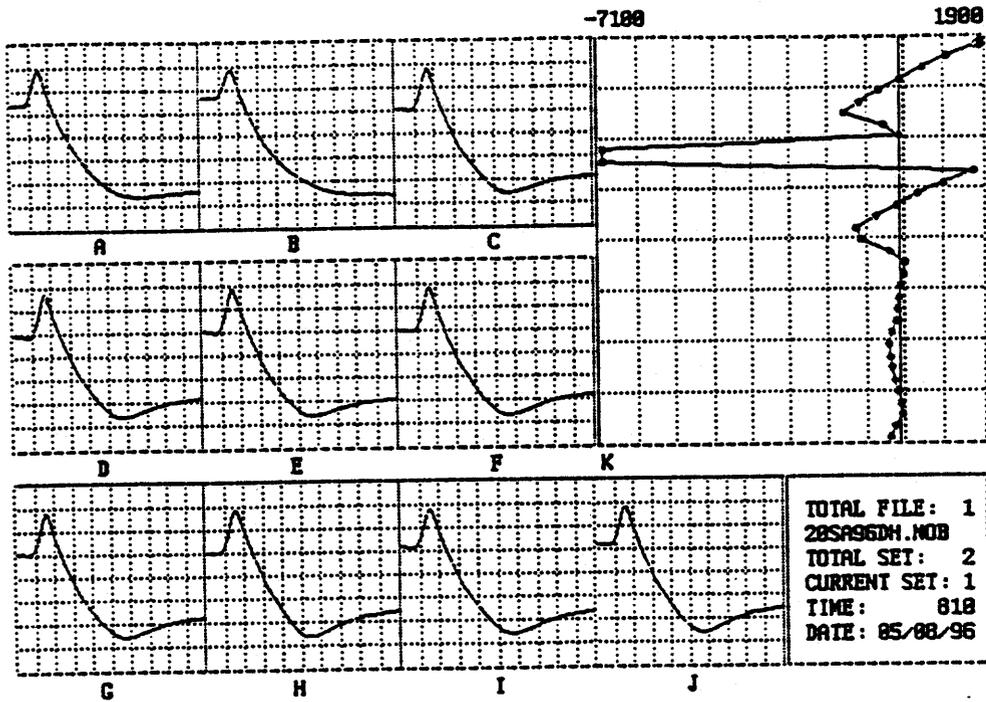
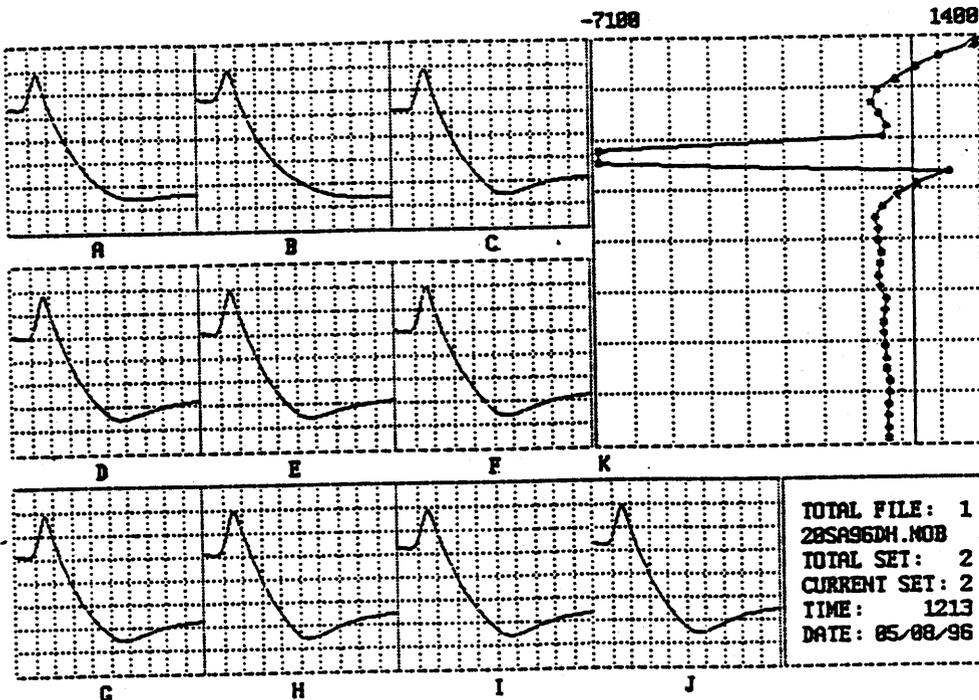
Figure D-2. TDR traces for test section 20454 recorded on August 05, 1996.

A review of the data from the mobile datalogger indicates that the TDR sensors are functioning as expected. All the TDR traces, which can be found in figure D-2 in appendix D, had the maximum and minimum points on the traces that enable analysis. However, in the same figure, plot K indicates potential problems with the mobile unit, possibly the CRREL multiplexer. As can be seen in plot K, a value of -6999 was noted for locations 10 and 11, suggesting potential problems at these locations in the mobile unit. A review of data from previous visits indicates that this problem existed as early as March 11, 1996.

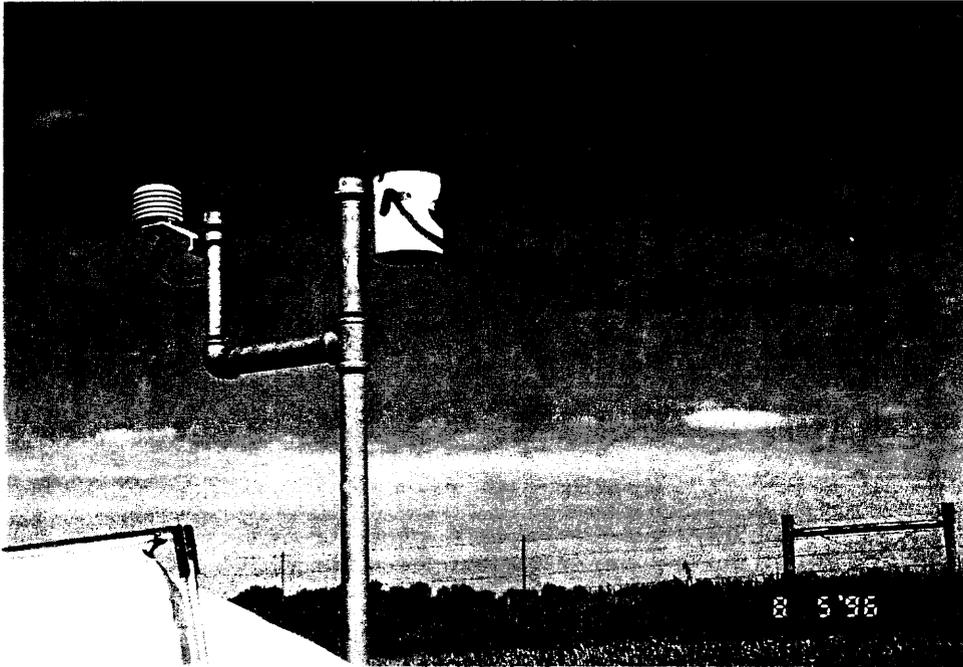
Photograph #1

As shown in photograph number 1 in appendix E, the collector unit (funnel) of the rain guage was detached from the weather station system probably by strong winds. Note the clips expected to hold the collector unit in place in the photograph are intact. The collector unit was found in the ditch along the eastbound lane, approximately 50 to 70 meters from its original location. Photographs 2 through 5 in appendix E show the damage to the collector unit. Note in photograph number 5 that the sieve in the collector unit is missing. Discussions with the local Kansas DOT staff in Abeline indicate that there were strong winds from July 23 through August 5, 1995, which most likely caused the collector unit to be detached from the weather station system. It is therefore recommended that the rainfall data from July 23 through August 5, 1996 not be entered into the IMS database.
