**LTPP Seasonal Monitoring
Program
Site Monitoring Suspension
Status Report
Section 231026, East Dixfield
Maine**

SMP SITE MONITORING SUSPENSION STATUS REPORT MAINE SECTION 231026

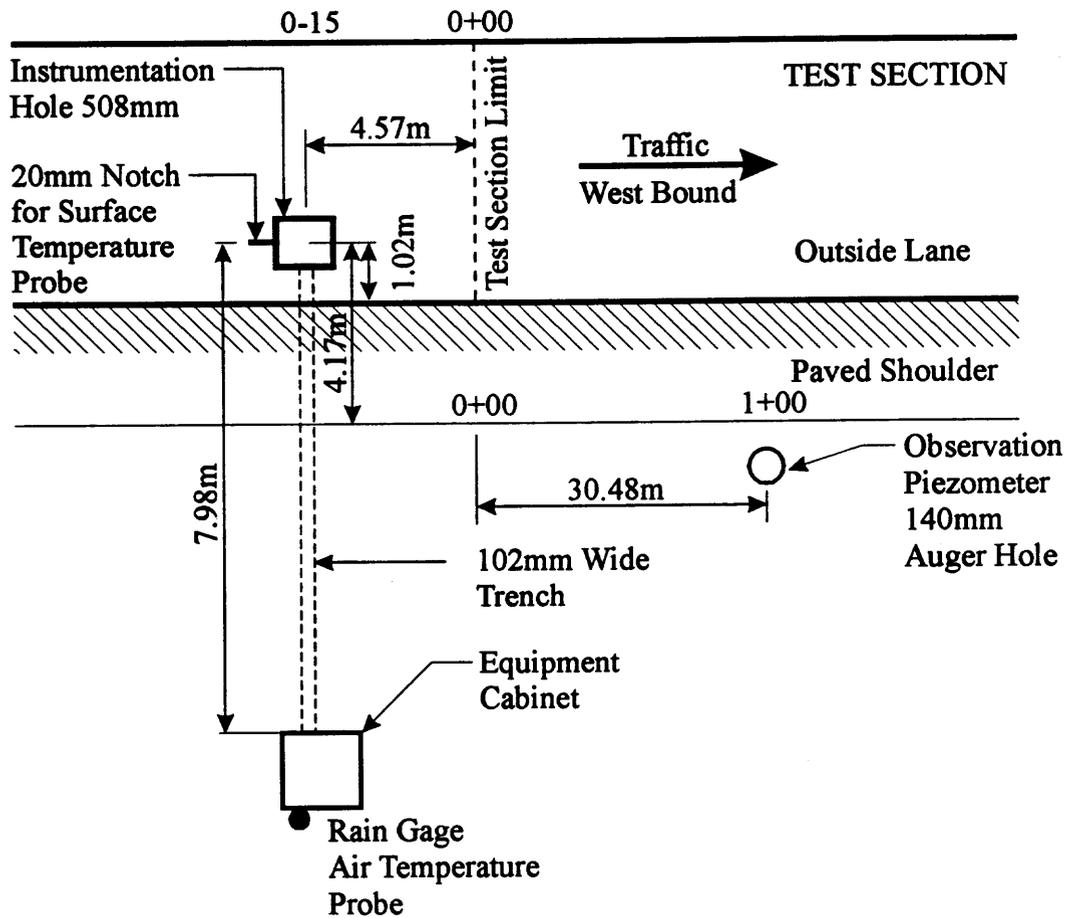
Figure 1. Location for Seasonal Monitoring Instrumentation Installed at GPS 231026

Figure 1 shows the locations of the installed instrumentation at the site. The instrumentation hole is at station 0-15 and the piezometer is at station 1+00. The state bench-mark is at station 0+58. This was used to check that the piezometer standpipe, that was used as a bench-mark, was not moving. The measurements from the permanent bench-mark indicated that the piezometer standpipe was not moving.

- Total Depth of Piezometer: 4.29m
- Distance of Piezometer Below Ground Level: 102mm

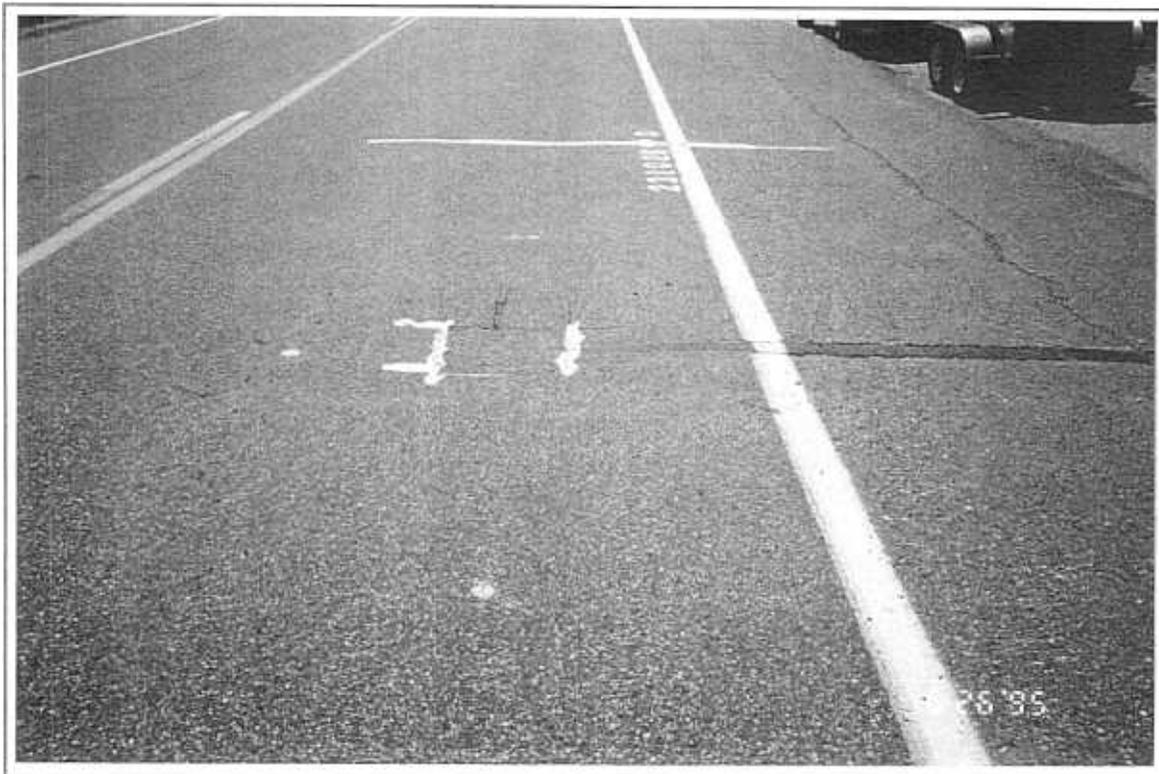
Instrumentation Hole, Seasonal Site 231026 ME, June 1995, During Suspension Preparation Activities

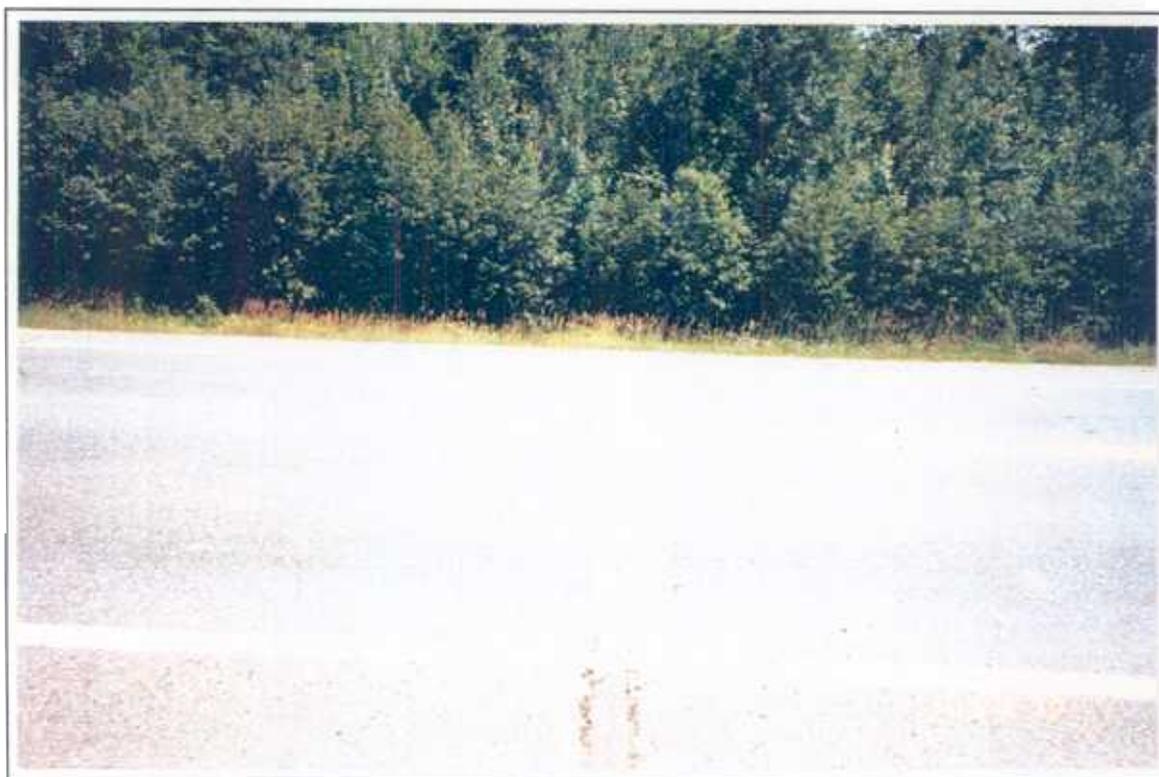
Instrumentation Hole, Seasonal Site 231026 ME, June 1995, During Suspension Preparation Activities
