U.S. Department
of Transportation
**Federal Highway
Administration**

**LTPP Seasonal Monitoring
Program**
Site Monitoring Suspension
Status Report
Section 241634, Ocean City
Maryland

SEASONAL MONITORING PROGRAM SUSPENSION STATUS REPORT MARYLAND SECTION 241634

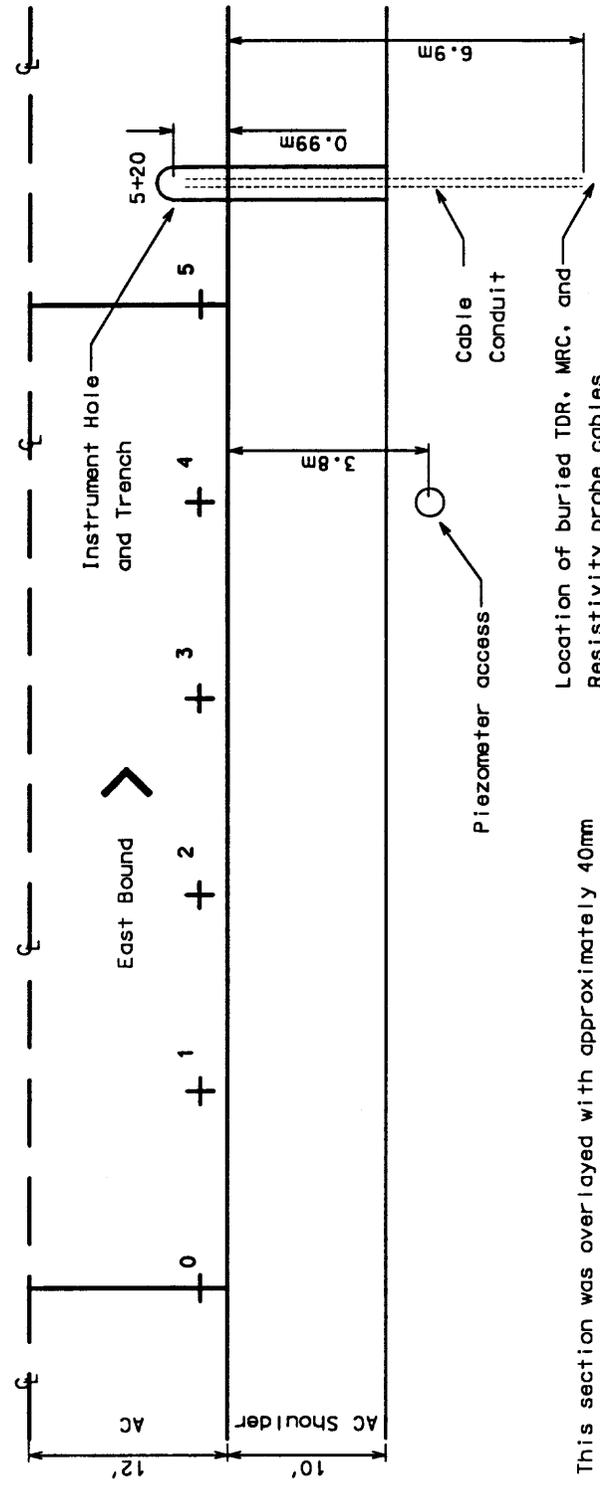
Figure 1. Plan view of Section 241634 -
Post Suspension

All the necessary suspension activities were completed on April 08, 1998. The dismantled equipment was removed from the site. The dismantled site contains all the underground instrumentation and the related cabling buried underground. Figure 1 shows the plan view of the site after completion of the close-out activities. The above ground instrumentation area was leveled. The MDSHA personnel were informed about the 2" galvanized pole base protruding out of the ground. They planned on removing the section protruding above ground.

Figure 1 shows the locations of the installed instrumentation at the site after the close-out. The instrument hole is at Station 5+20 and the piezometer is at Station 4+00. Table 2 gives the elevations of the portion of test section 241634 that was used for elevation measurements. All offsets are measured from the PK nails found at the outside pavement edge.

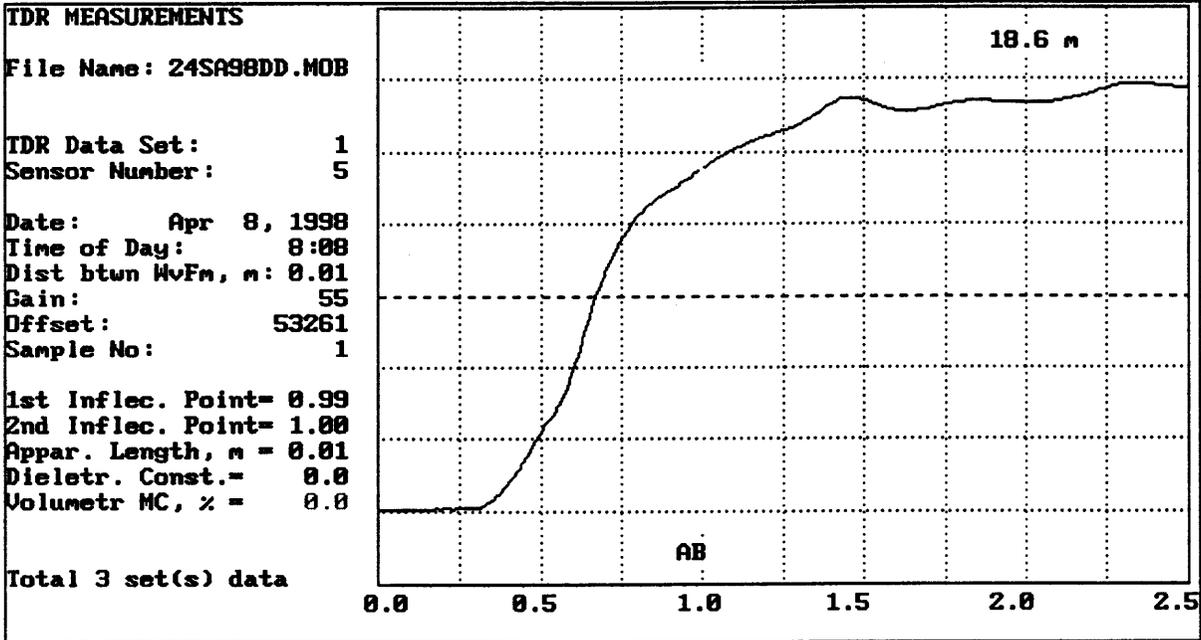
Figure 2: Faulty TDR sensor #5

At the time of suspension TDR sensor number five was the only sensor that was not functioning (Trace shown in Figure 2). This probe has not been functioning since October of 1997. The plots from ONSFIELD, MOBFIELD and SMPCHECK follow expected trends and produce expected values. Pictures from the site suspension are provided at the end of this document.

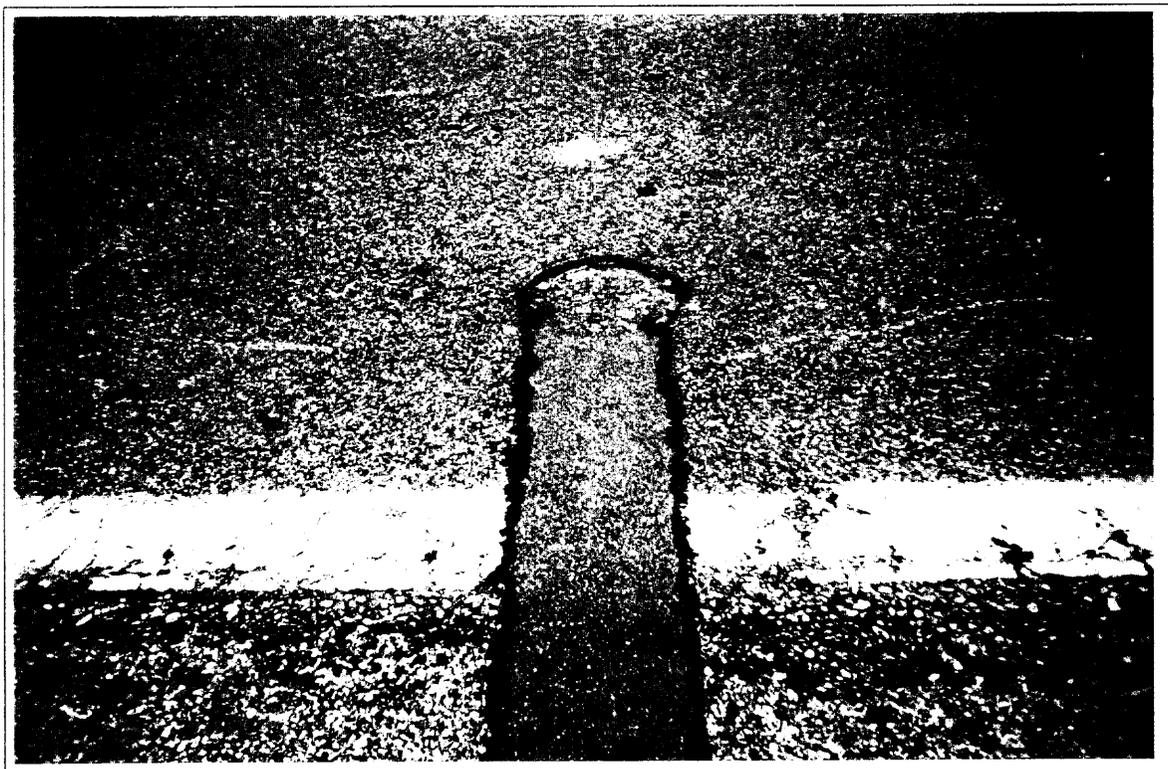
Photo 2: Instrument Hole Area - Pre-Overlay

All the suspension preparation activities at site 241634 were conducted during the final site visit on April 08, 1998. A manual distress survey of the entire section and cross profile surveys were conducted. The site paint markings did not need to be refreshed. On this day three sets of FWD tests, one set of elevations, and a distress survey of the instrumentation area were conducted. The water table measurements and the manual resistivity measurements (2 and 4 point) were performed in the morning and afternoon. The onsite datalogger was downloaded before being dismantled. Two sets of TDR traces and resistance voltages were extracted by the mobile datalogger. The instrument hole and trench area were in good condition.
