U.S. Department
of Transportation
**Federal Highway
Administration**

**LTPP Seasonal Monitoring
Program**
Site Monitoring Suspension
Status Report
Section 241634, Ocean City
Maryland

MARYLAND SECTION 241634

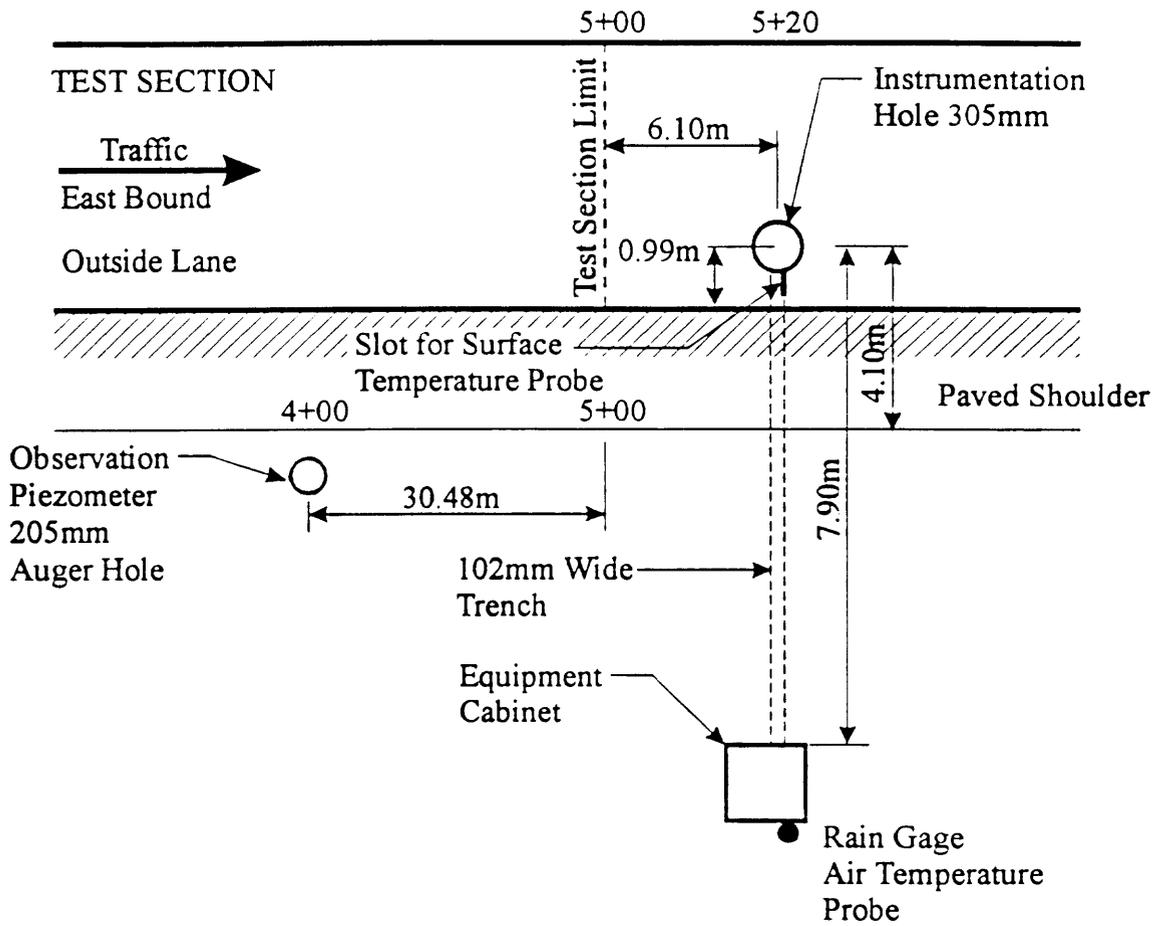
Figure 1. Location of Seasonal Monitoring Instrumentation Installed at GPS 241634

Figure 1 shows the locations of the installed instrumentation at the site. The instrument hole is at Station 5+20 and the piezometer is at Station 4+00. Table 2 gives the elevations of the portion of test section 241634 that was used for elevation measurements. All offsets are measured from the PK nails found at the outside pavement edge.

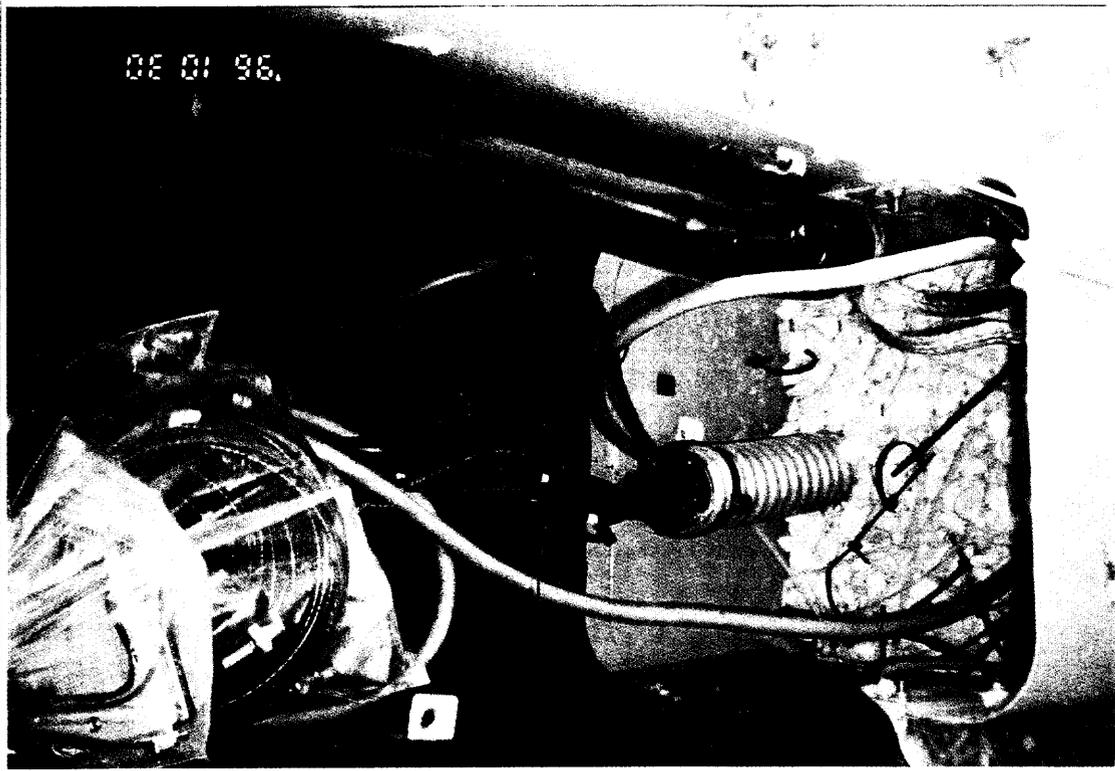
Inside Equipment Cabinet, Seasonal Site 241634,
October 1996, After Suspension Activities
