**LTPP Seasonal Monitoring
Program**
Site Monitoring Suspension
Status Report
Section 331001, Concord
New Hampshire

SMP SITE MONITORING SUSPENSION STATUS REPORT NEW HAMPSHIRE SECTION 331001

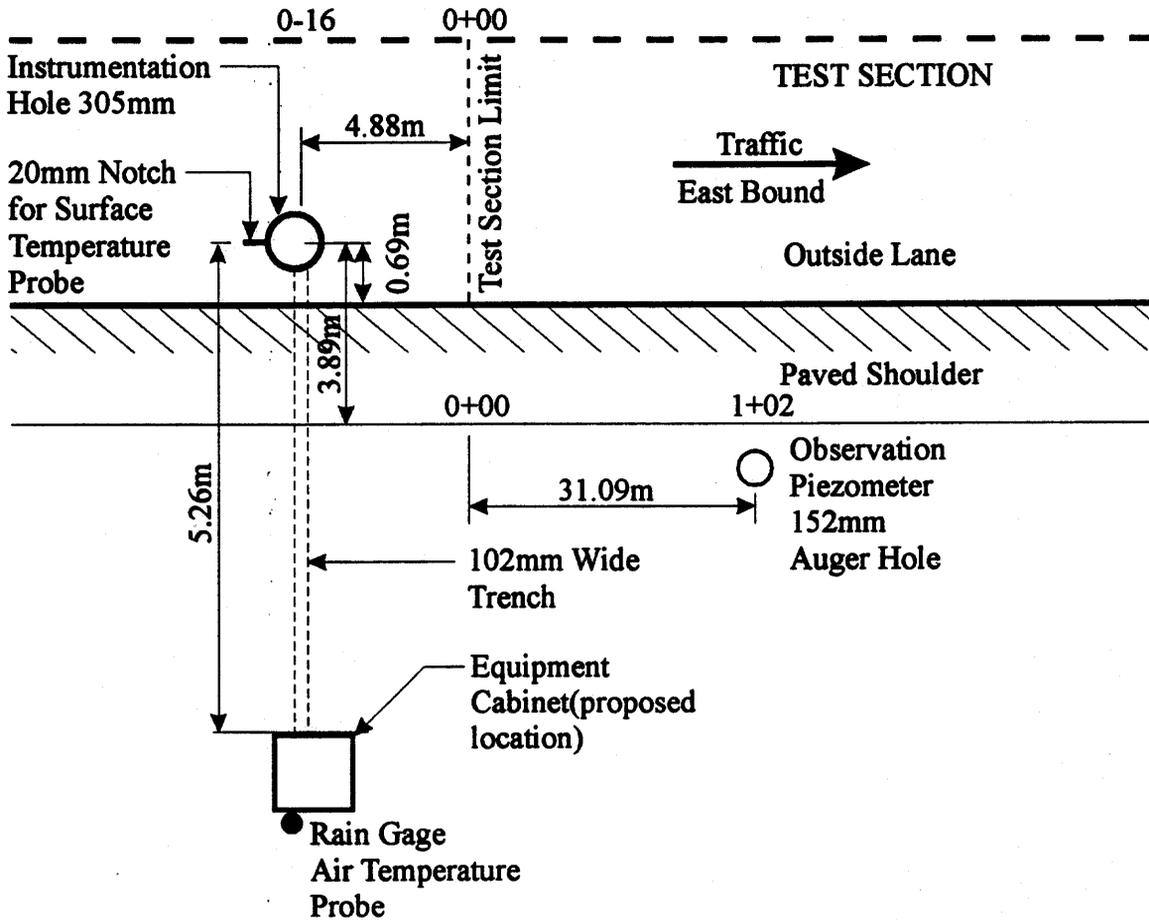
Figure 1.- Location for Seasonal Monitoring Instrumentation at GPS 331001

Figure 1 shows the locations of the installed instrumentation at the site. The instrumentation hole is at station 0-16 and the piezometer is at station 1+00. Figure 2 gives the plan view of the portion of test section 331001 that was used for elevation measurements. All offsets are measured from the PK nails found at the outside pavement edge.

- Total Depth of Piezometer: 4.29m
- Distance of Piezometer Below Ground Level: 152mm

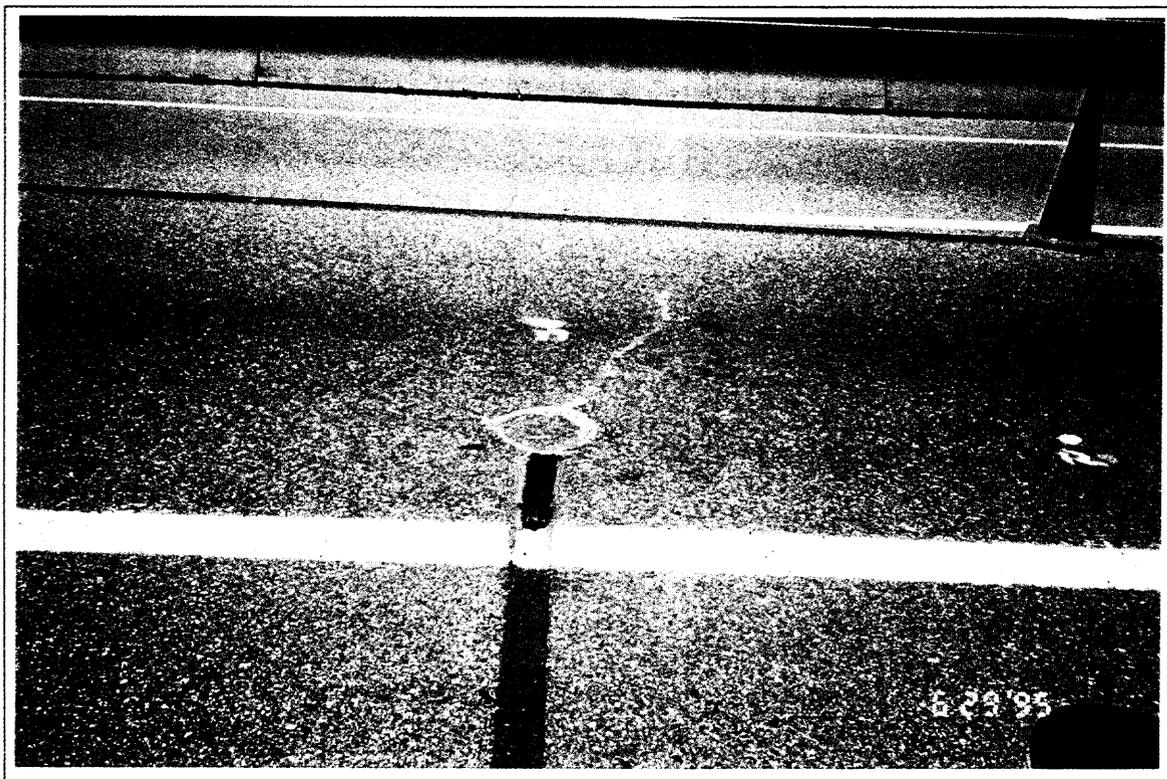
Instrumentation Hole, Seasonal Site 331001 NH, June 1995, During Suspension Preparation Activities

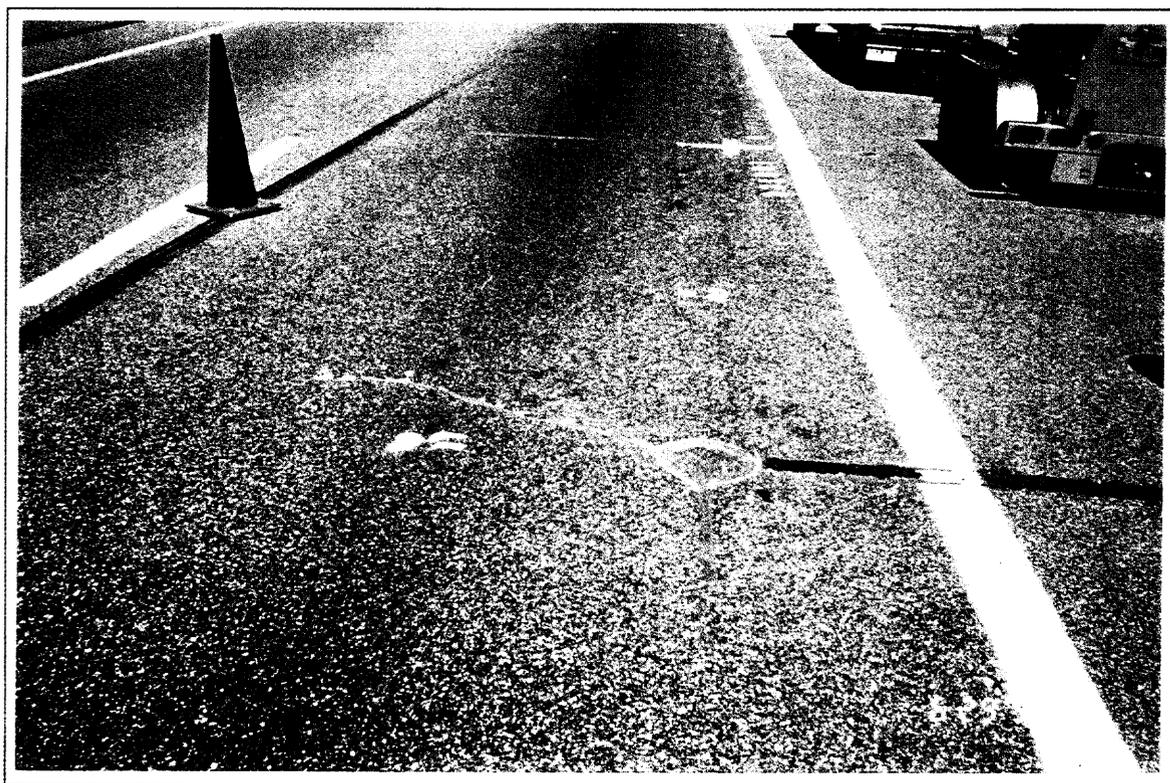
Instrumentation Hole, Seasonal Site 331001 NH, June 1995, During Suspension Preparation Activities
