**LTPP Seasonal Monitoring
Program**
Site Monitoring Suspension
Status Report
Section 360801, Hamlin
New York

NEW YORK SECTION 360801

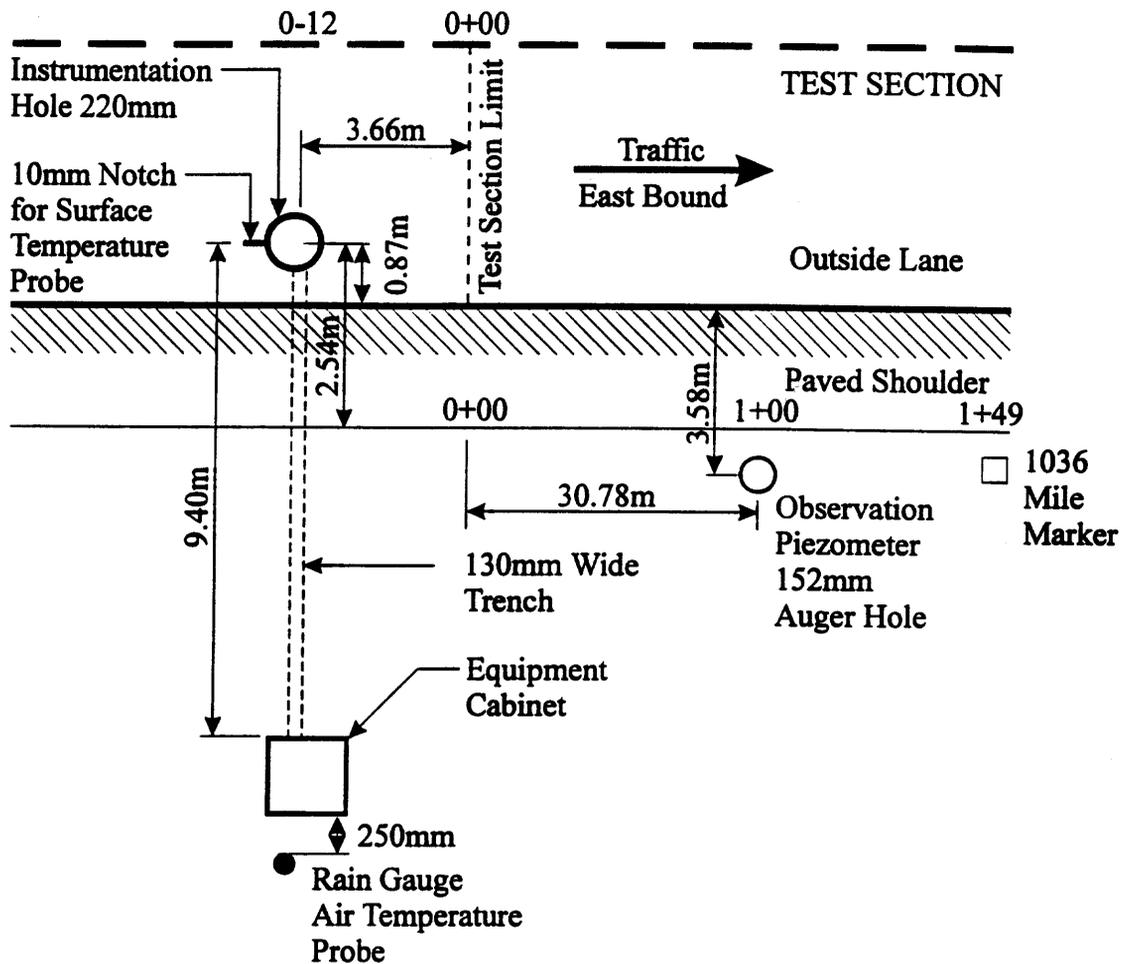
Figure 1. Location of Seasonal Monitoring Instrumentation Installed at SPS 360801

Figure 1 shows the locations of the installed instrumentation at the site. The instrumentation hole is at station 0-12 and the piezometer is at station 1+00. Table 2 gives elevations of the portion of test section 360801 that was used for elevation measurements. All offsets are from the PK nails found at the outside pavement edge.

- Height of Air Temperature Probe: 2.82m
- Height of Tipping Bucket Rain Gauge: 2.85m
- Depth of Piezometer: 4.28m

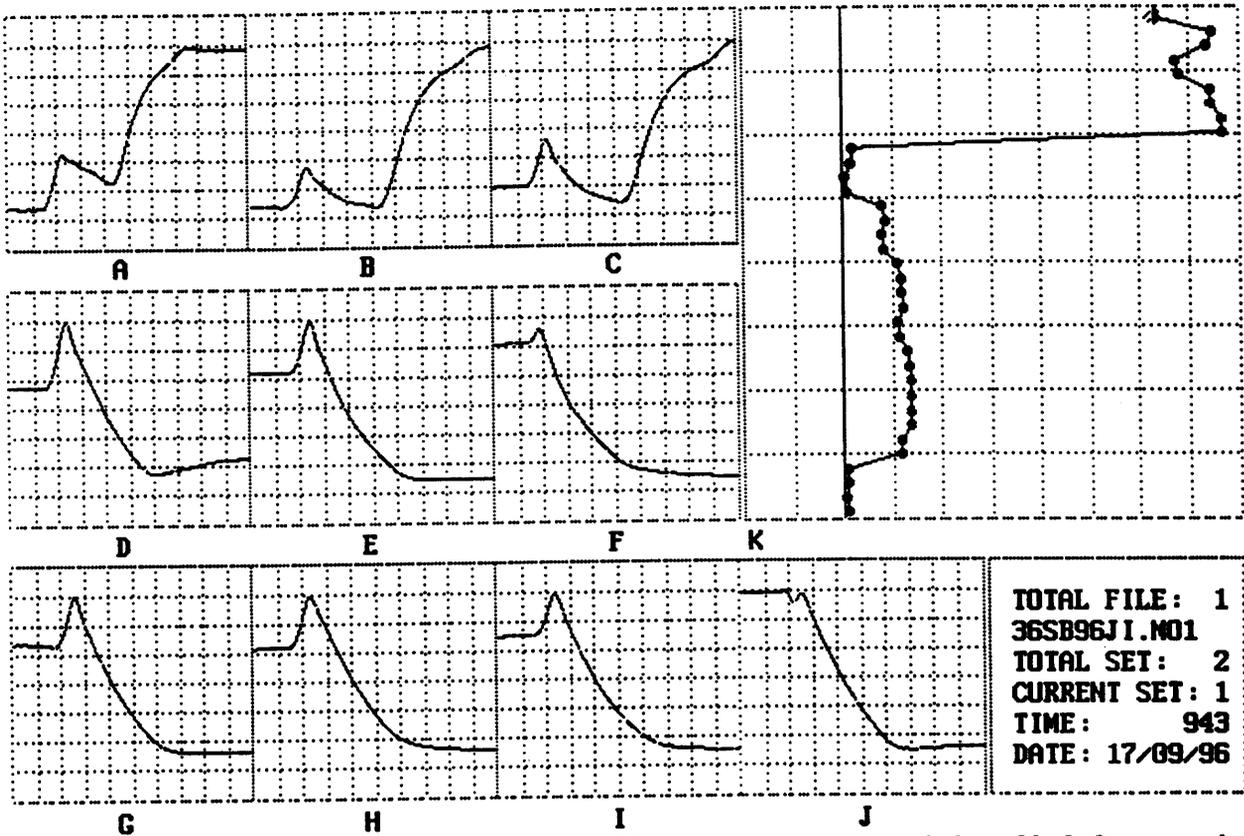
Figure 2. Mobile Data Collecteion Set #1 - September 17, 1996

TDR sensor numbers 5 to 10 produced traces that are indicative of highly conductive soils (as shown in figure 2). This is to be expected because of the high water table. Other than the plugged tipping-bucket, at the time of suspension, all instrumentation was working well. All plots from ONSFIELD, MOBFIELD, and SMPCHECK follow expected trends and expected values.

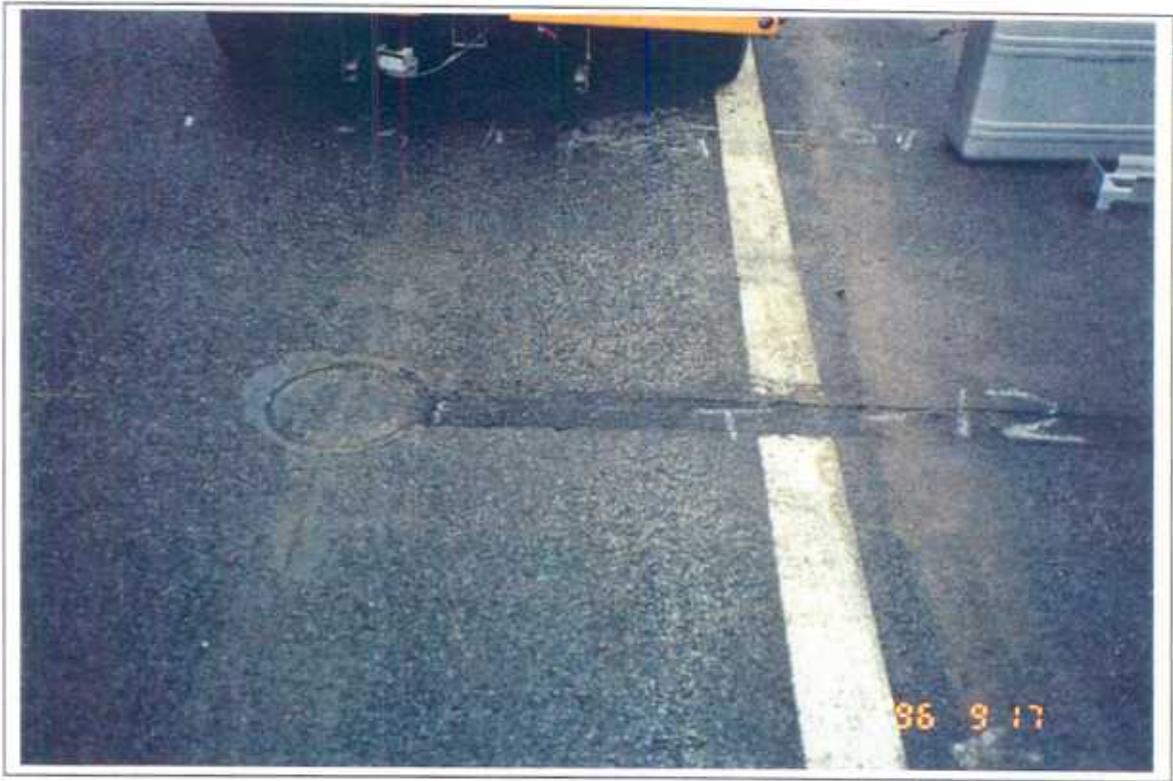
Instrument Hole, Seasonal Site 360801, September 1996, After Suspension Activities

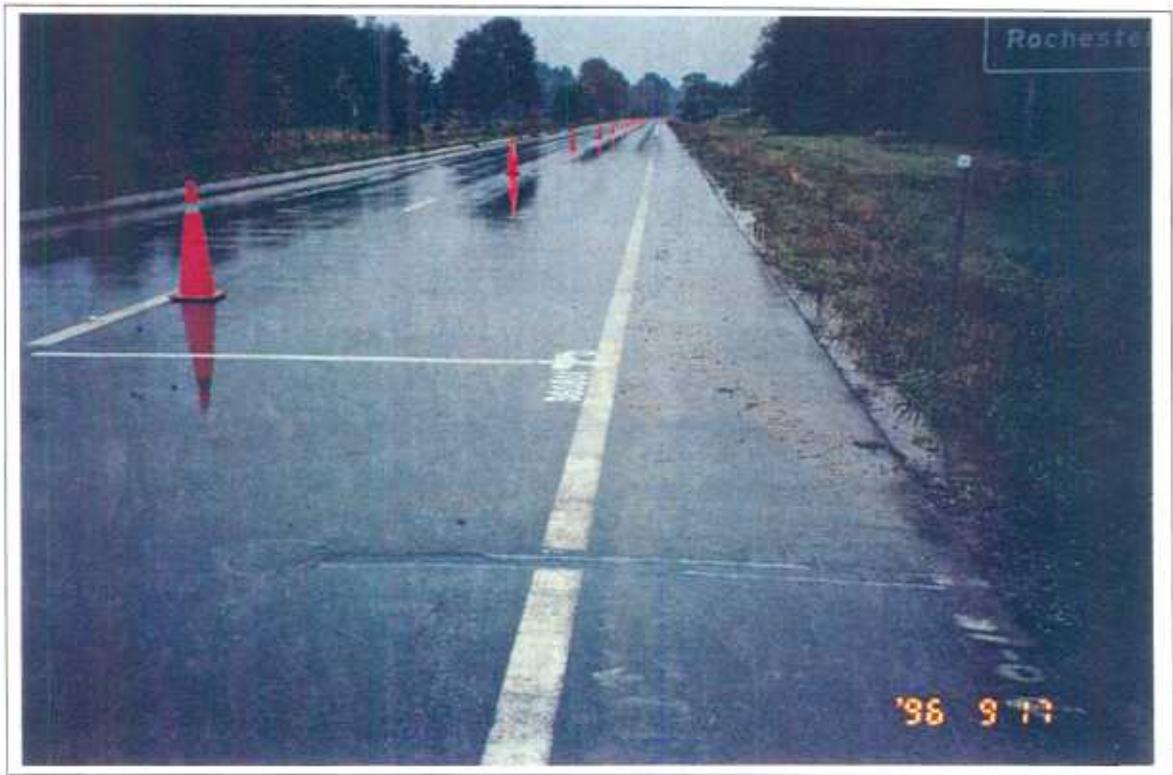
Instrument Hole and Trench Area, Seasonal Site 360801, September 1996, After Suspension Activities
