**LTPP Seasonal Monitoring
Program**
Site Monitoring Suspension
Status Report
Section 421606, Altoona
Pennsylvania

SMP SITE MONITORING SUSPENSION STATUS REPORT

PENNSYLVANIA SECTION 421606

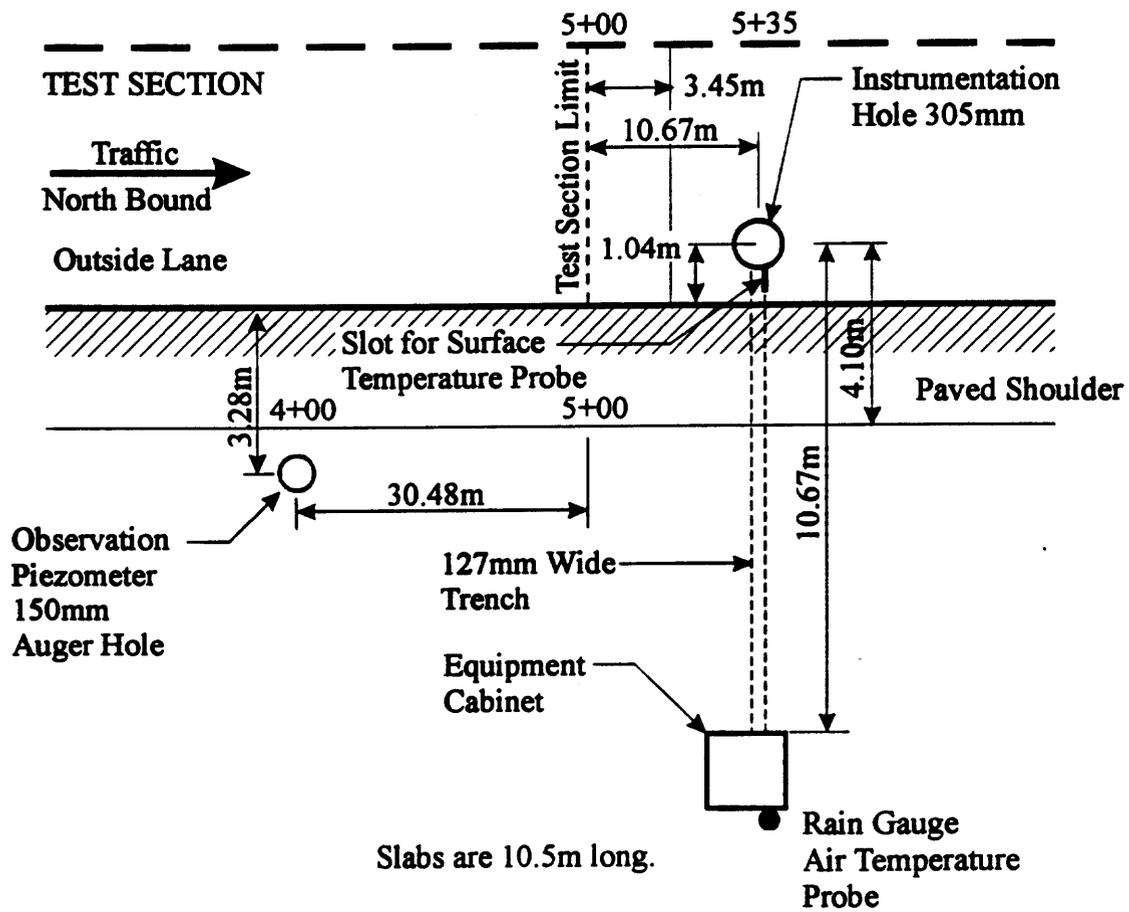
Figure 1. Location of Seasonal Monitoring Instrumentation Installed at GPS 421606

Figure 1 shows the locations of the installed instrumentation at the site. The instrumentation hole is at station 5+35 and the piezometer is at station 4+00. Table 1 gives elevations of the portion of test section 421606 that was used for elevation measurements. All offsets are measured from the outside pavement edge at the pavement shoulder interface.

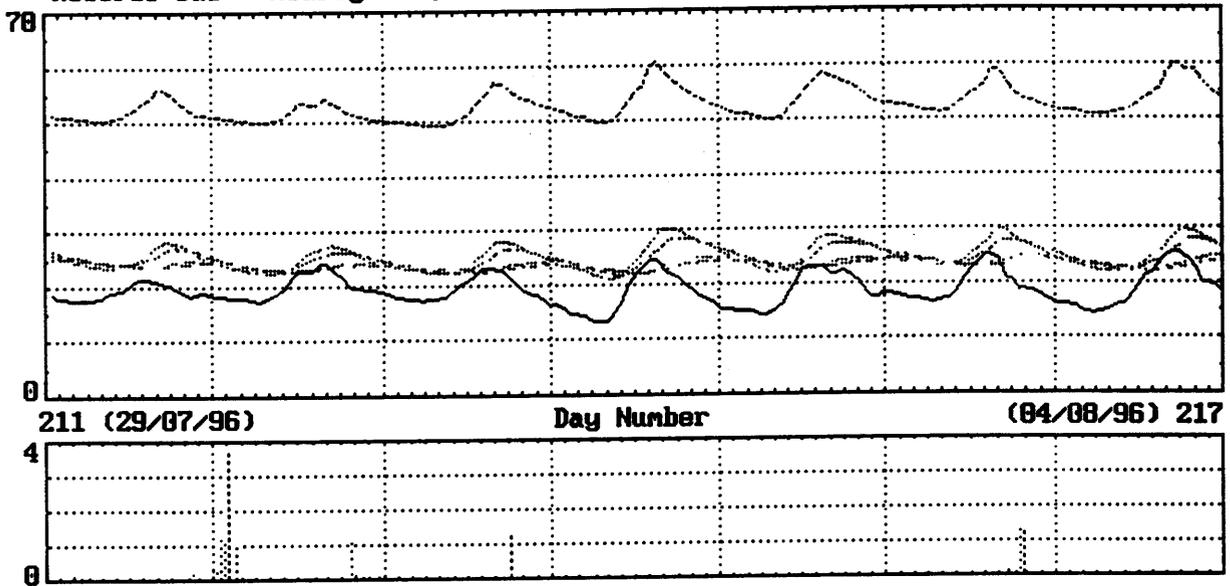
Figure 2. Sample of the Erroneous Readings Provided by MRC Sensor #1

The installation of site 421606 followed the "LTPP Seasonal Monitoring Program: Instrumentation Installation and Data Collection Guidelines" closely. Core holes exist in the slab adjacent to the 5+00 end. Ideally the instrument hole should have been in a slab that did not contain any deformations. Since the 0+00 end also contained core holes, the 5+00 end remained the preferred location. Rain arrived before all instrumentation installation could be completed. A tent was erected over the instrument hole to prevent water from entering it. The MRC#1 sensor was not working at the time of suspension. It has provided erroneous readings since March of 1996. The TDR#9 sensor has functioned intermittently since March of 1996.

At the time of suspension, other than the MRC#1 sensor and the TDR # 9 sensor, there were no unresolved problems with any of the sensors. The plots from ONSFIELD, MOBFIELD and SMPCHECK follow expected trends and produce expected values. Figure 2 shows the daily temperature trends during a sample period when the MRC#1 sensor was malfunctioning.
