U.S. Department
of Transportation
**Federal Highway
Administration**

**LTPP Seasonal Monitoring
Program**
Site Monitoring Suspension
Status Report
Section 501002
New Haven, Vermont

SEASONAL MONITORING PROGRAM SUSPENSION STATUS REPORT VERMONT SECTION 501002

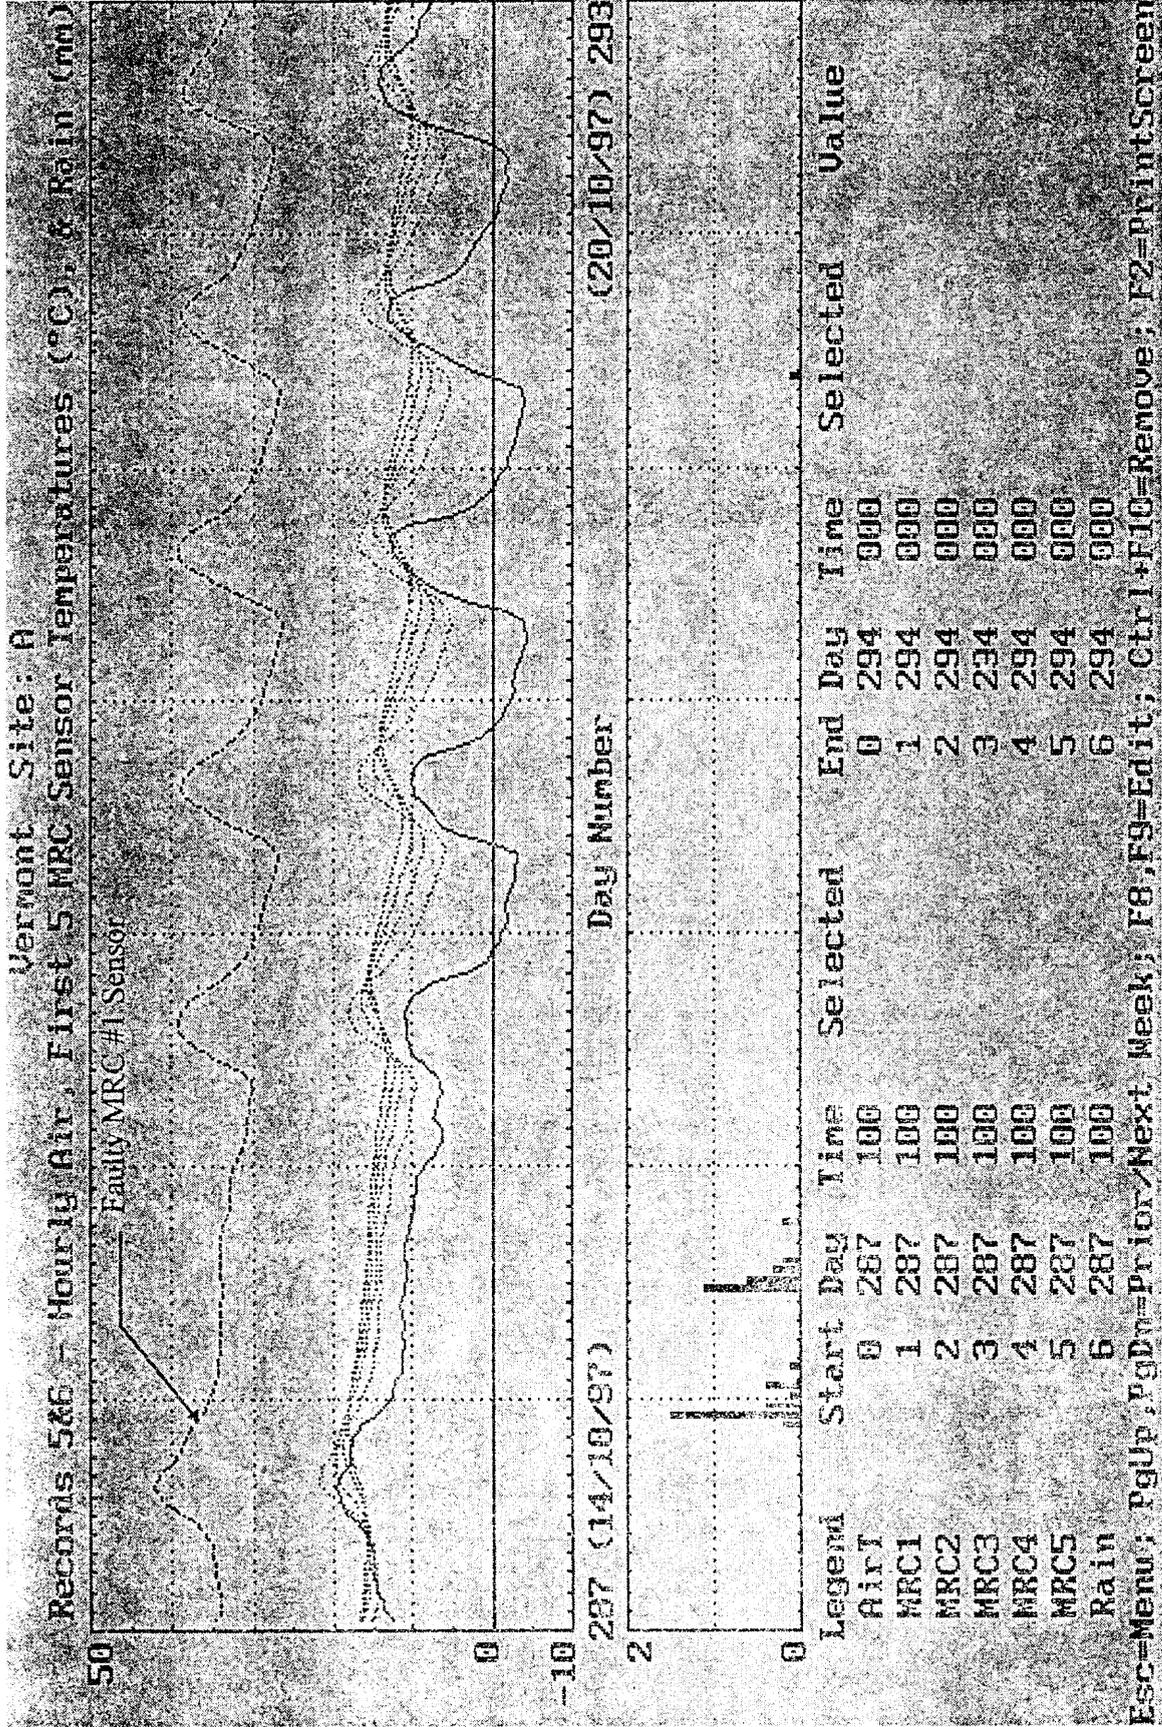
Figure 2: Sample of Erroneous Readings from MRC Sensor #1

At the time of suspension, MRC #1 sensor was not functioning. This sensor was not functioning at the time Round 2 data collection activities began in October 1996. Figure 2 shows the trend of the faulty MRC #1 sensor. Also, TDR sensors #5 and #6 were not functioning. These sensors were not producing readable traces at the time Round 2 data collection began. Figure 3 shows the last set of mobile data collected before the site was suspended. Other than the above, there were no unresolved problems with any of the sensors at the time of site suspension activities. The plots from ONSFIELD, MOBFIELD and SMPCHECK follow expected trends and produce expected values.

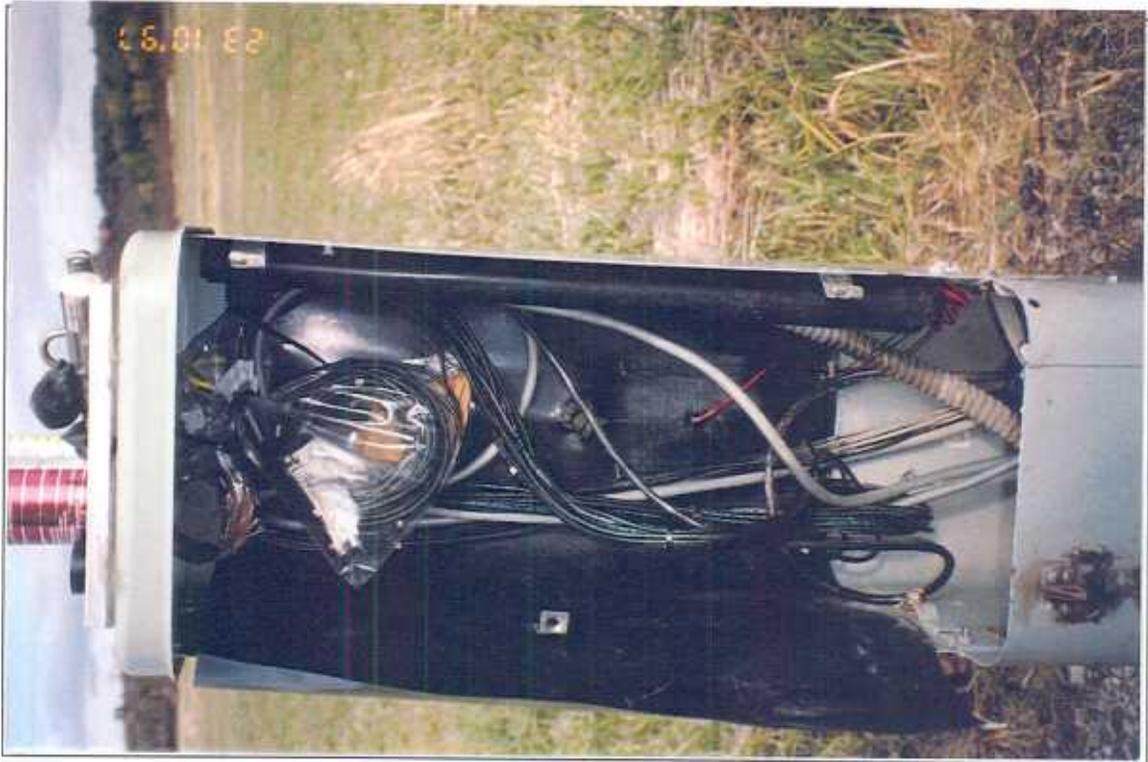
The solar panel was disconnected. After all wires to the control panel were disconnected, the panel was detached from the equipment cabinet along with the CR10 datalogger, terminal strip and battery pack. The TDR cables, resistivity cable and MRC lead wires were sprayed with an anti-corrosive compound and sealed with desiccant packs in air tight bags. All cables/wires were hung up high inside the equipment cabinet. After the last piezometer reading was recorded, the pipe was cleaned and sealed with grease. The access cover and seat were cleaned and lubricated before being covered and brought up to grade with native soil.

Inside Equipment Cabinet, Seasonal Site 501002 - Oct. 1997, after Suspension Activities

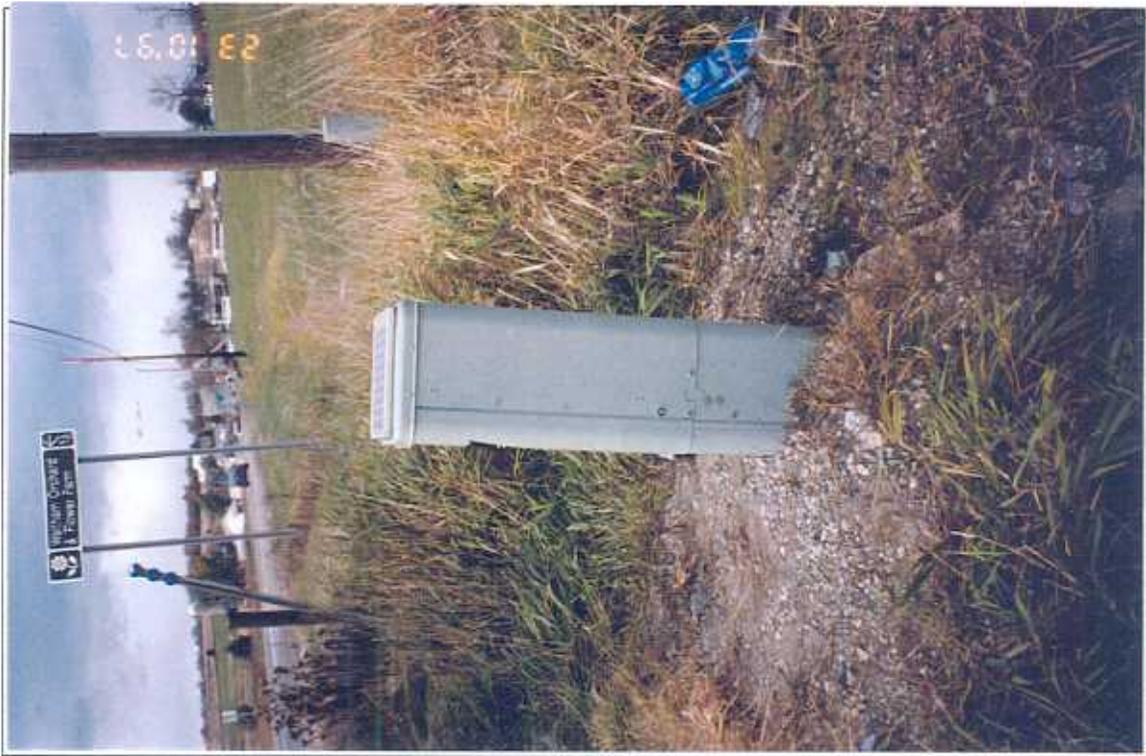
The air temperature probe, tipping bucket, and the upper part of the support pole were dismantled. The lead wires from the air temperature probe and tipping bucket were removed from the cabinet and sprayed with an anti-corrosive compound. The above ground conduit from the pole to the equipment cabinet was removed and the resulting hole in the back of the cabinet sealed. The bottom portion of the support pole was cleaned and lubricated prior to installing the end cap.

Equipment Cabinet, Lower portion of inst. pole, Seasonal Site 501002 - Oct. 1997, after Suspension Activities
