**U.S. Department
of Transportation
Federal Highway
Administration**

**LTPP Seasonal Monitoring
Program
Site Monitoring Suspension
Status Report
Section 501002, New Haven
Vermont**

SMP SITE MONITORING SUSPENSION STATUS REPORT

VERMONT SECTION 501002

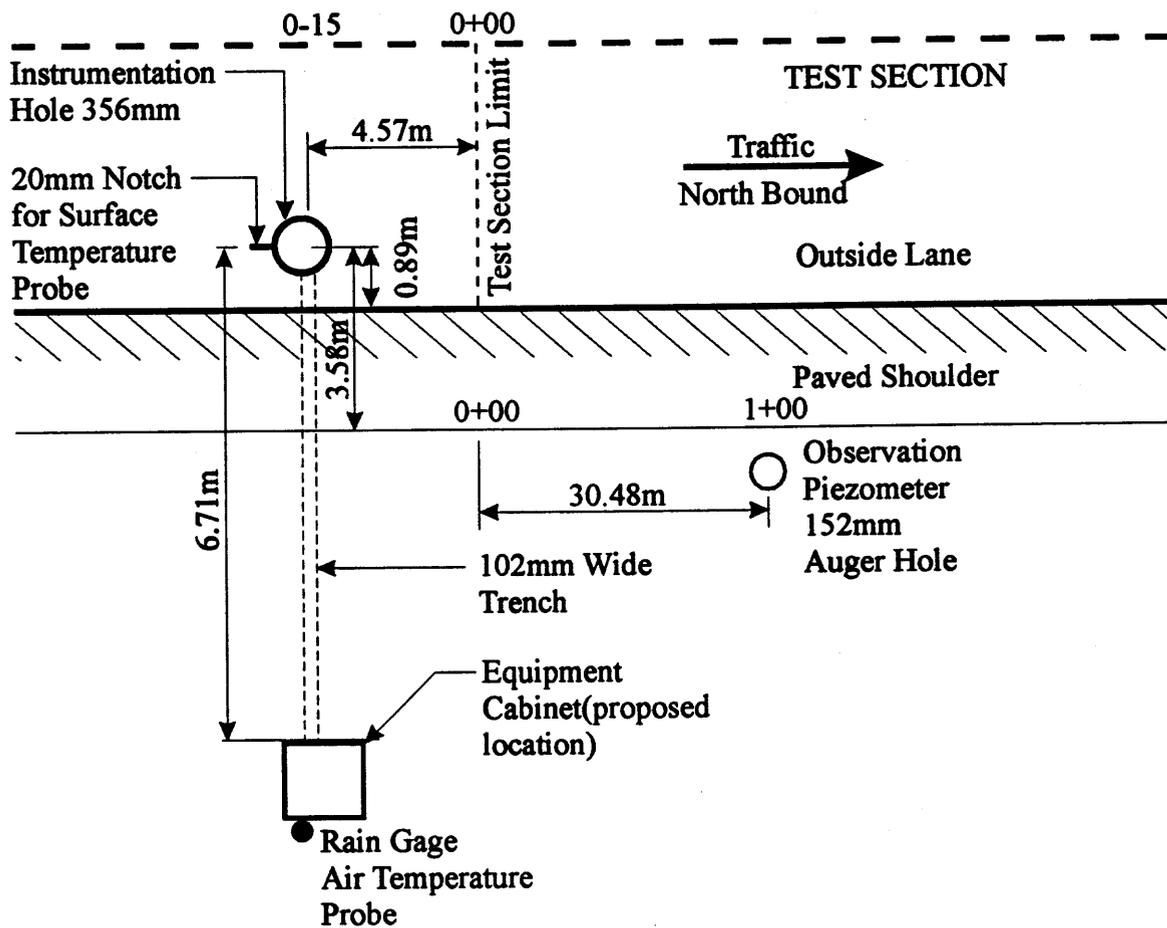
Figure 1.- Location for Seasonal Monitoring Instrumentation at GPS 501002

Figure 1 shows the locations of the installed instrumentation at the site. The instrumentation hole is at station 0-15 and the piezometer is at station 1+00. Figure 2 gives the plan view of the portion of test section 501002 that was used for elevation measurements. All offsets are from the PK nails found at the outside pavement edge.

- Total Depth of Piezometer: 4.88m
- Distance of Piezometer Below Ground Level: 102mm

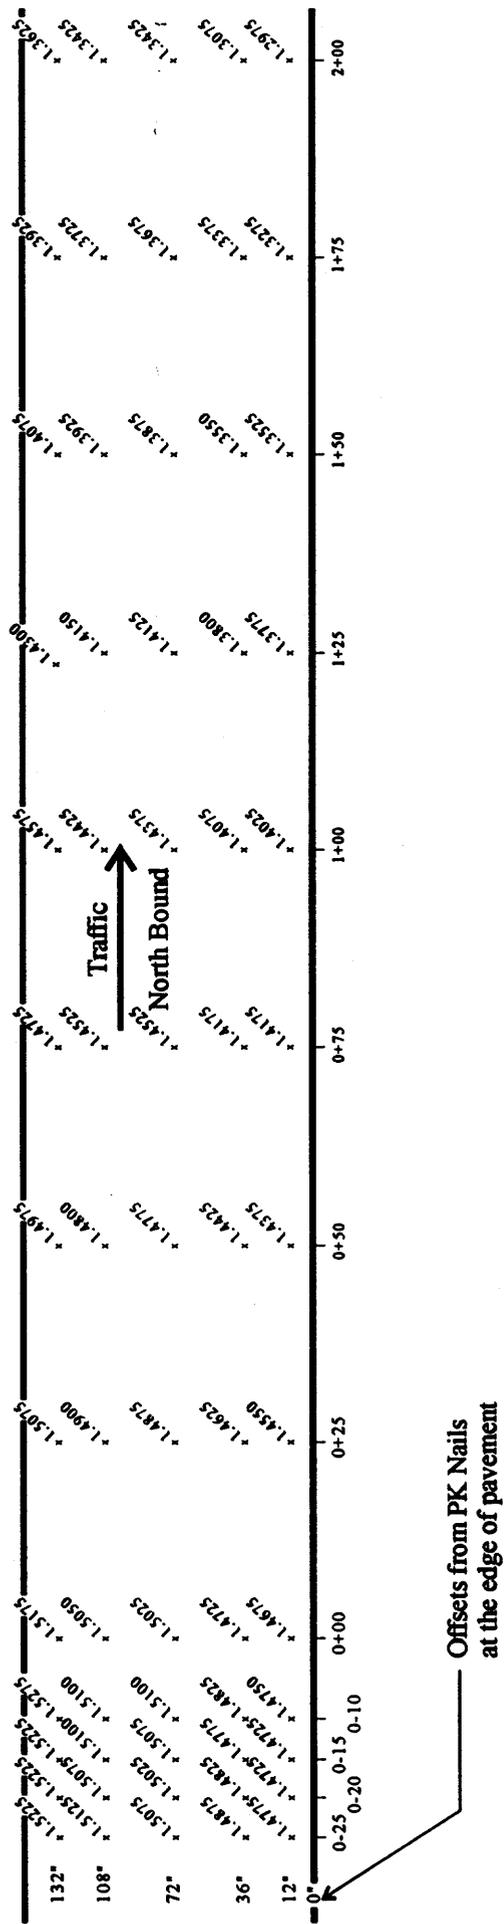
Figure 2. - Location for Elevation Measurements at GPS 501002

- All offsets are measured from the PK nails at the pavement edge.
- All elevations provided are from the June 28, 1995 survey with the top of the piezometer pipe set at 1.000m.
- Instrument hole is located at station 0-15

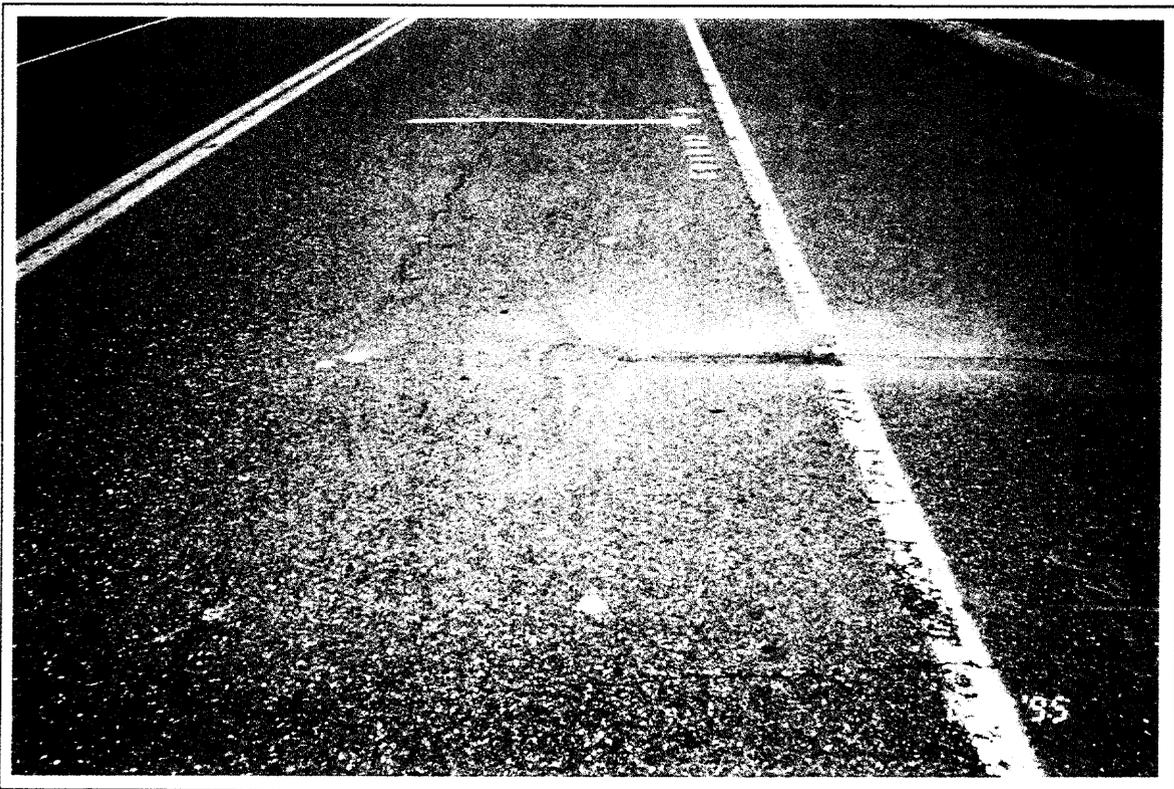
Instrumentation Hole, Seasonal Site 501002 VT, June 1995, During Suspension Preparation Activities

The suspension preparation activities at 501002 were conducted during the final three site visits. A manual distress survey was conducted on April 28, 1995. The PK nails were reconfirmed and replaced as required on May 31, 1995. The site paint markings were refreshed at this time. June 28, 1995 was the last day of activity at the site. On this day three sets of FWD tests, one set of elevations, and a distress survey of the instrumentation area were conducted. The water table measurements and the manual resistivity measurements (2 and 4 point) were performed in the morning and afternoon. The onsite datalogger was downloaded before being dismantled. Two sets of TDR and resistance voltages were extracted by the mobile datalogger. The instrument hole, trench, and surface temperature probe slot areas were reground and sealed as needed.
