**LTPP Seasonal Monitoring  
Program**  
Site Monitoring Suspension  
Status Report  
Section 510114, Danville  
Virginia

# SMP SITE MONITORING SUSPENSION STATUS REPORT

## VIRGINIA SECTION 510114

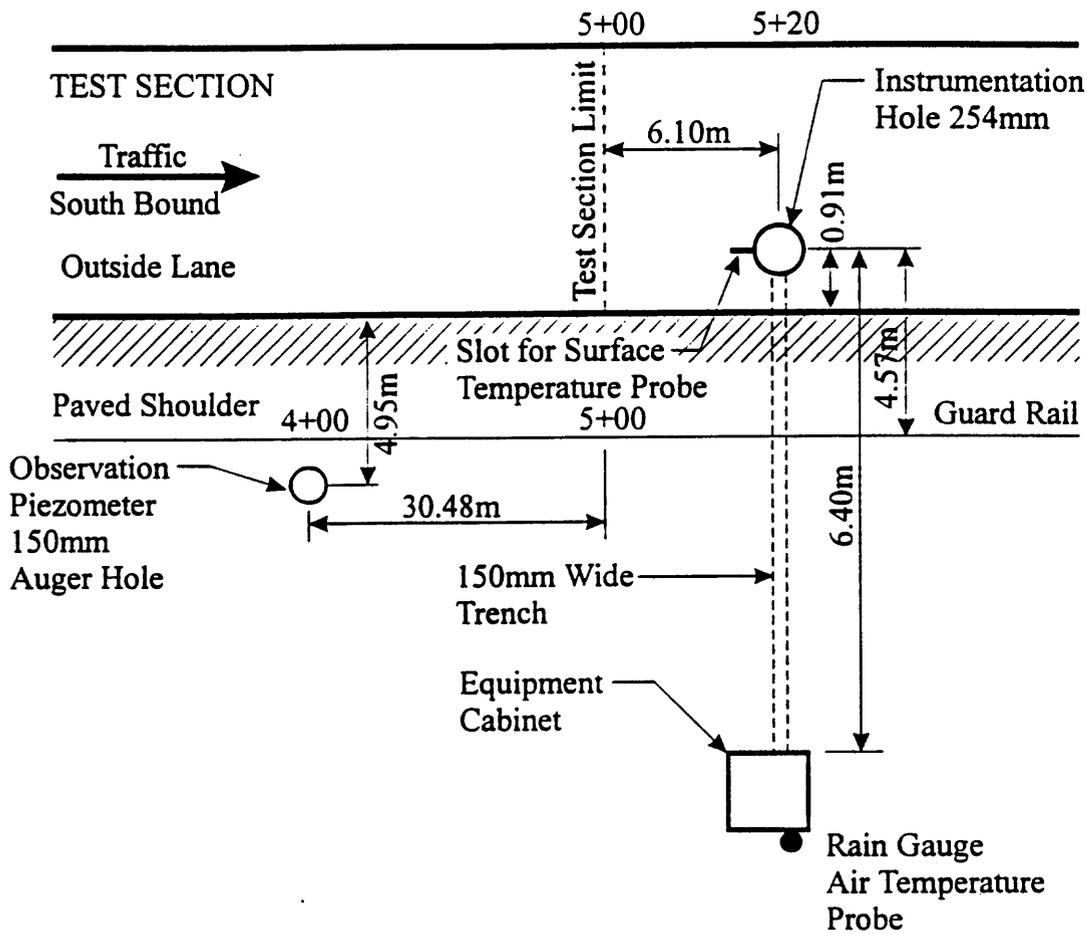
Figure 1. Location of Seasonal Monitoring Instrumentation Installed at SPS 510114

Figure 1 shows the locations of the installed instrumentation at the site. The instrumentation hole is at Station 5+20 and the piezometer is at Station 4+00. Table 2 gives elevations of test section 510114 before and after the overlay. All offsets are from the PK nails found at the outside pavement edge.
