**- Site Service Report -**

**Project Name/Location: FTTP SITE I-70 WEST BOUND MI 287-5**

**Job Description: Temperature Sensor**

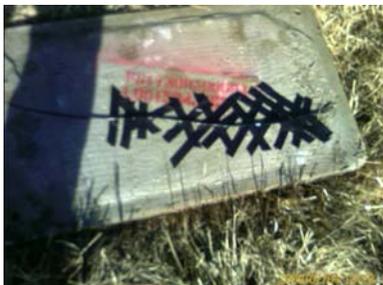
- Temperature sensor has been attached on the back of the pull box cover, see attached picture.
- Called Rey to make sure temperature sensor was working as expected.
- According to Ray it was sensing 8°C
- Loops and bending plate working as expected.
