**INTERNATIONAL ROAD DYNAMICS INC.**

| <b>- Site Service Report -</b> |

**Project Name/Location:** LTPP Site Danville VA, RT 29 S/B

**Service Date(s):** 11 Mar 2011

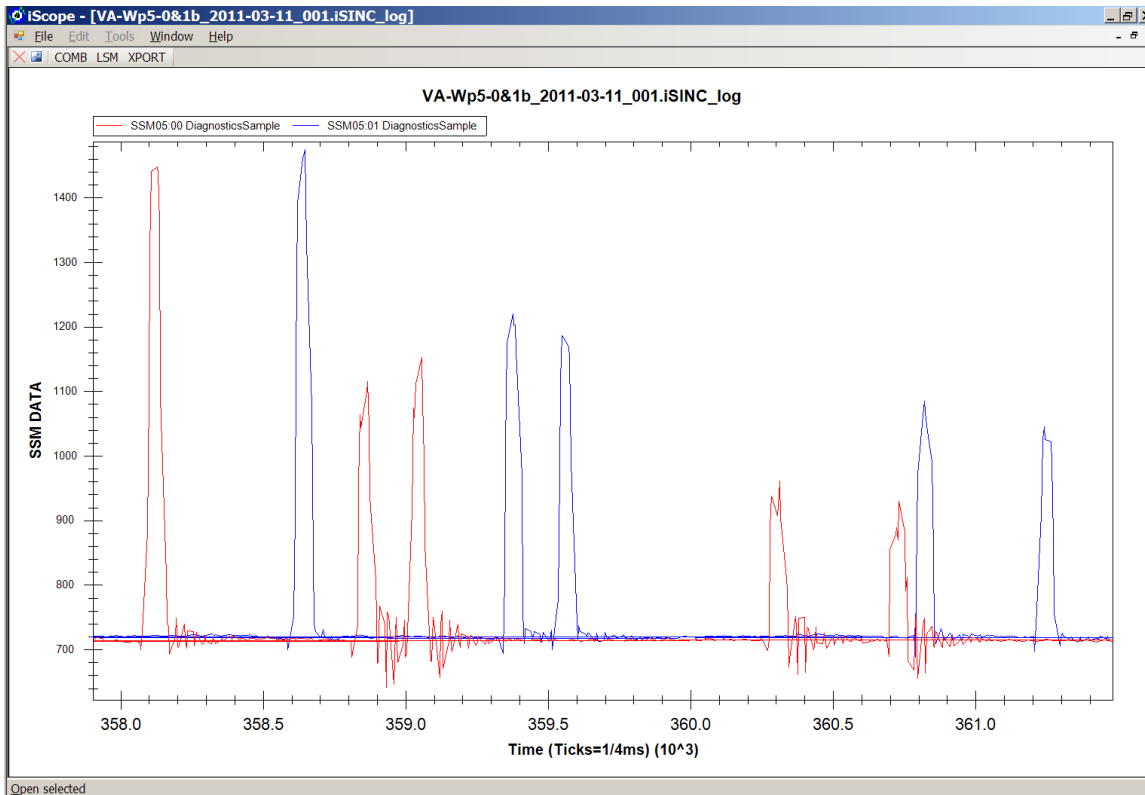
The weighpad signals appear somewhat trashy. If there is an issue with weighing accuracy in the future, it will likely be due to ringing on the leading weighpad. May be able to fix it with remounting the weighpad; otherwise it will need a new one.

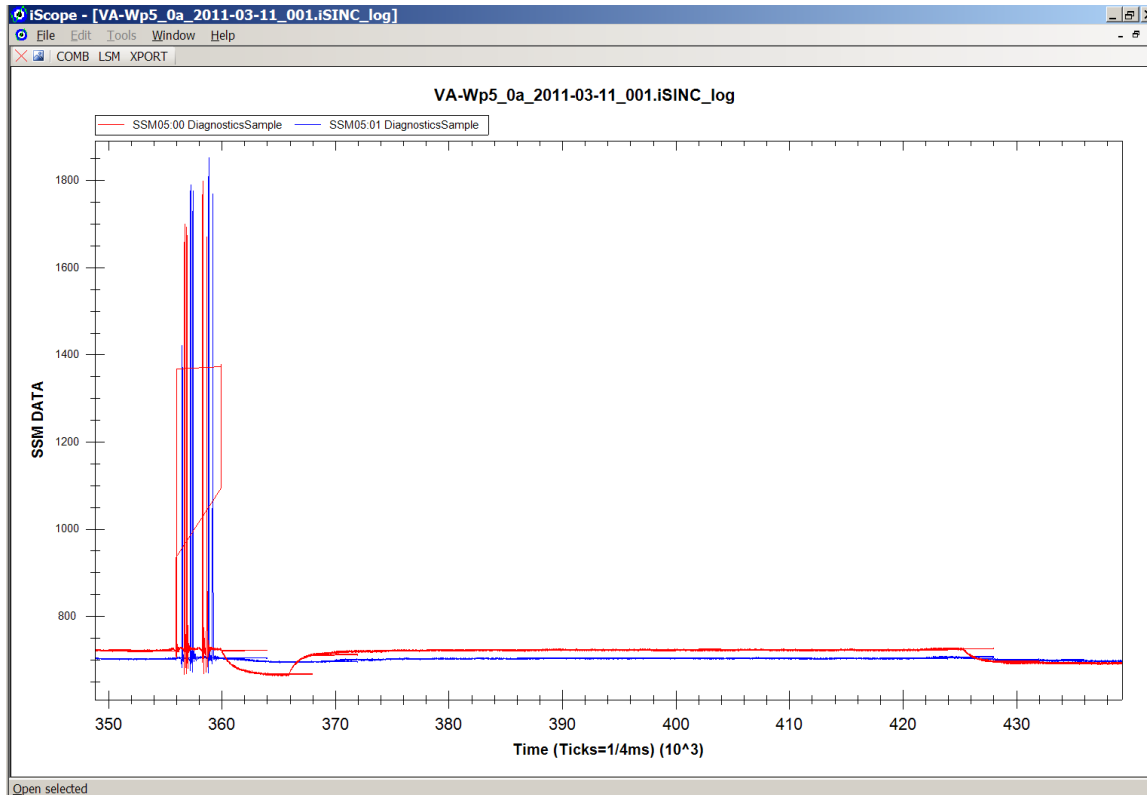
The leading weighpad also has an unstable zero point. The SSM seems to be figuring it out OK, but will fail if the problem gets much worse.
