## 200-250ft

CELL 63

ENK 2.  
6/16/09

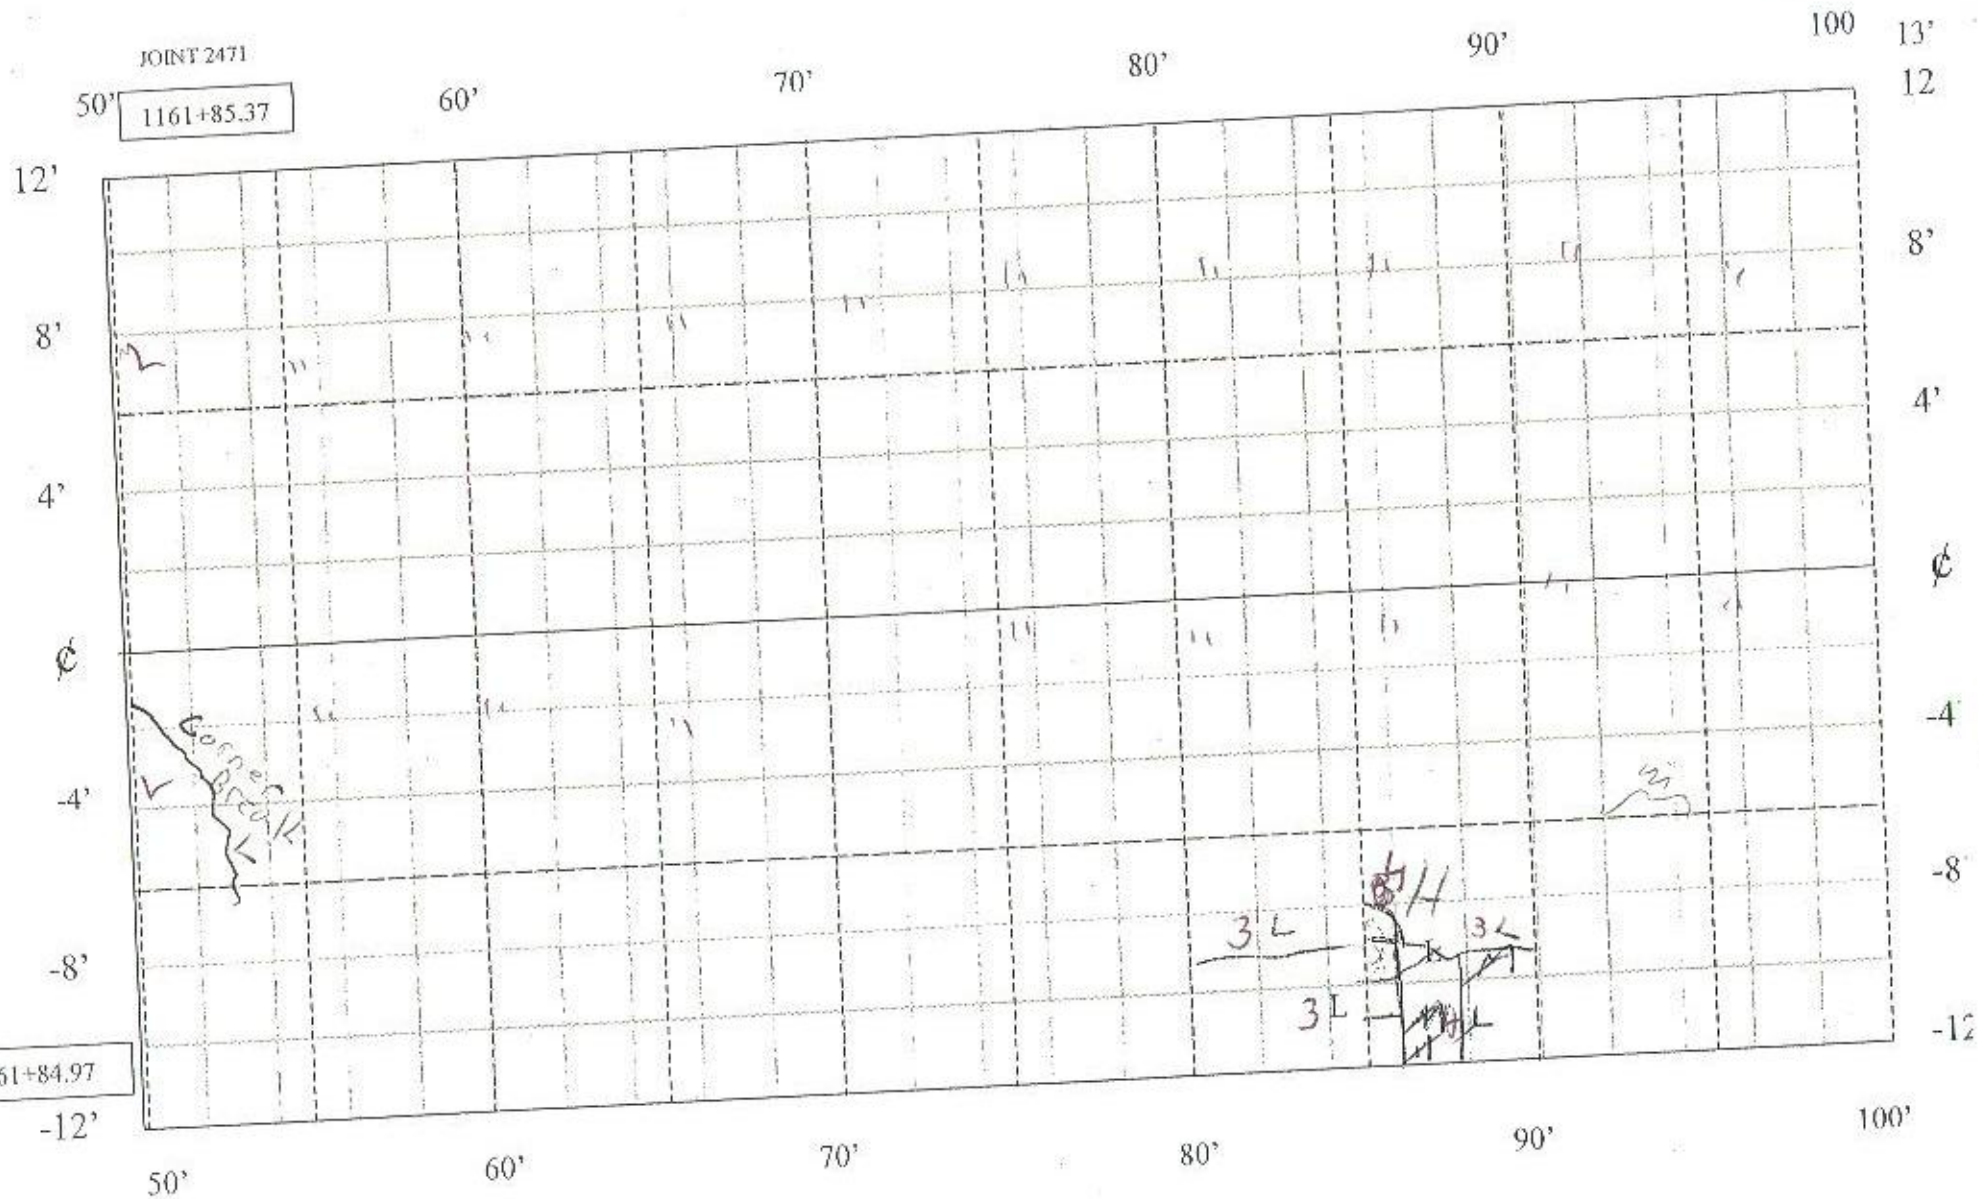
50-100ft

CRACKS ALL ALONG BOTH SHOULDERS

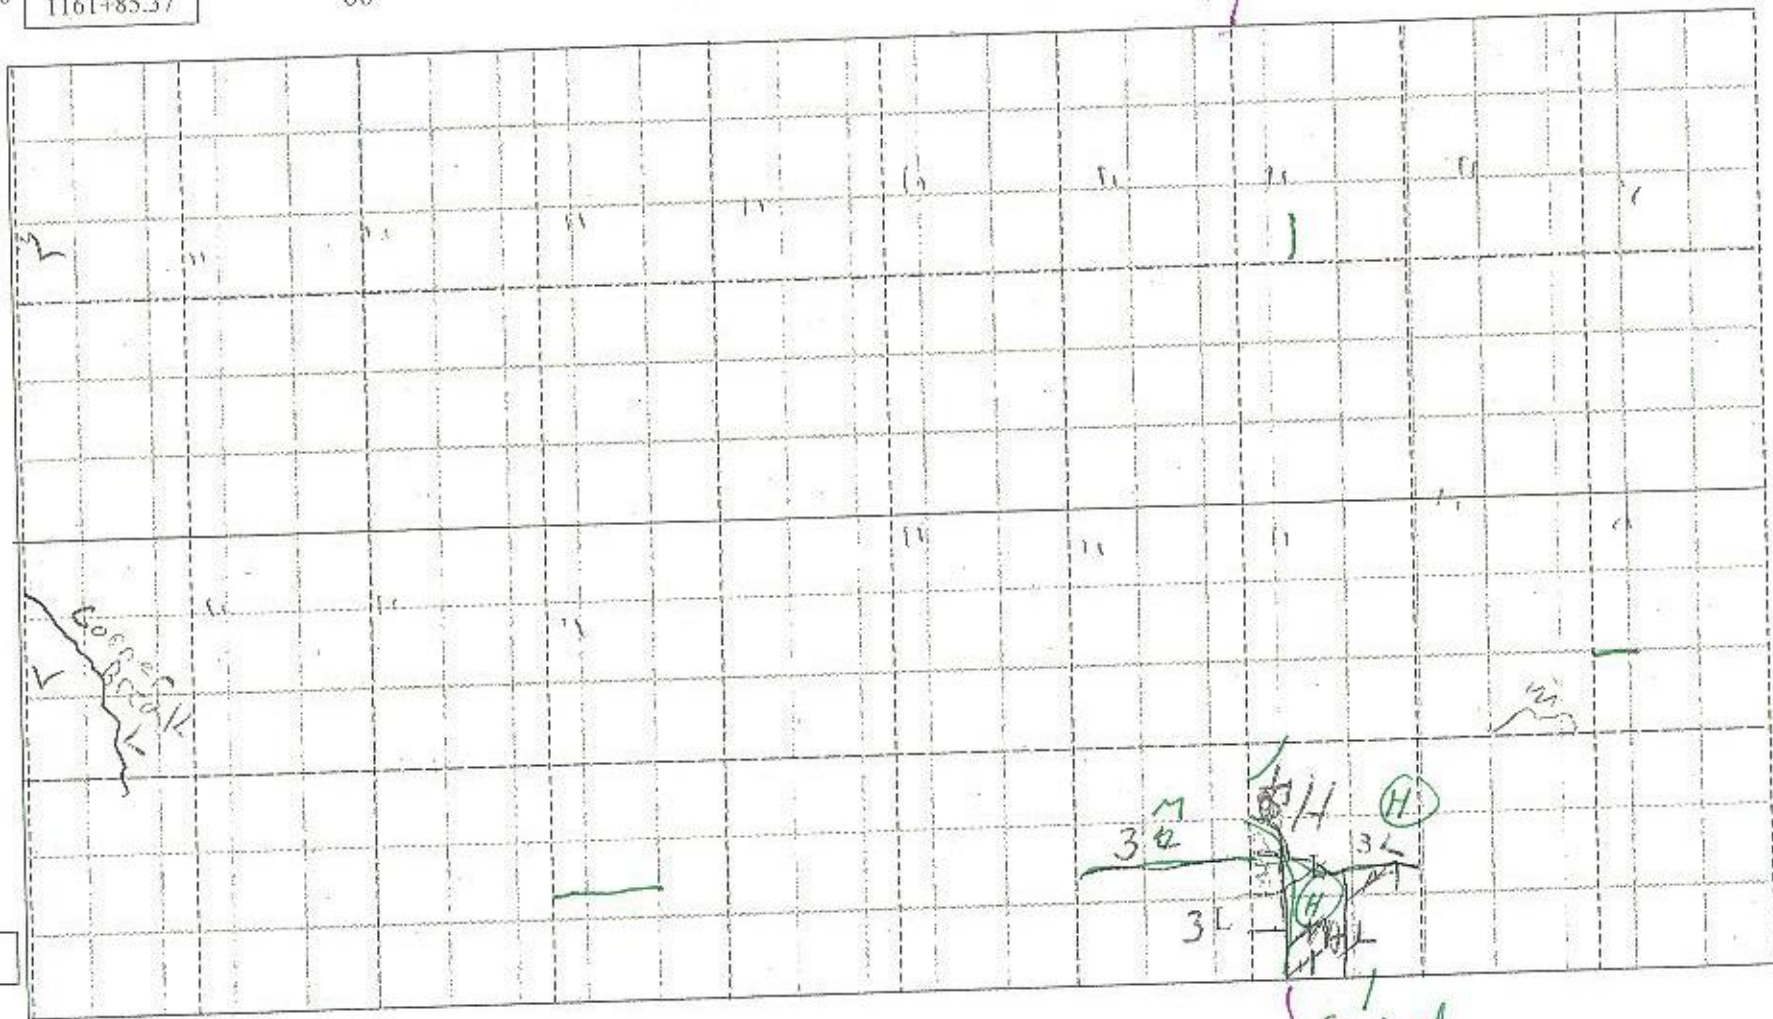
50-100ft

CRACKS ALL ALONG BOTH SHOULDERS

shld  
crack

fractured  
panel

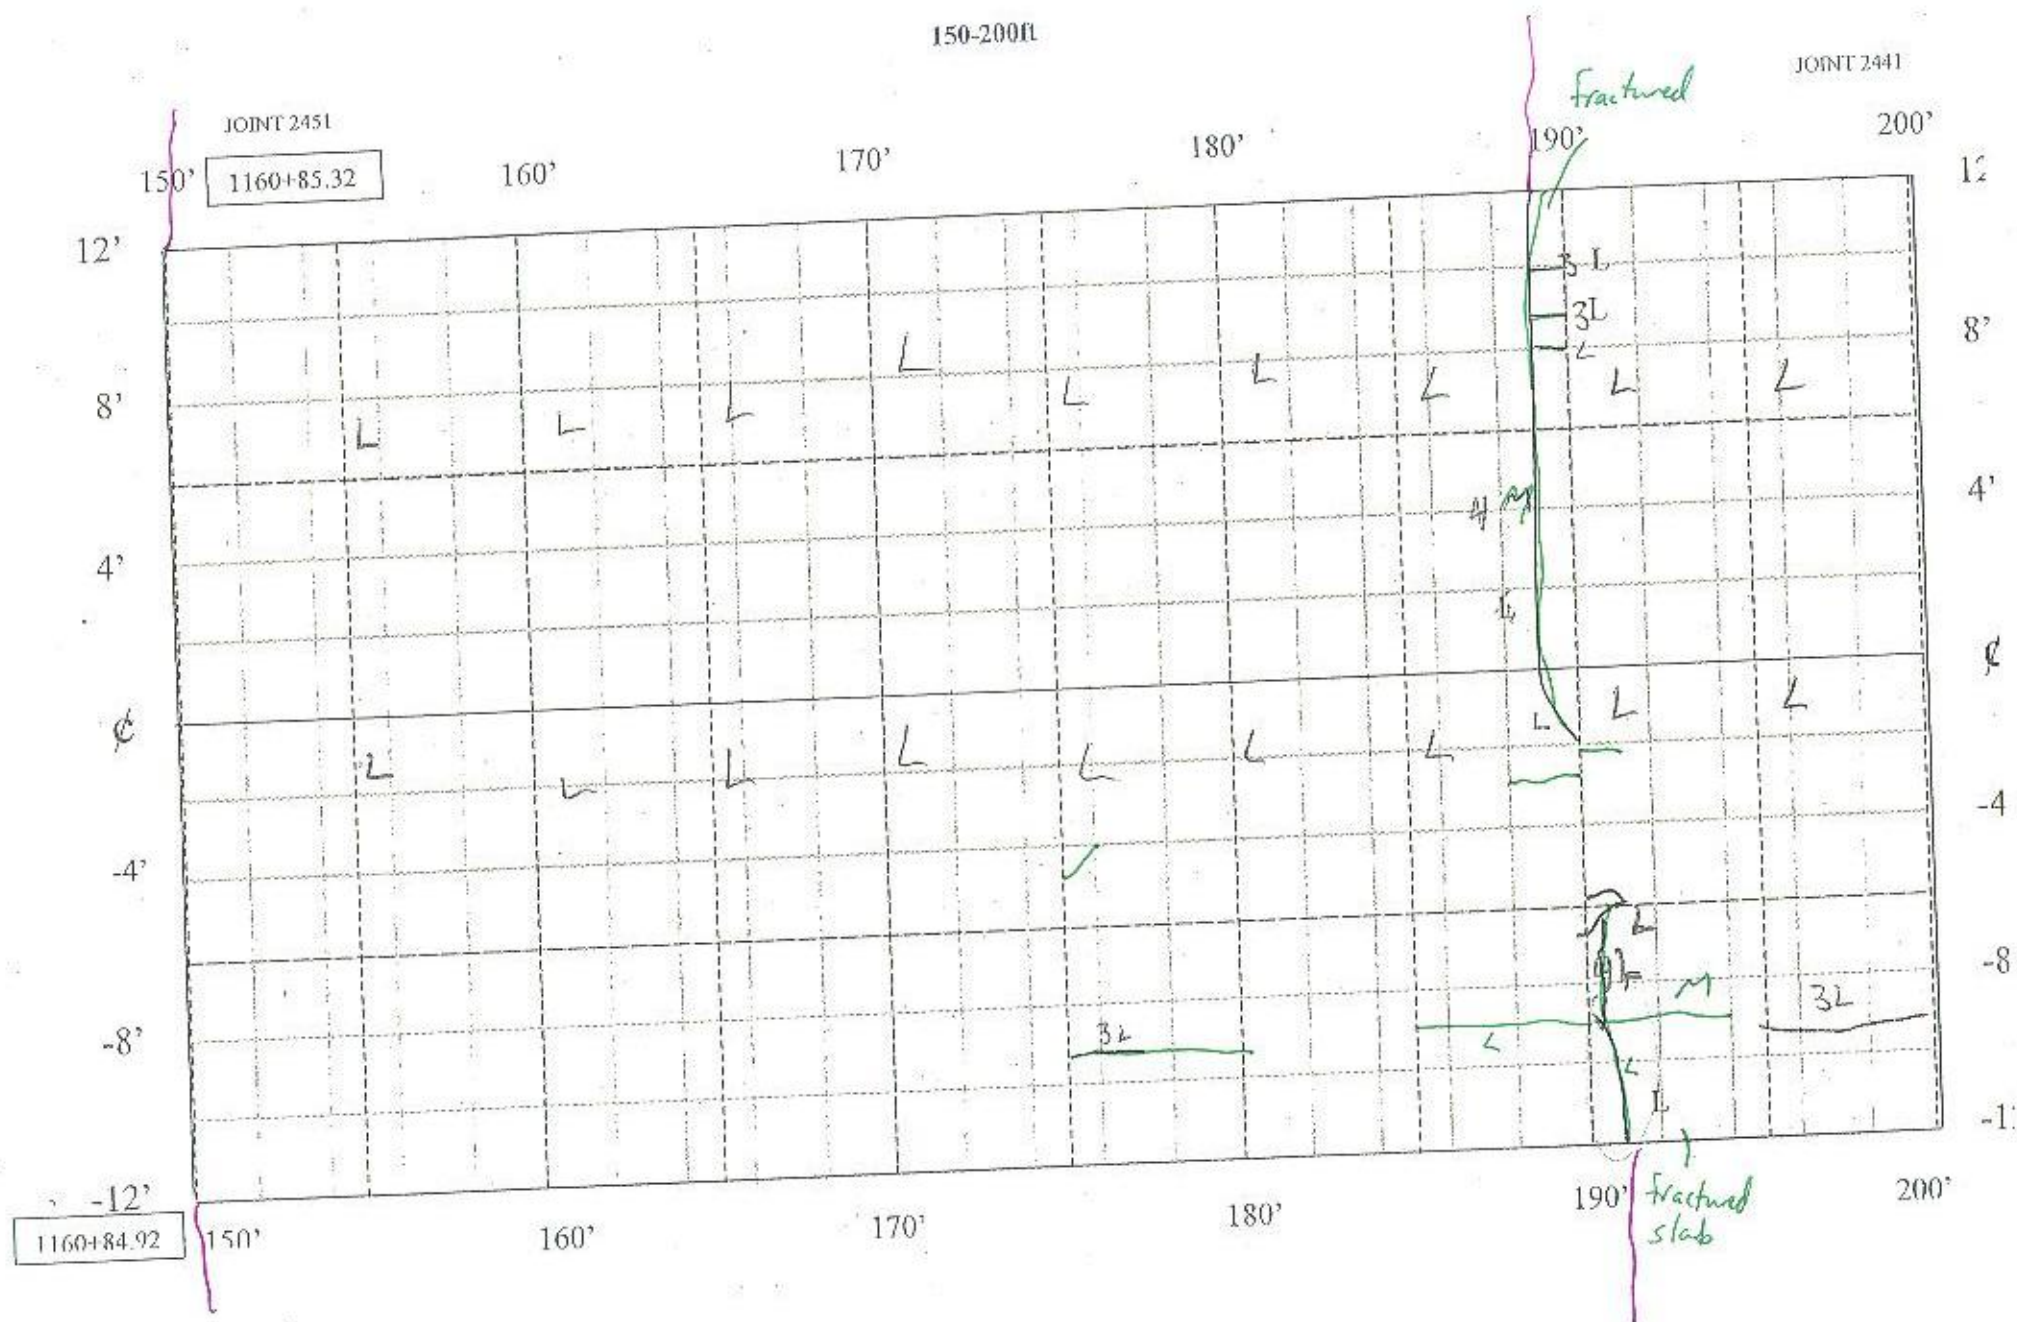
## 150-200fl

Fractured

fractured slab
