File M104 5/5/2014 DAV

CELL 4  
0 - 50 ft

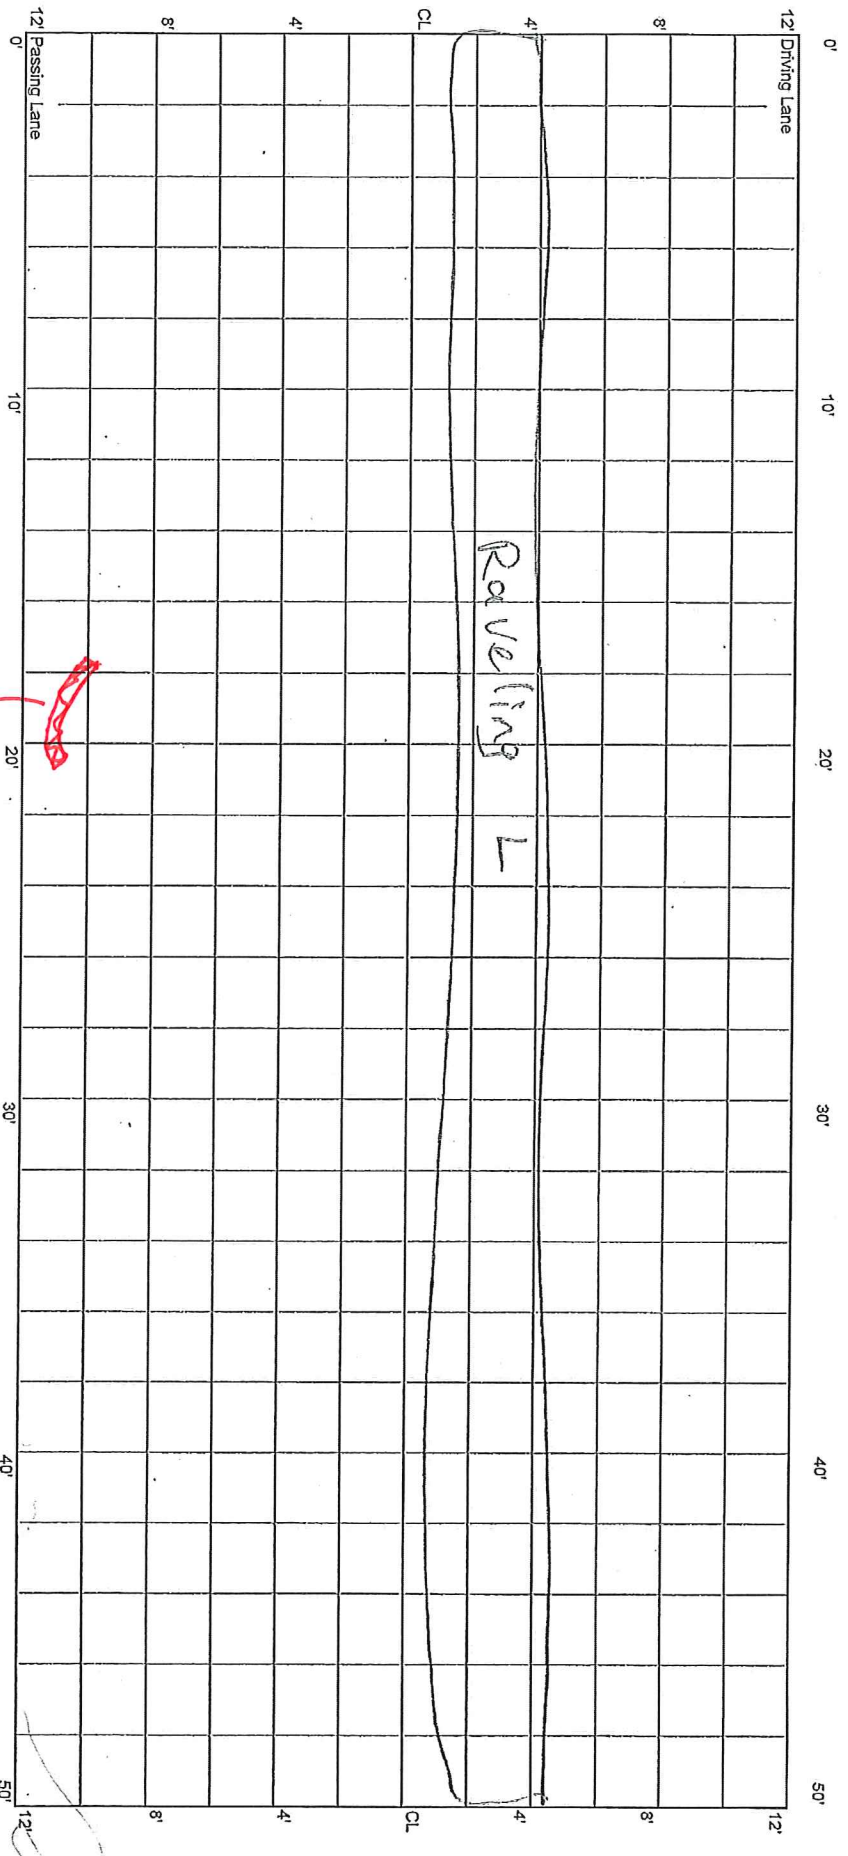
CELL 4  
300 - 350 ft

probably a tear from vehicle?  
looks like R<sub>L</sub>
