(previous survey 10/5/12)

File LV21

Cell 37  
0 - 50 ft

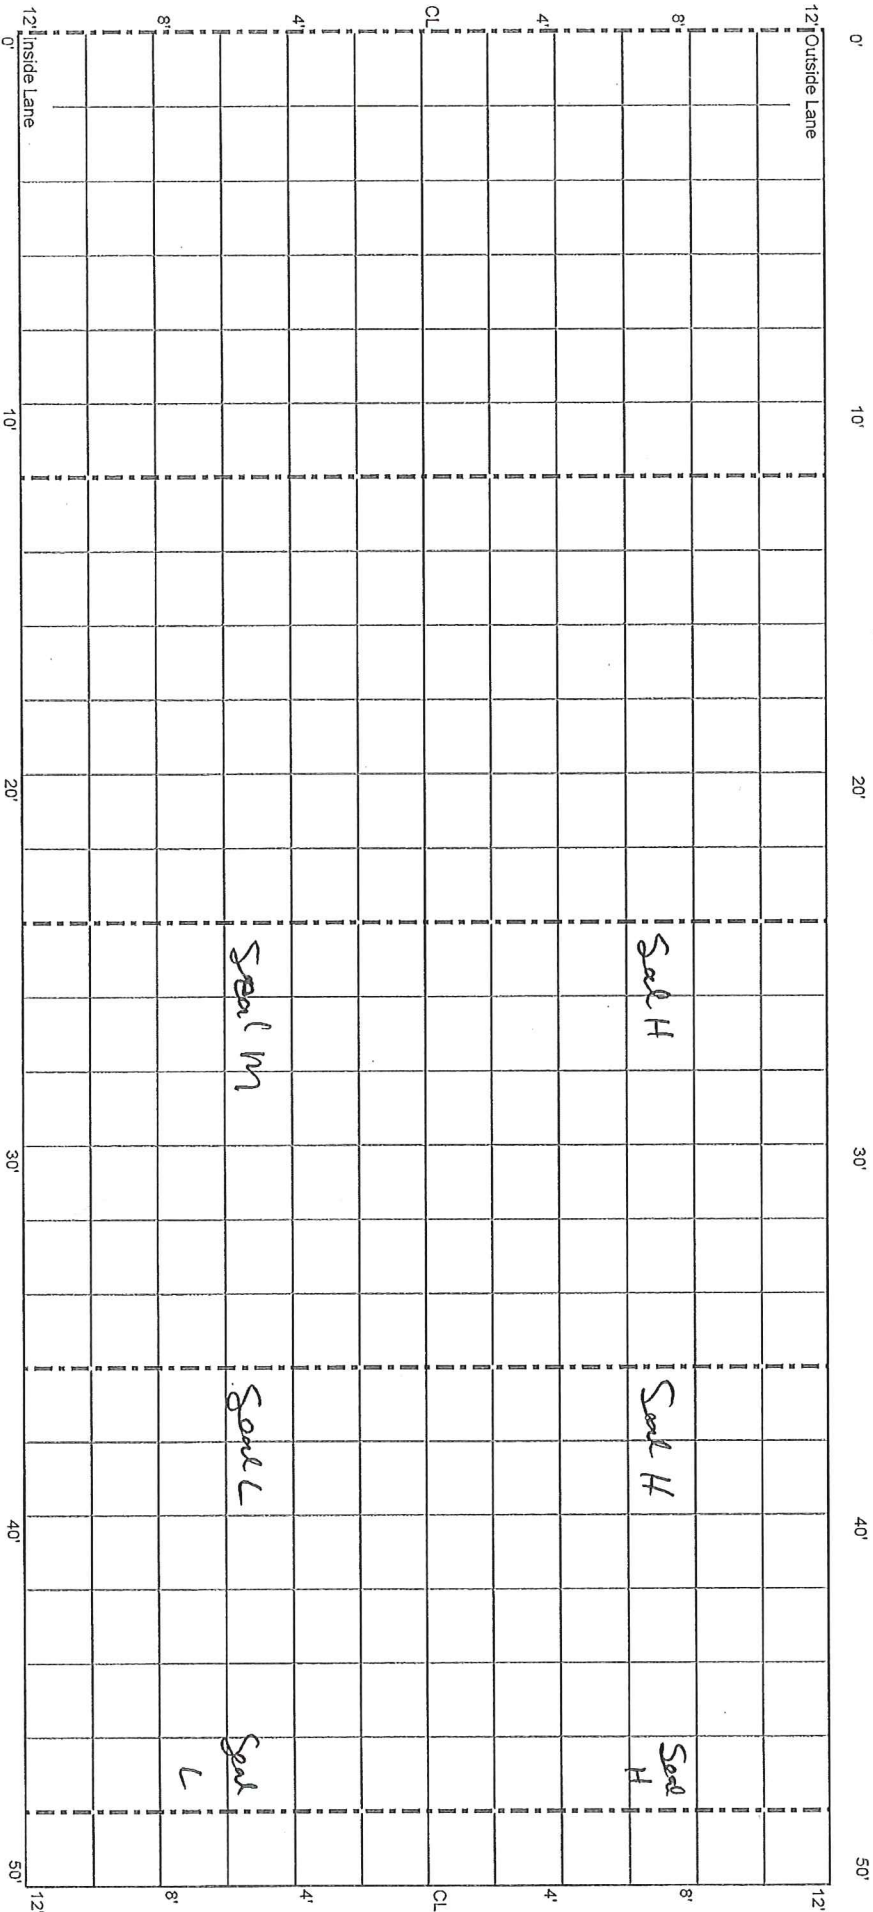
Diamond grinding blew out  
sealant in Outside Lane
