File ML28

9/24/2013 BAT

CELL 21  
0 - 50 ft

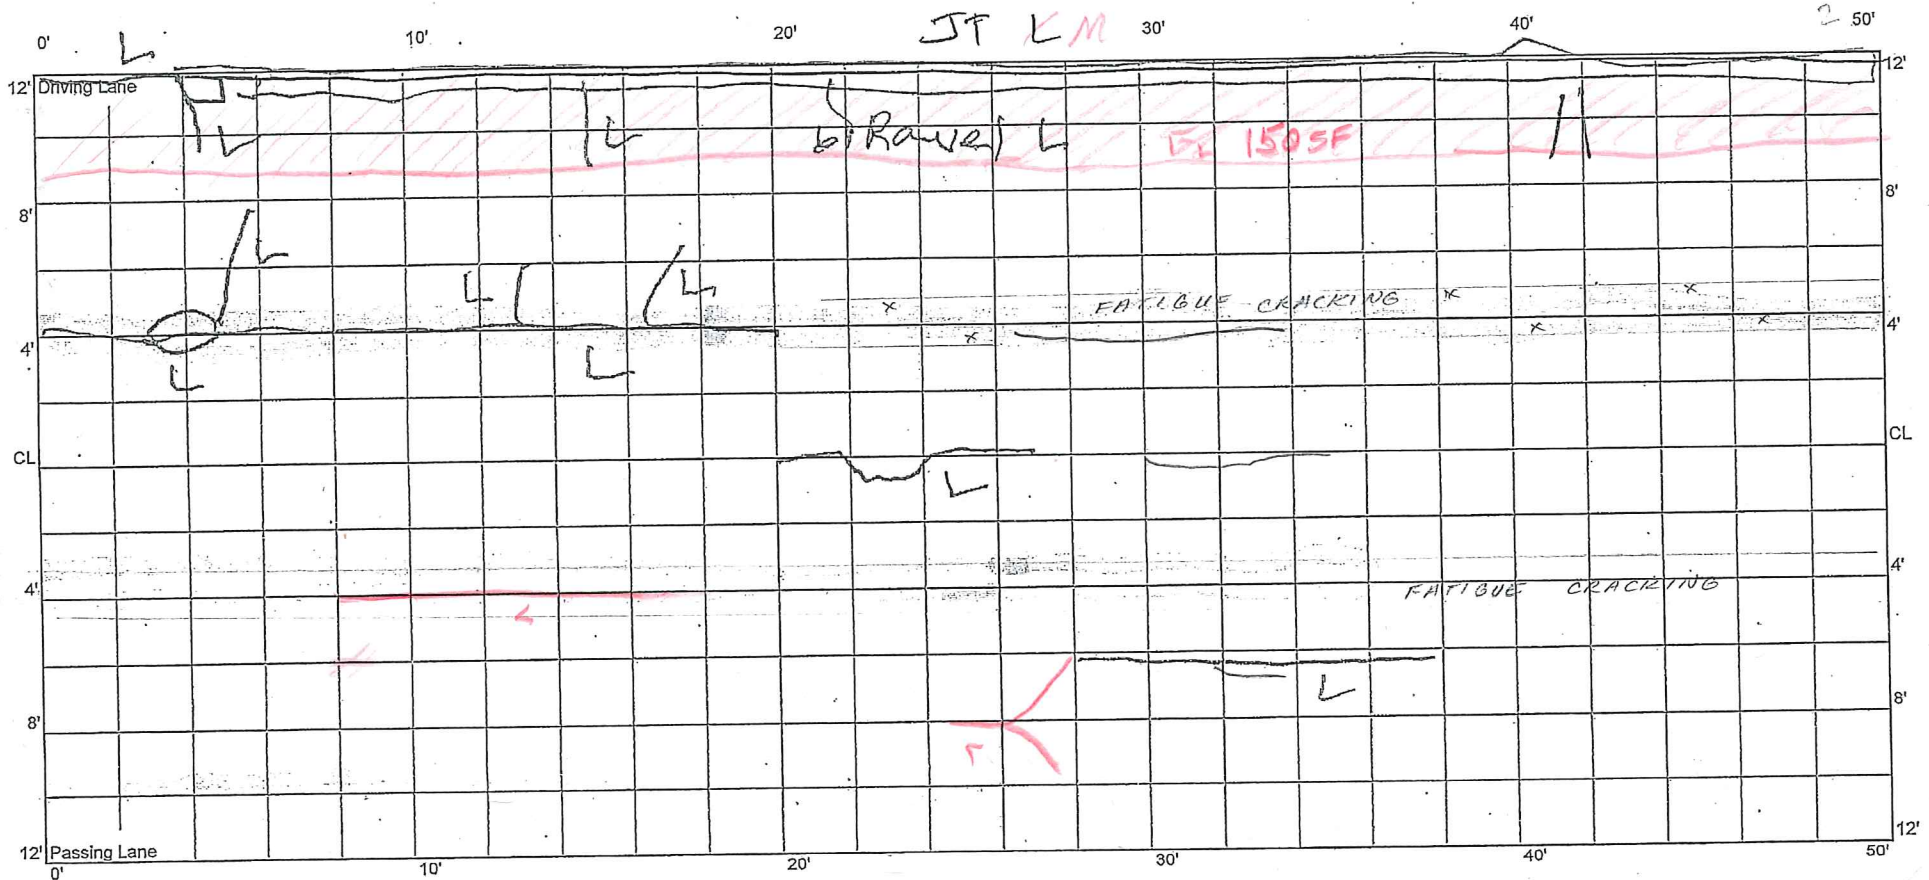
1/10

note: w/p cracking was observed  
These are not long. cracks  
but look very fatigue like.  
They are very fine cracks.

STAINING on short xverse cracks  
in OL owp.

2 JT L 5'  
NWP 2' Long L

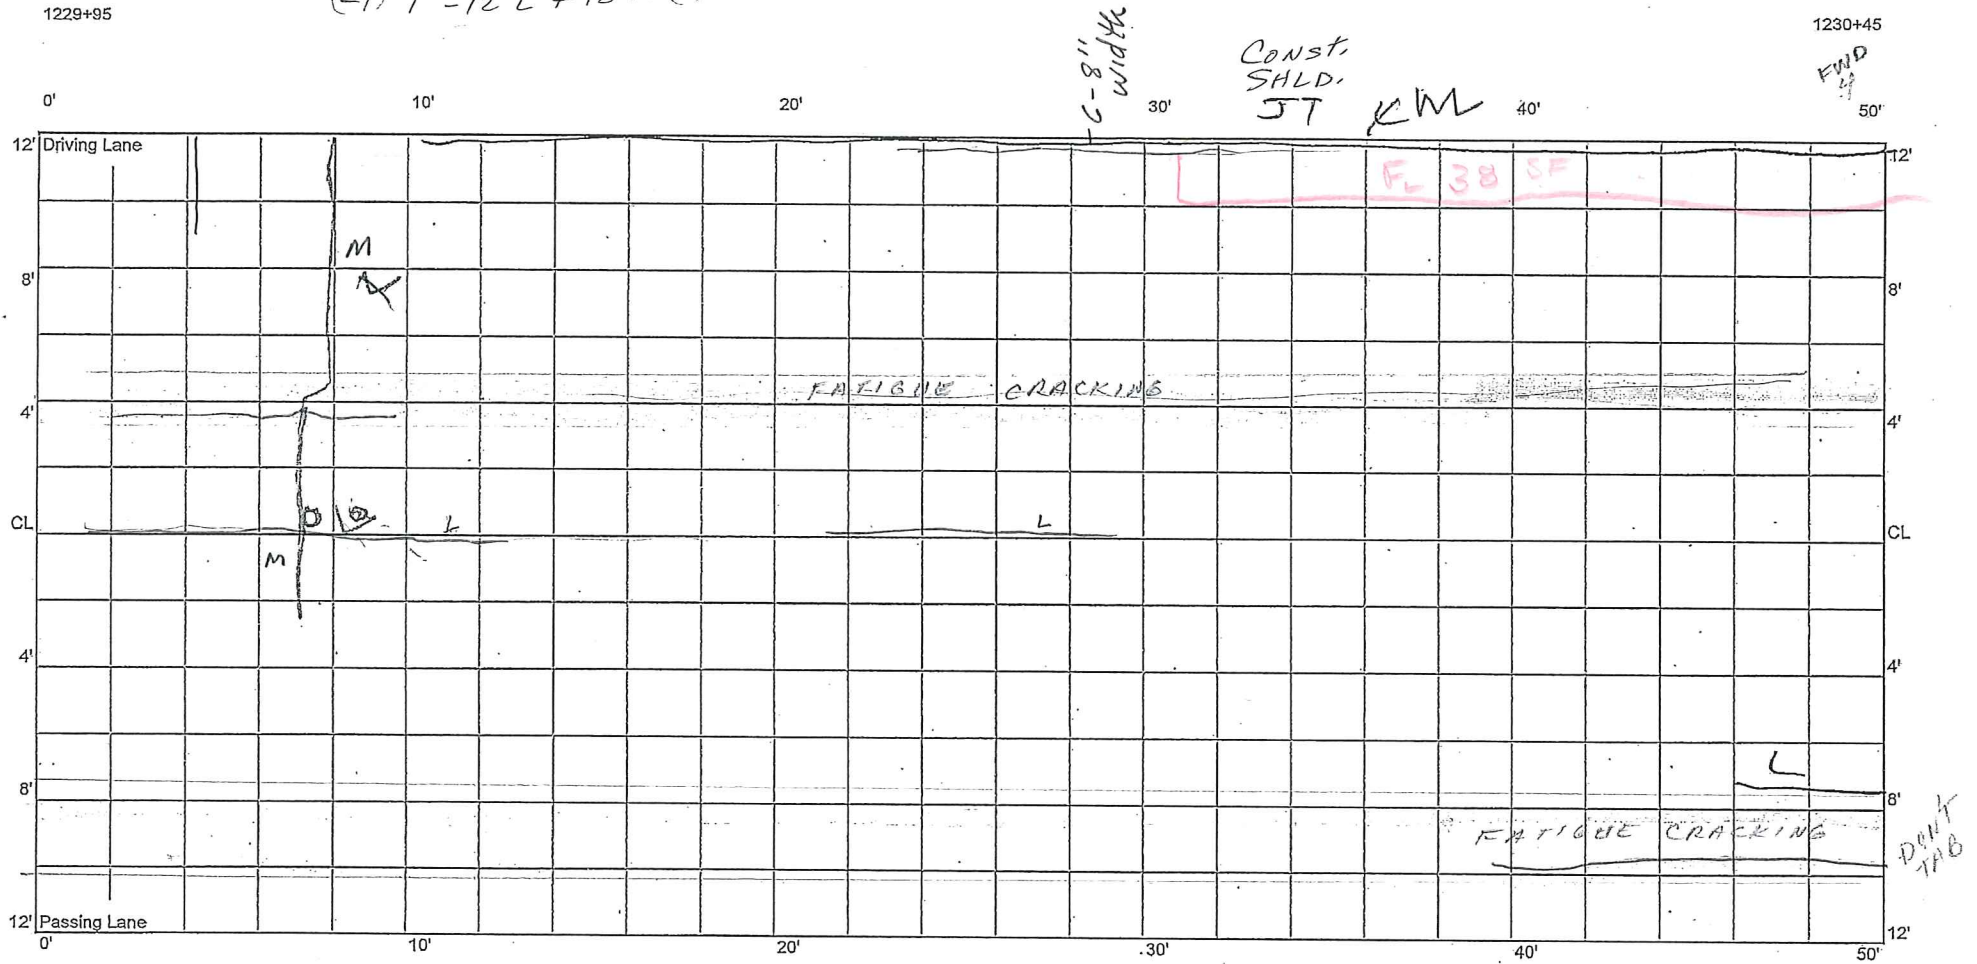
3/10

T (1) 3'L  
(-1) T -12'L + 12'M (1)

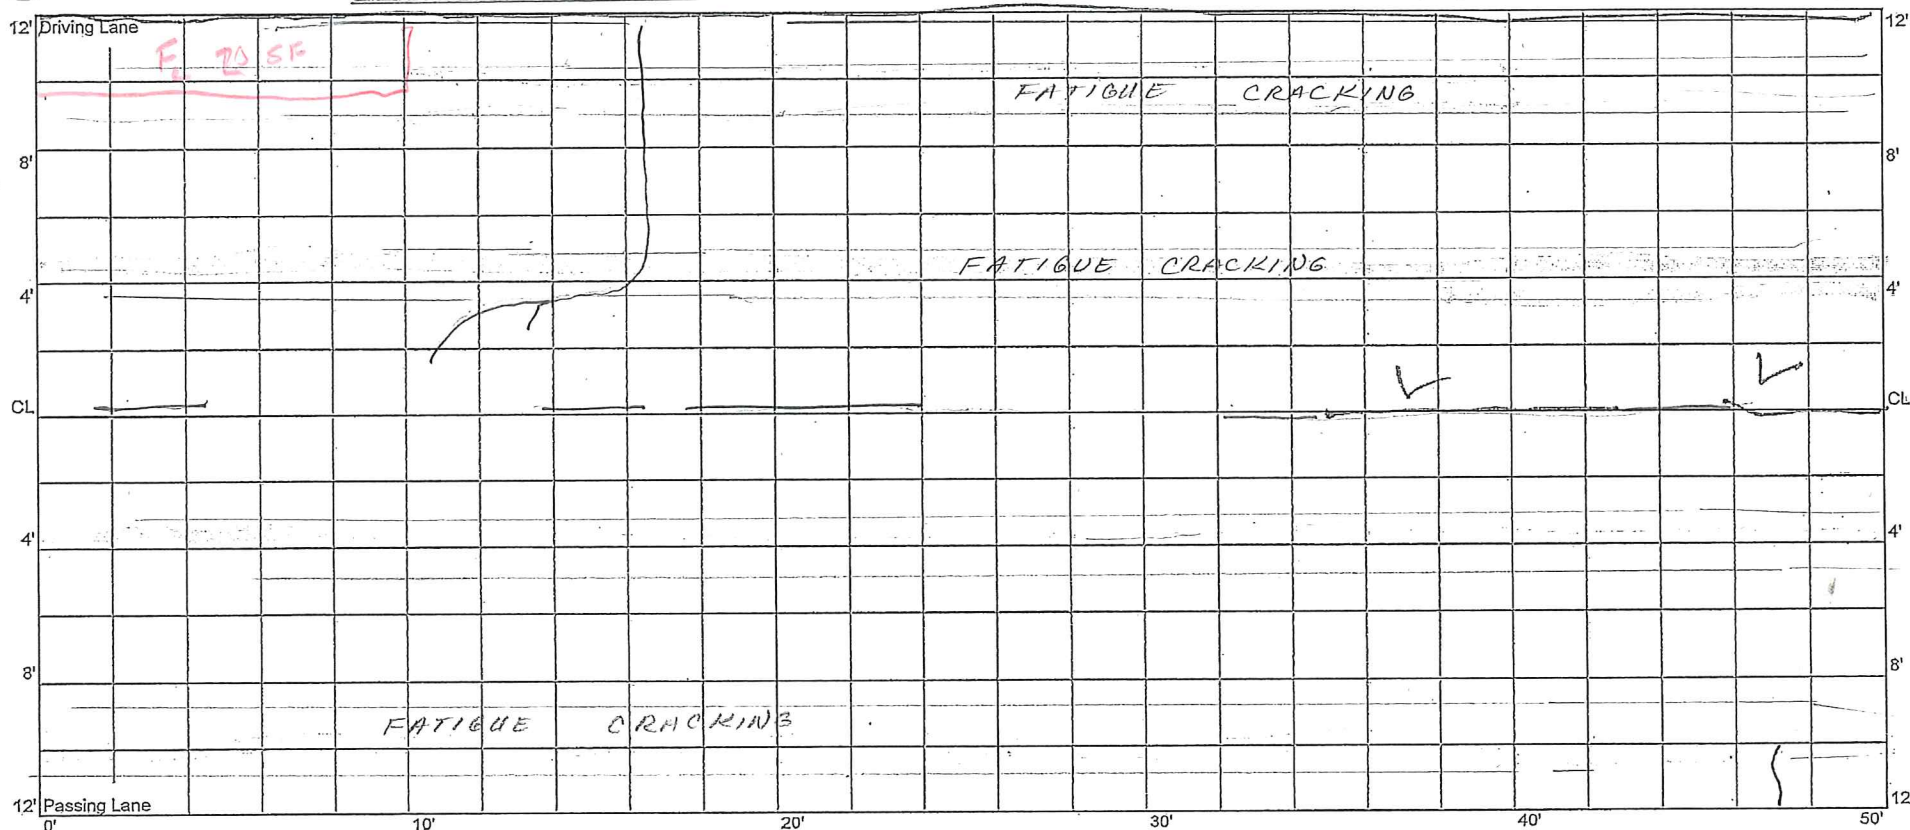
8/10

Fine fatigue cracks. Dwp.

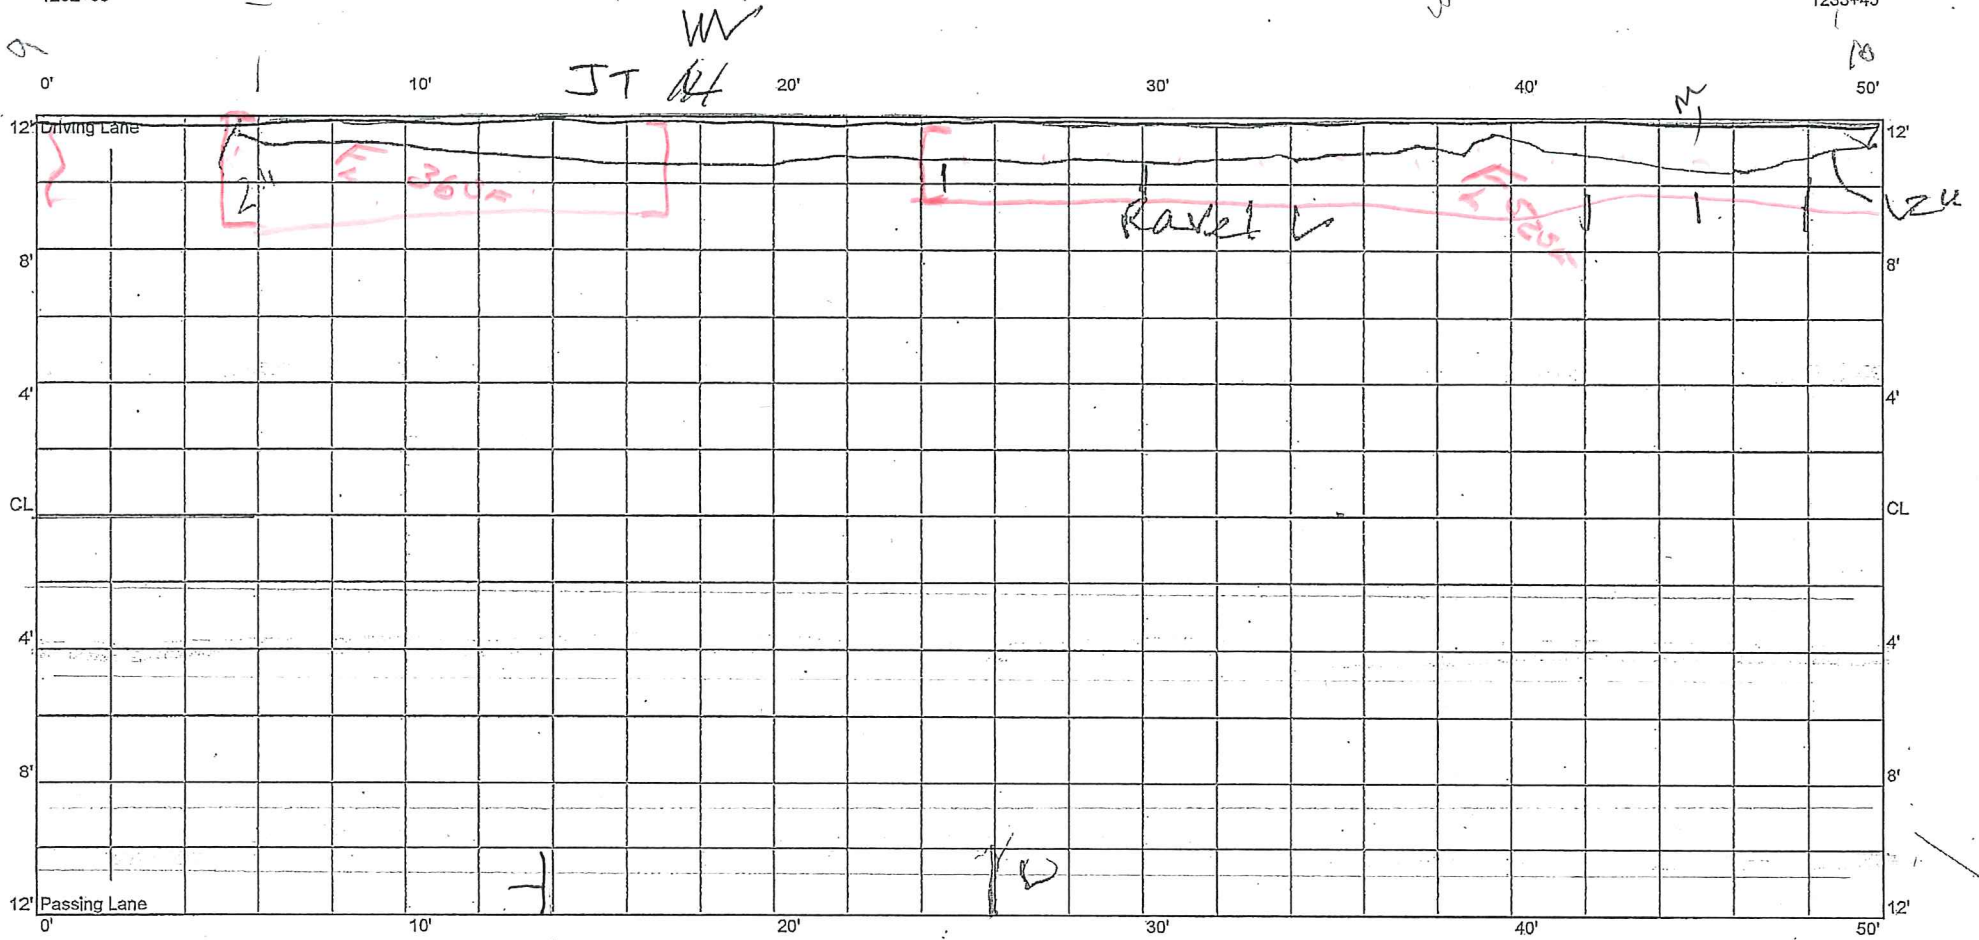
9/10

Pol  
W/P  
3" / 6" random  
fog to 2 1/2'

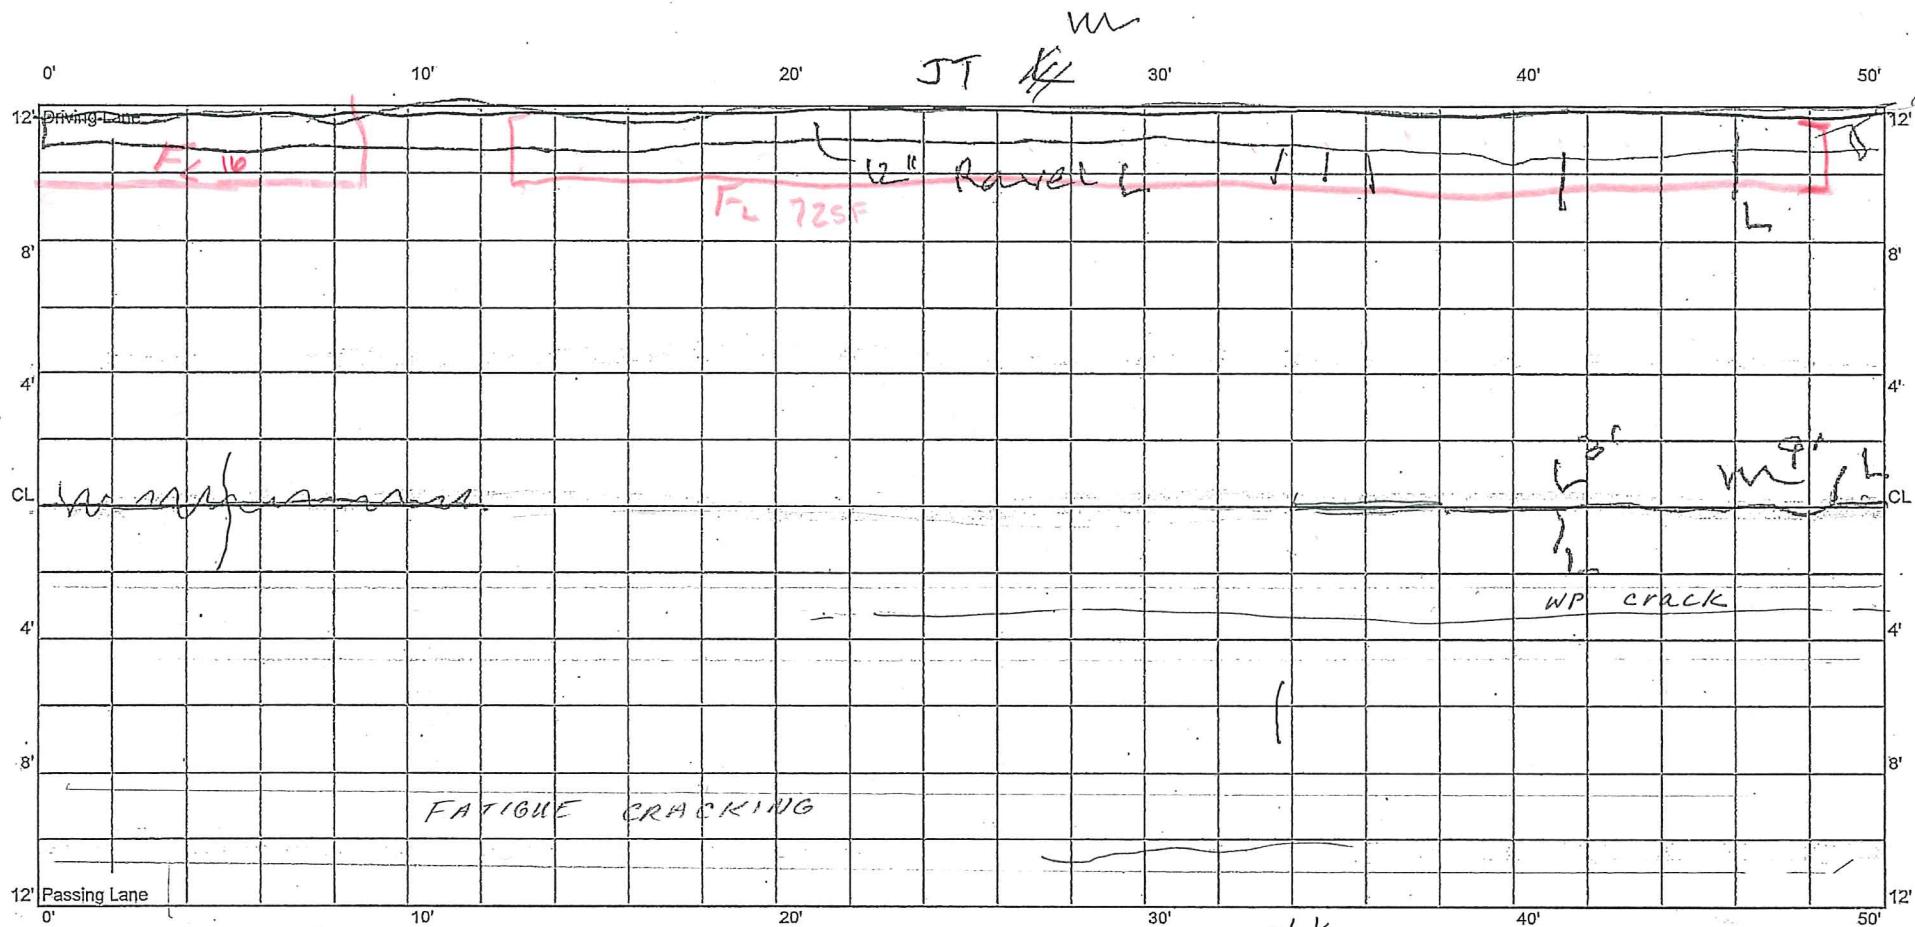
10/10

Trans 2' L  
Q JT 4'
