11/23/2015 LEP  
No New Distress

(Previous Survey 10/3/2012)

File LV17

CELL 33  
0 - 50 ft

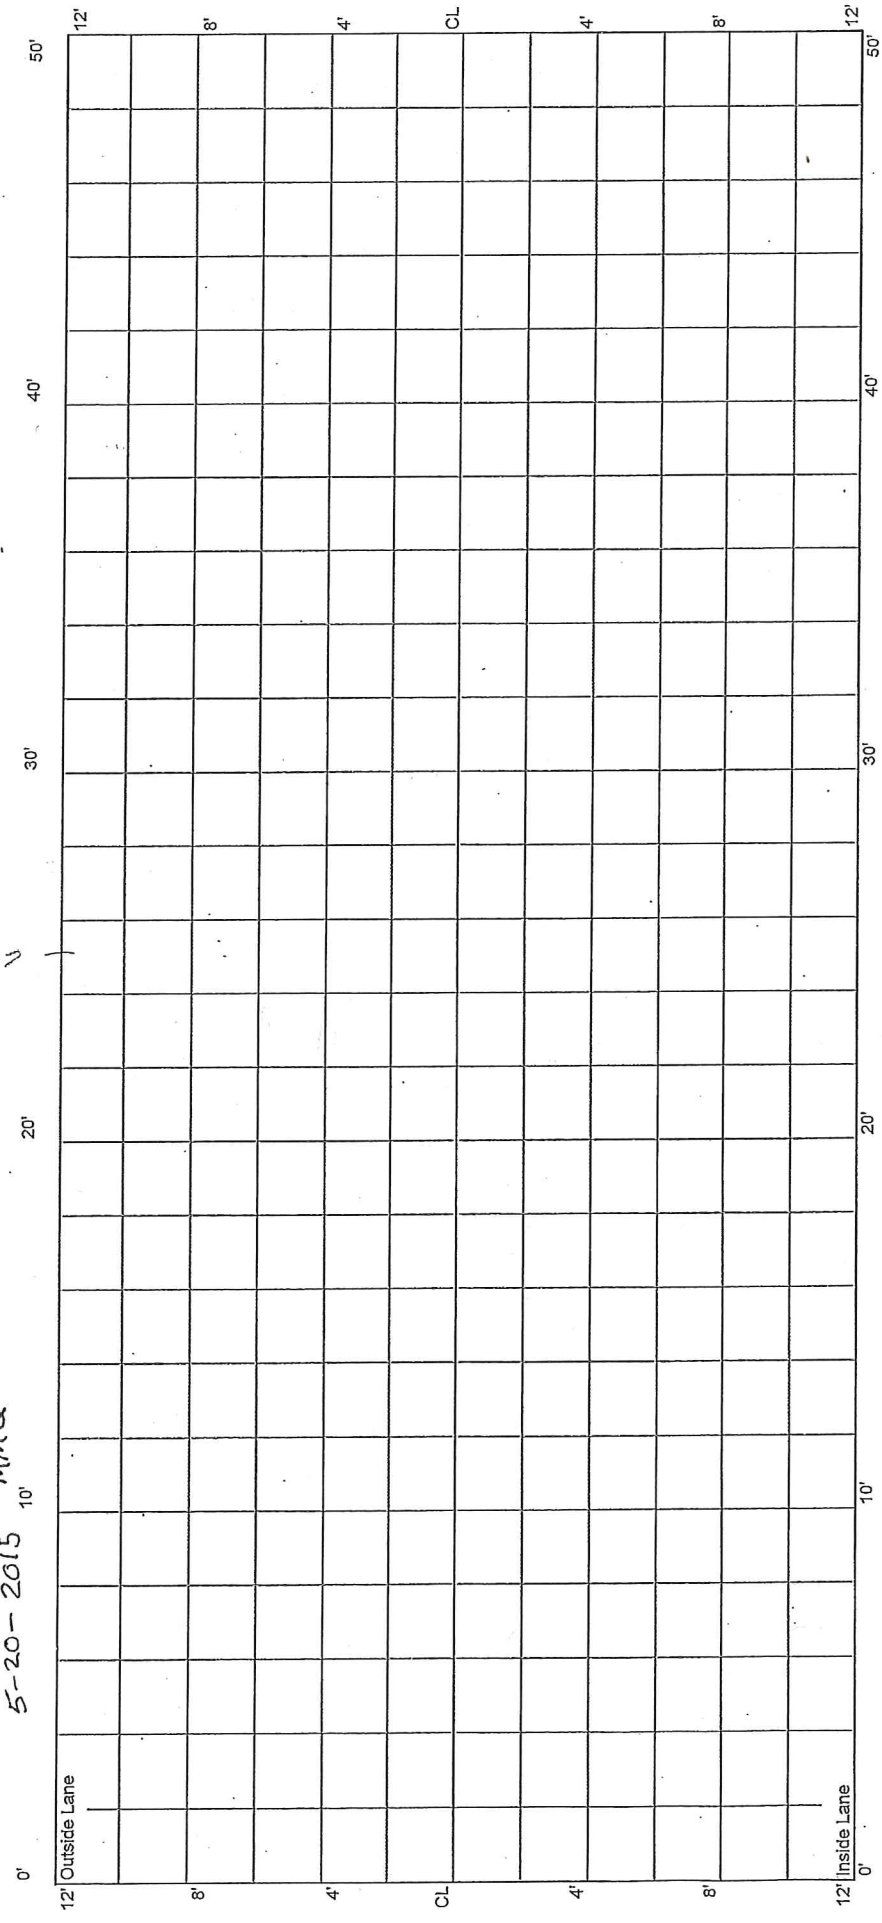
shows Oxidization and mild wear - drying out on surface

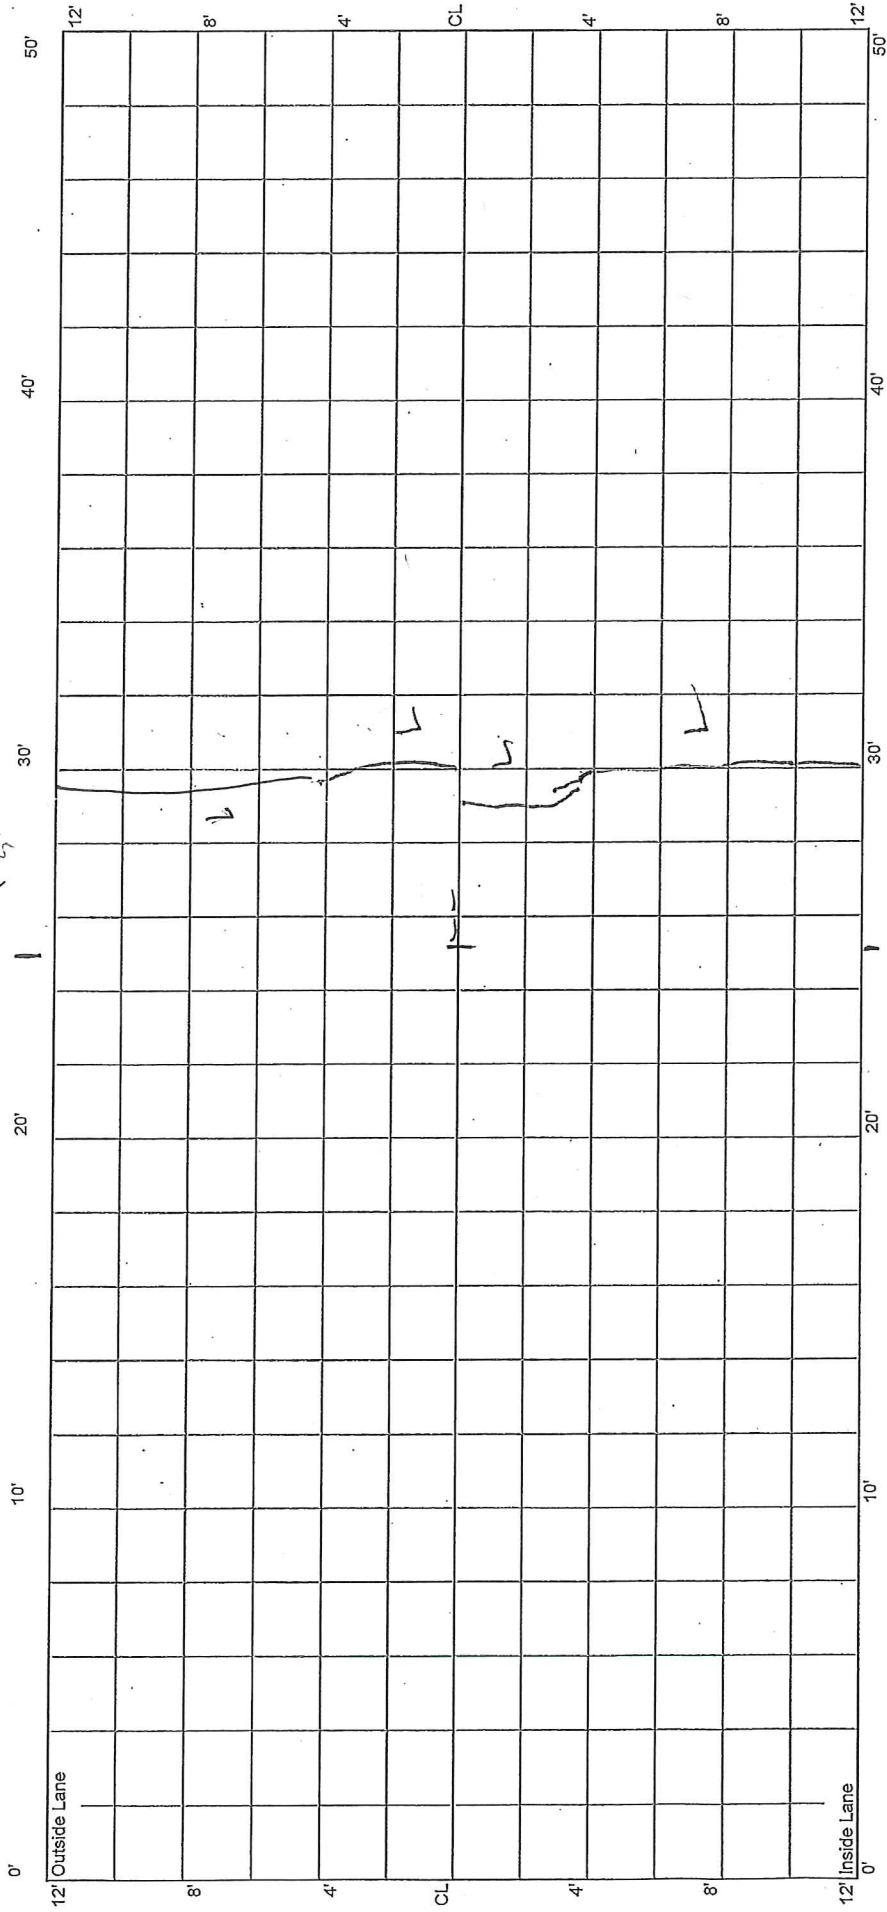
CELL 33  
100 - 150 ft

Centerline  
rumblestrip  
stops @ 6500
