CELL 34  
0 - 50 ft

File LV18

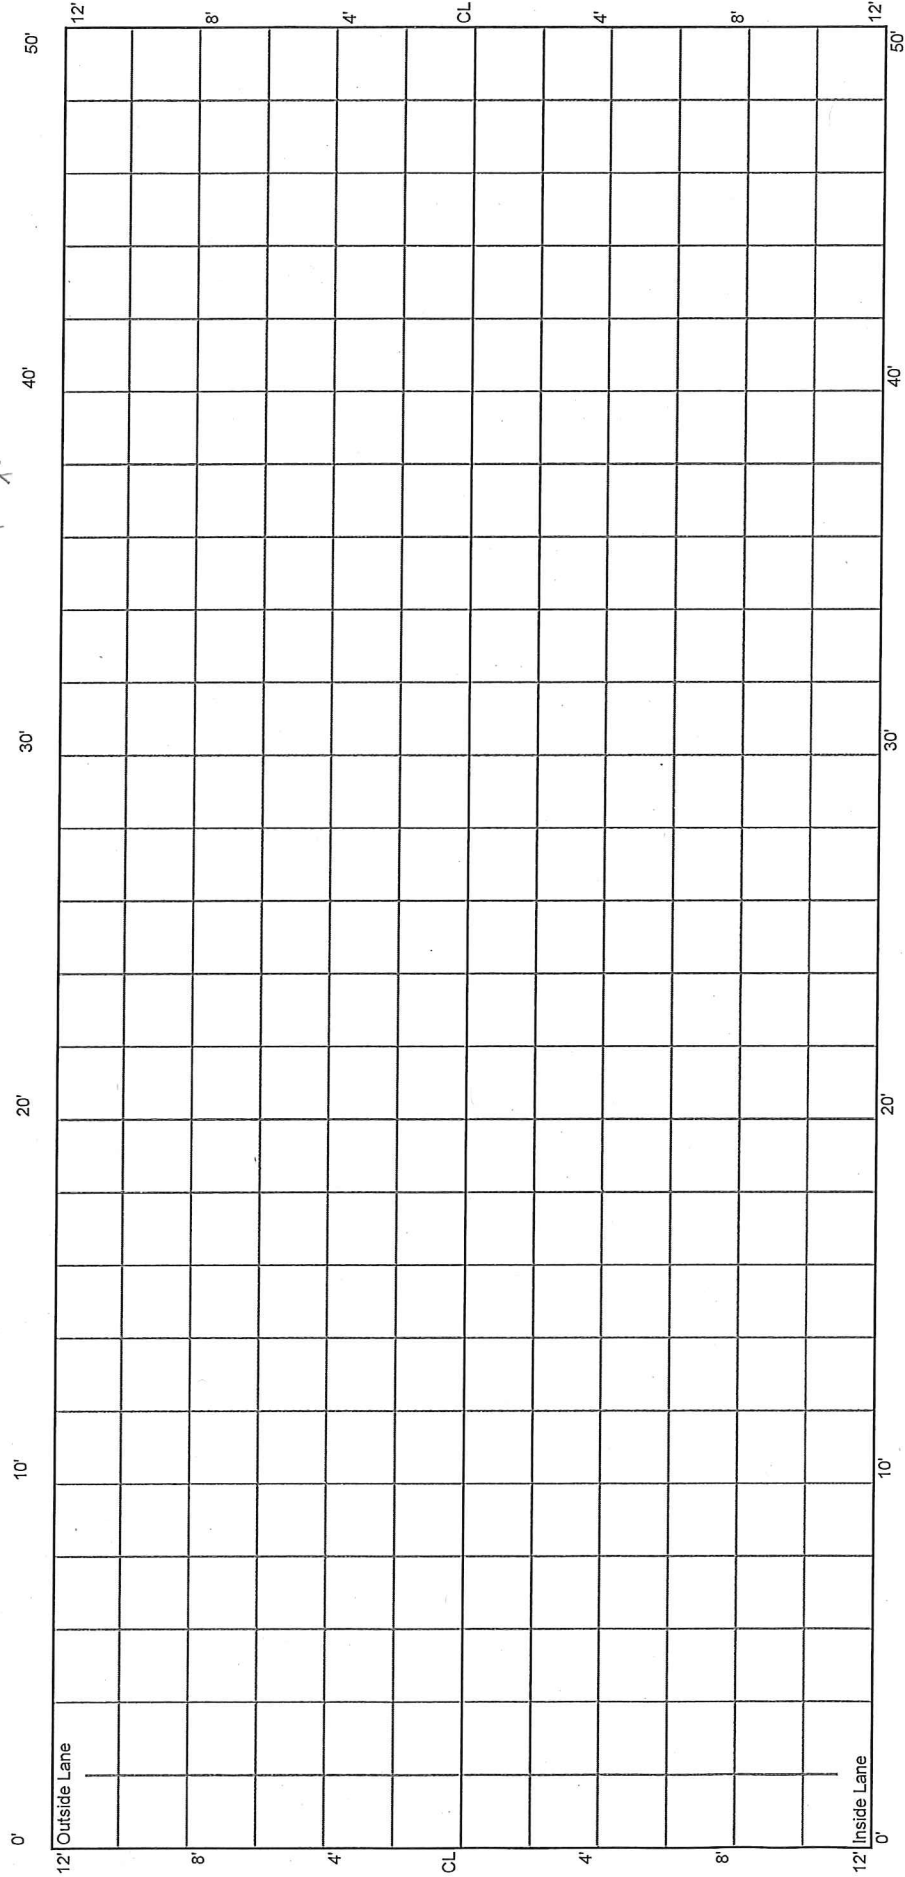
Raining light - water collecting in out, inside lane

no other distress

5-8-2015 BJB no addl distress

5-7-2015  
rubble strip added  
to both sides by center line
