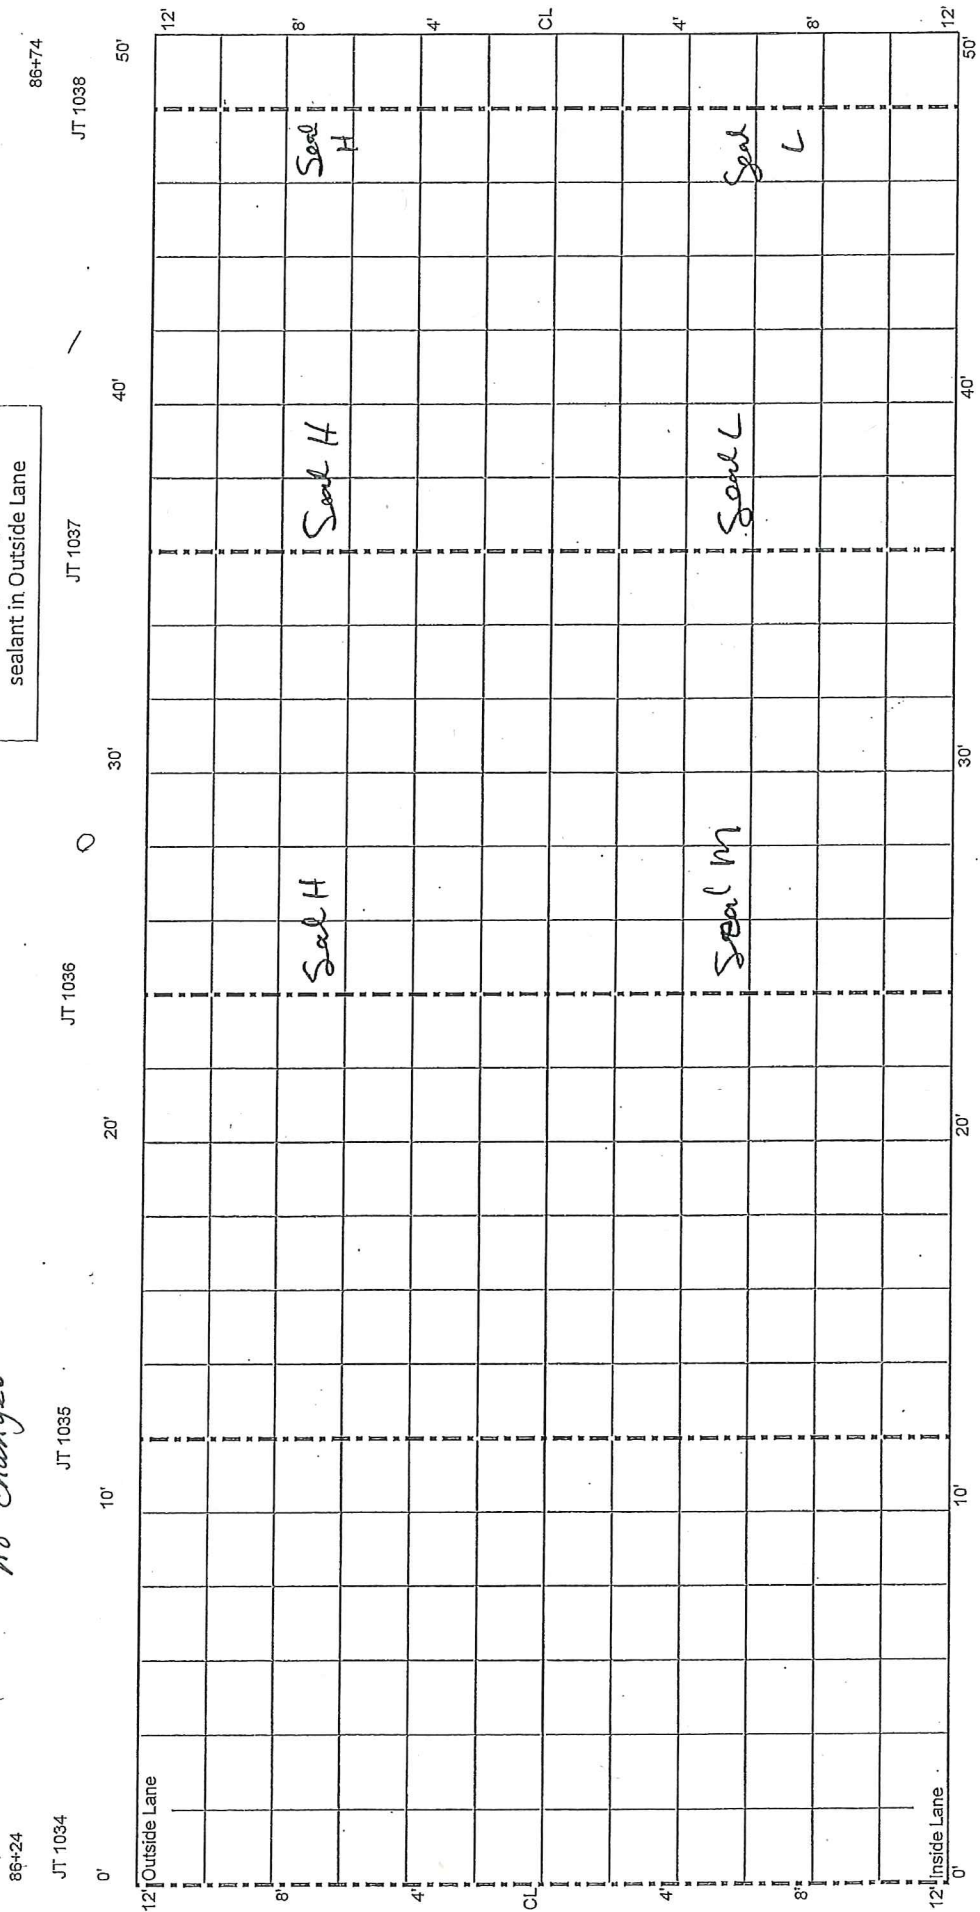
Cell 37  
0 - 50 ft

Diamond grinding blew out  
sealant in Outside Lane
