9/24/2013 BAT  
(previous survey 9/24/2012)

File ML16

CELL 70  
0 - 50 ft

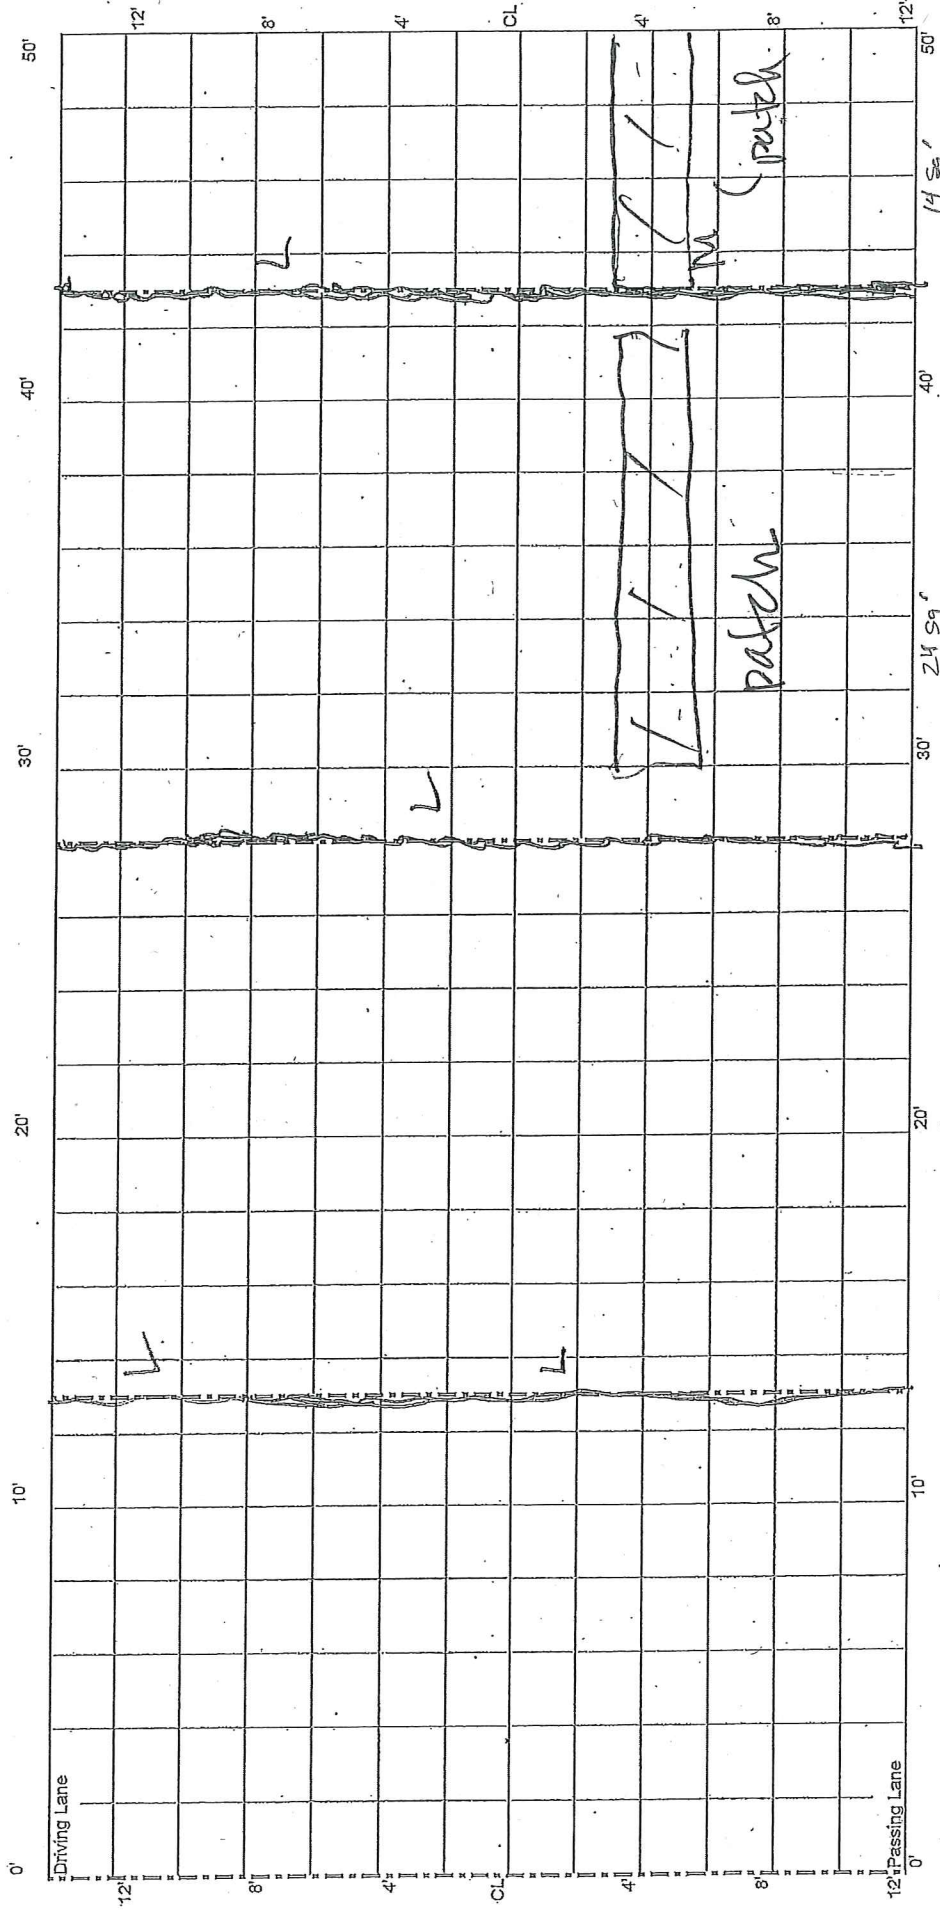
reflection cracking

Note: PATCH WAS NOT FROM DISTRESS.  
HAMA REMOVED FOR STUDY.

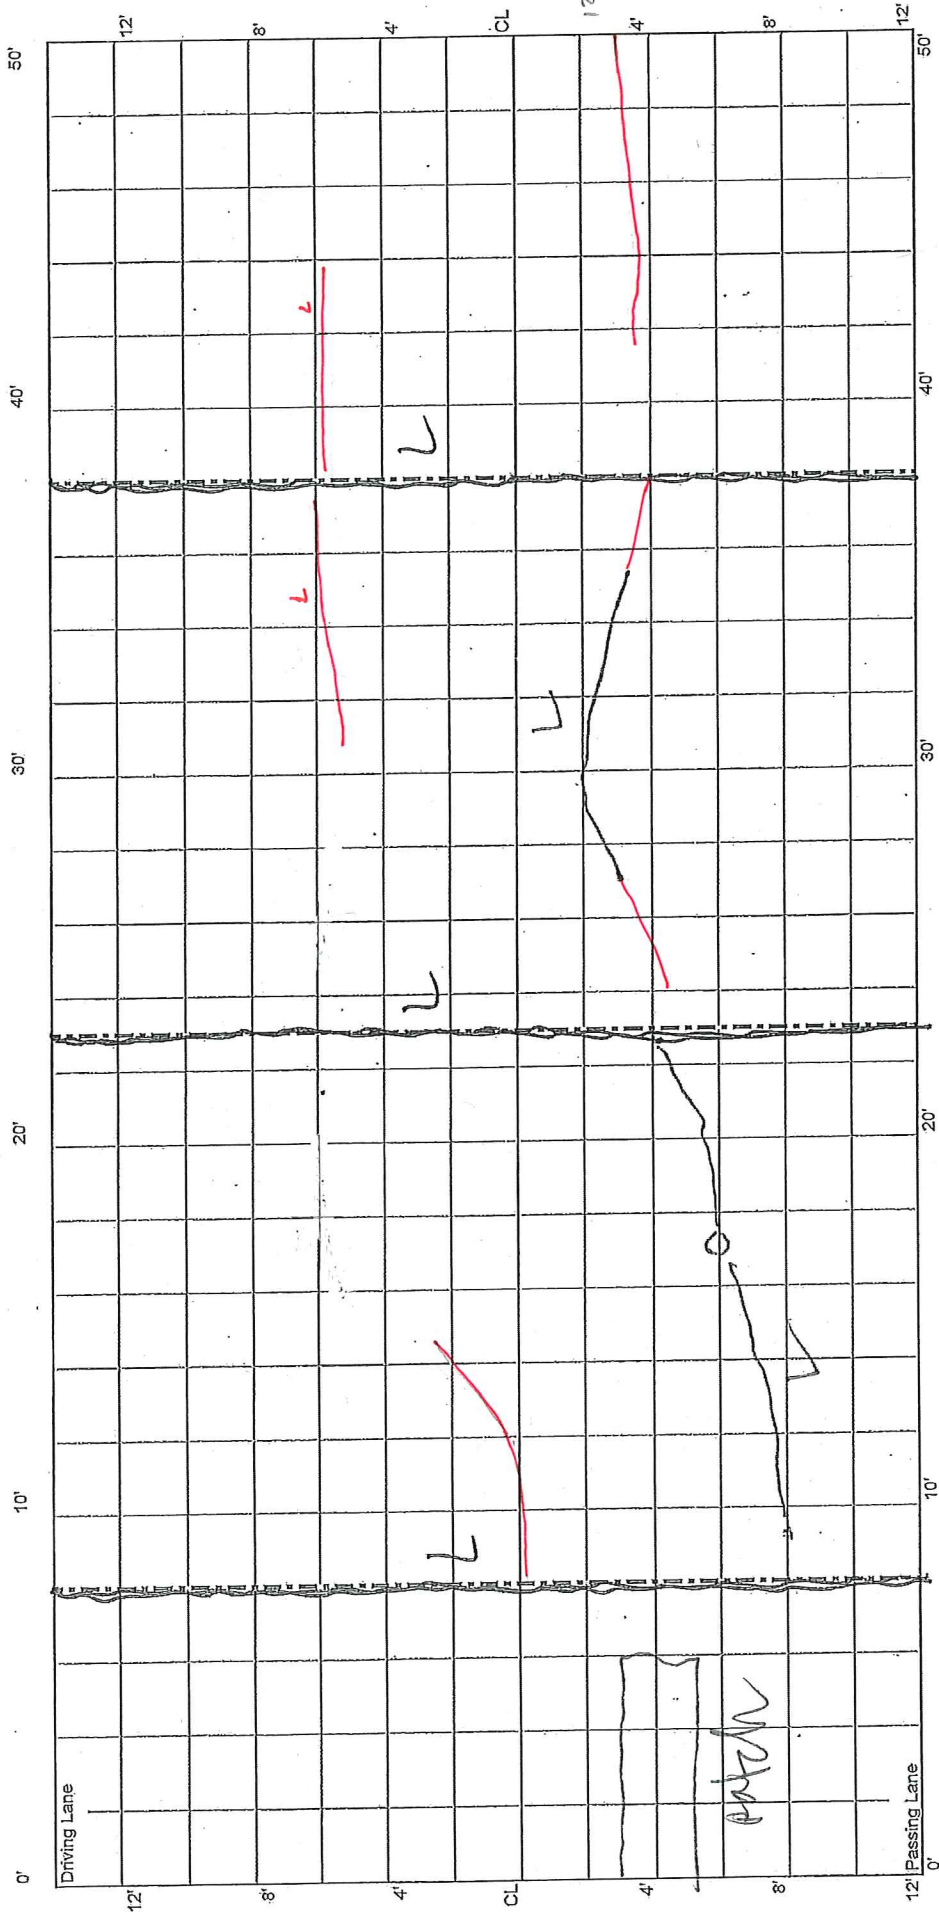
CELL 70  
50 - 100 ft

↑ Saw. Seal L

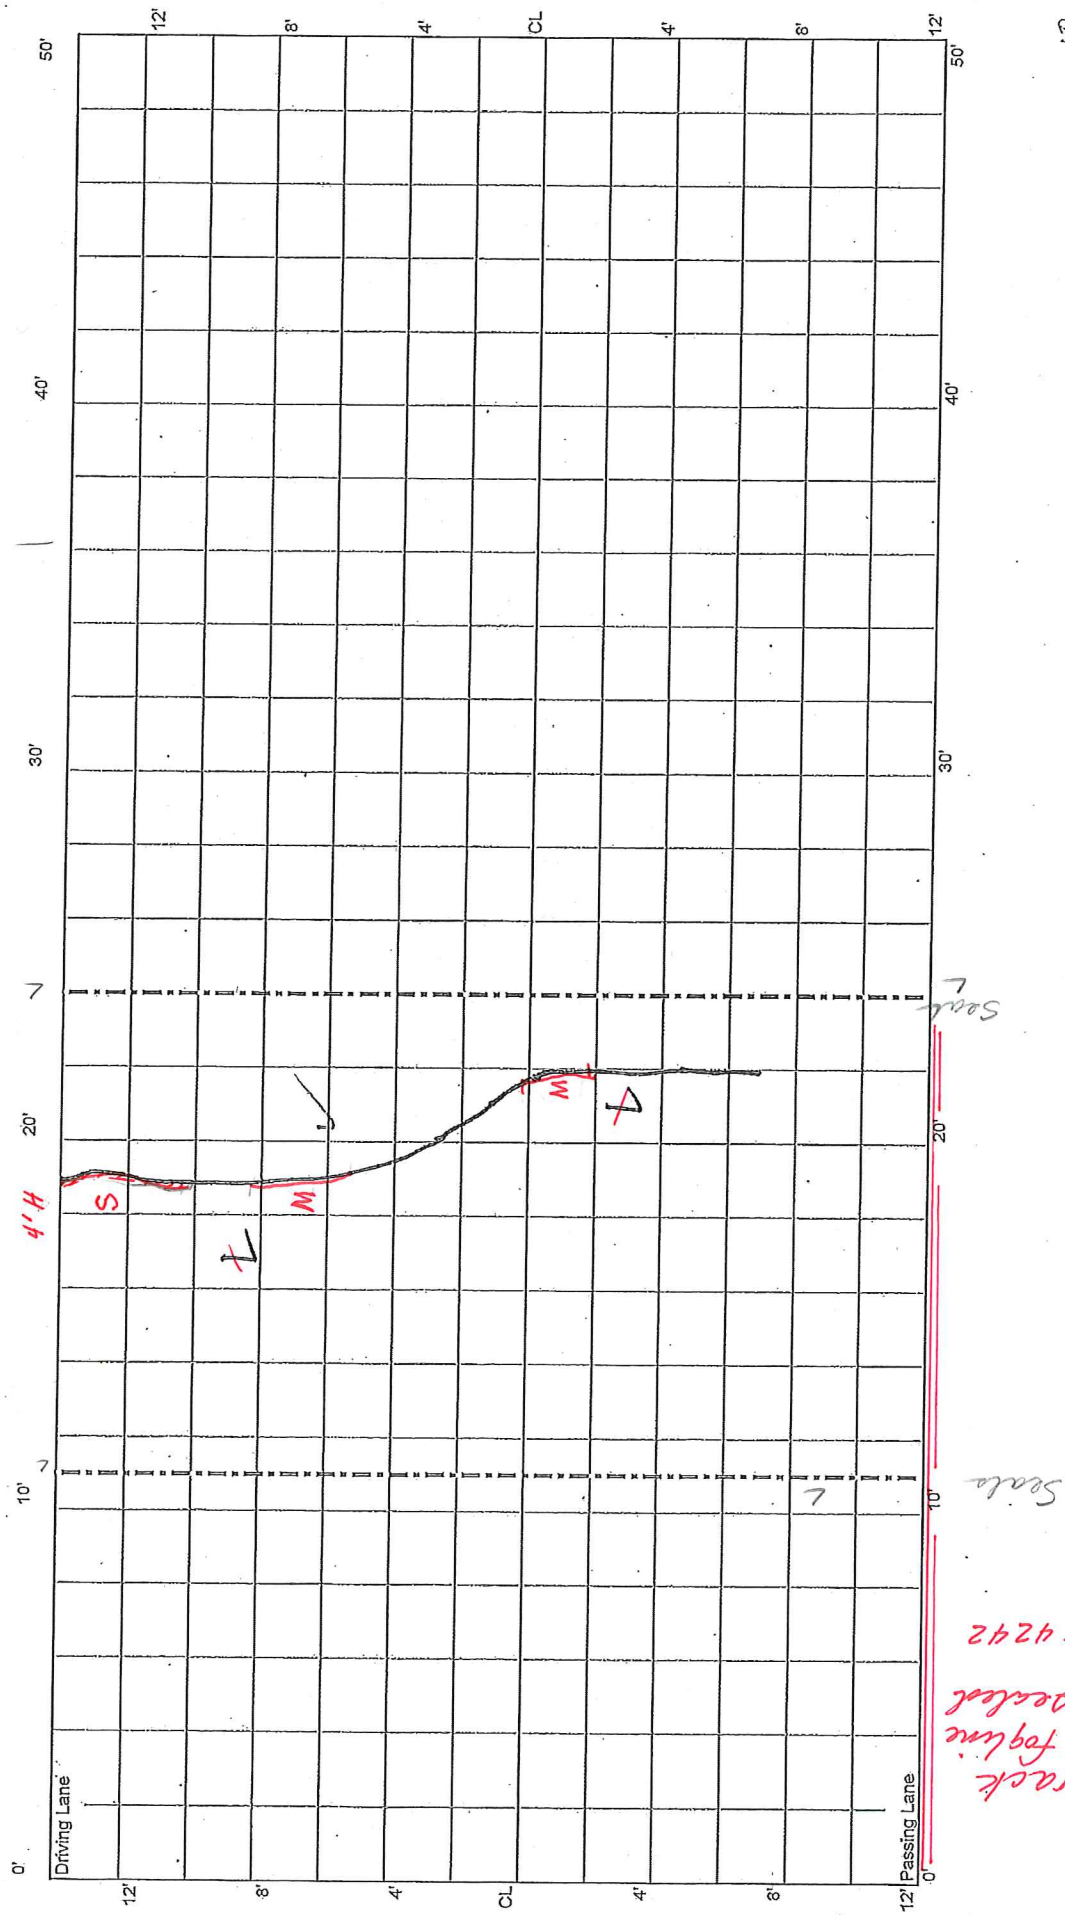
Crack  
on fogline  
needed  
To  
JT 4242
