CELLS 114-914  
0 - 50 ft

File ML21

Transition Cell 114

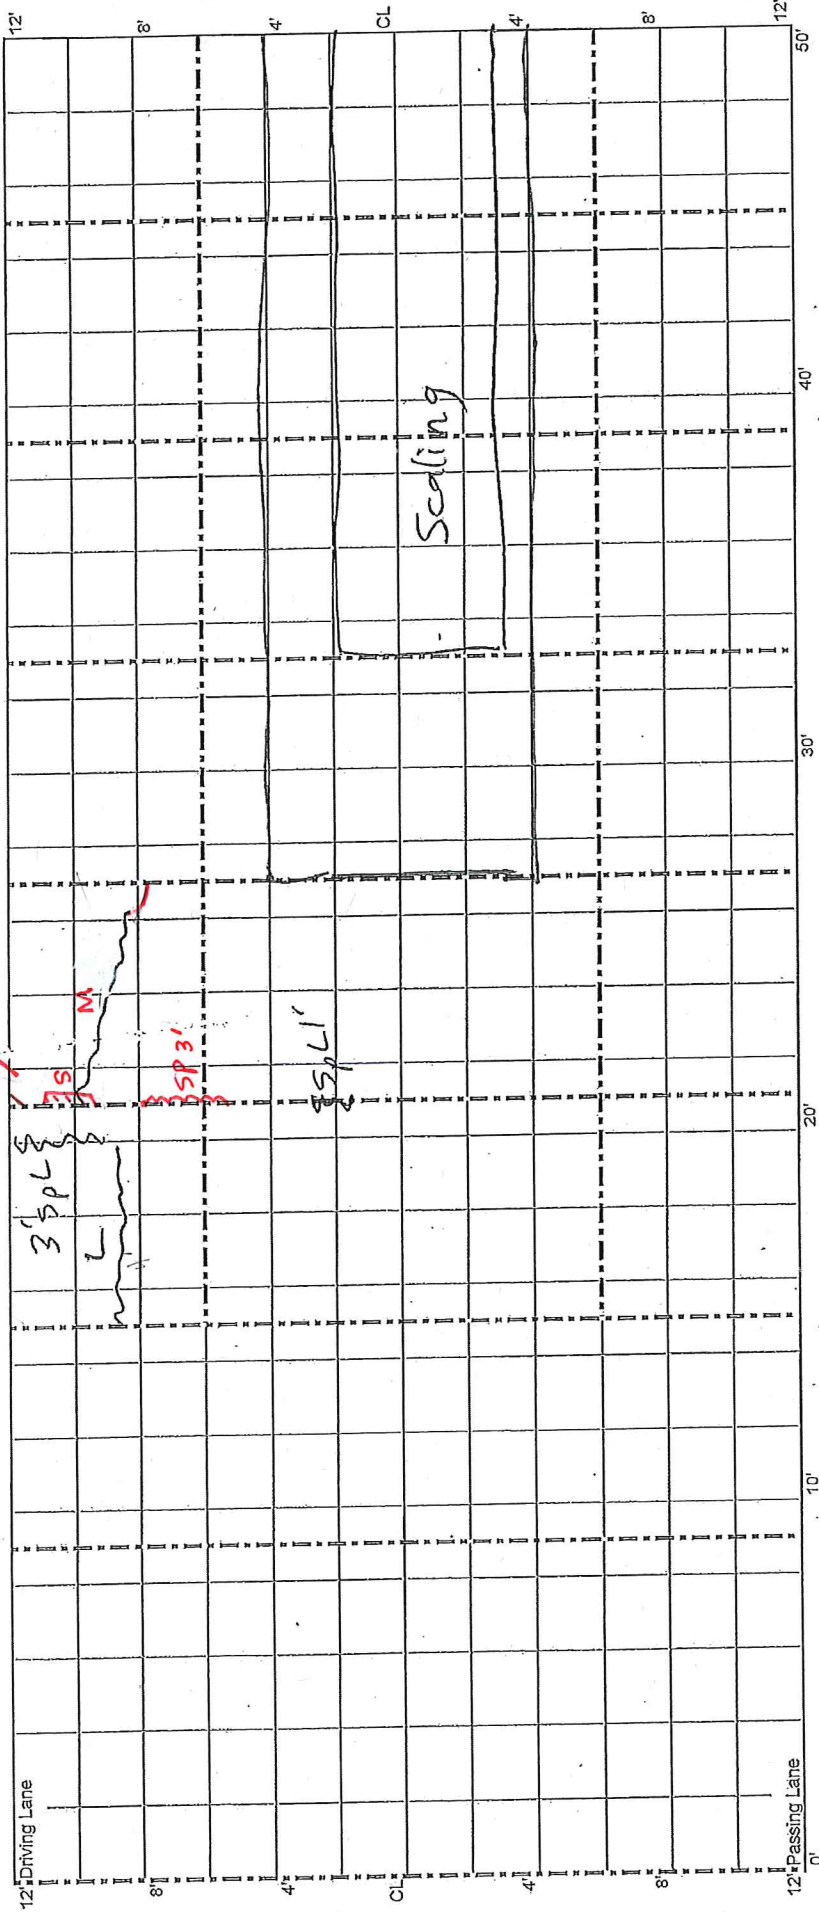
noteable faulting throughout.  
5/13/2015 BJB

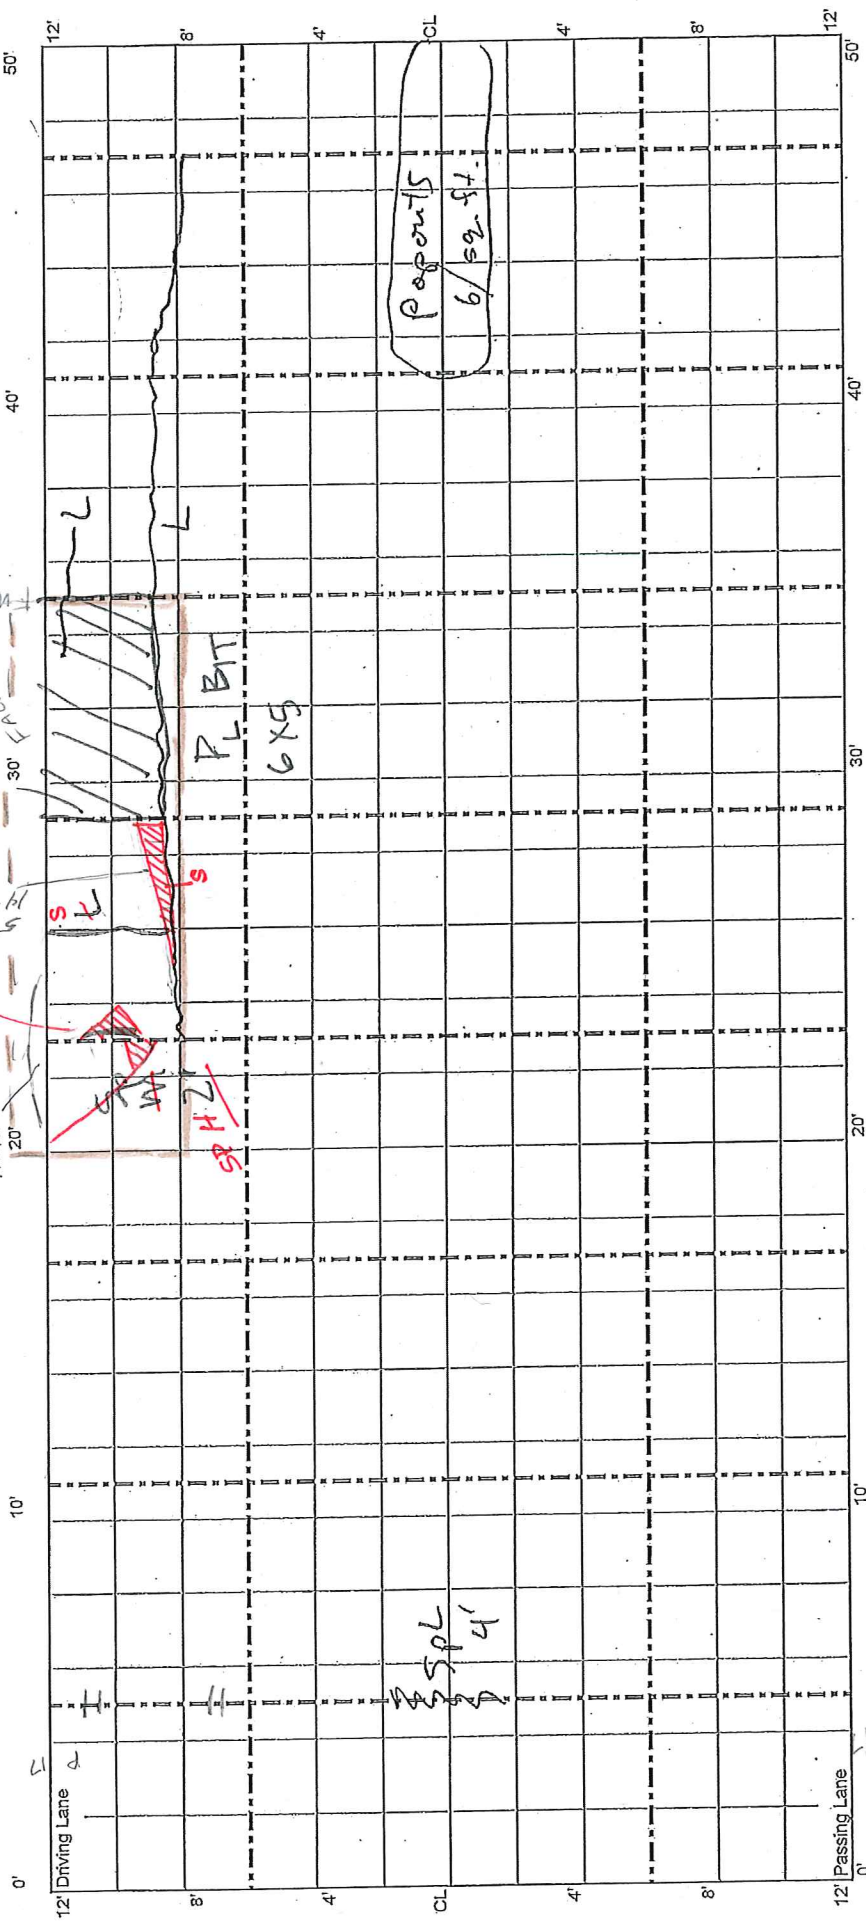
CELLS 214-314  
 100 - 150 ft

June 2015  
 PATCH REPLACED  
 WITH LARGER PATCH  
 15' 5" on survey  
 80% TOTAL

SHOULDER  
 CRACKED  
 MISSING  
 HMA

5" SEVERE  
 DAMAGE  
 1/2" TO TAPER

FAULTING  
 22'

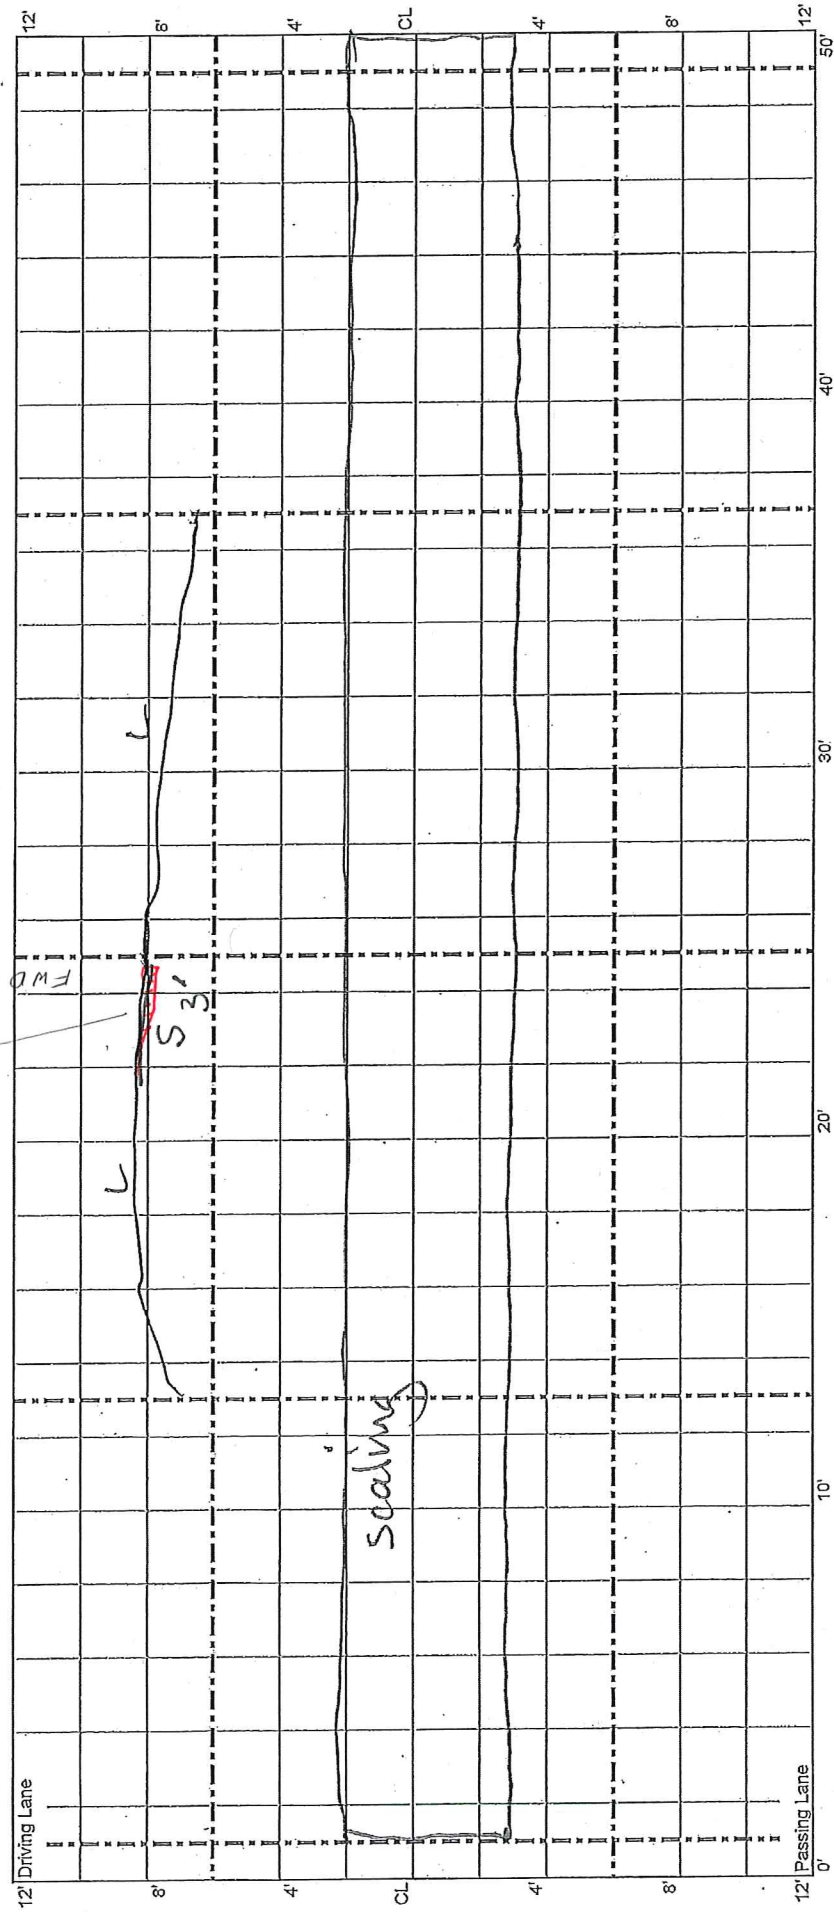
CELL 614  
350 - 400 ft

SEWER  
4" Taper 31  
FWD 58
