(previous survey 4/26/2013)

Transition Cell 114

CELLS 114-914  
0-50 ft

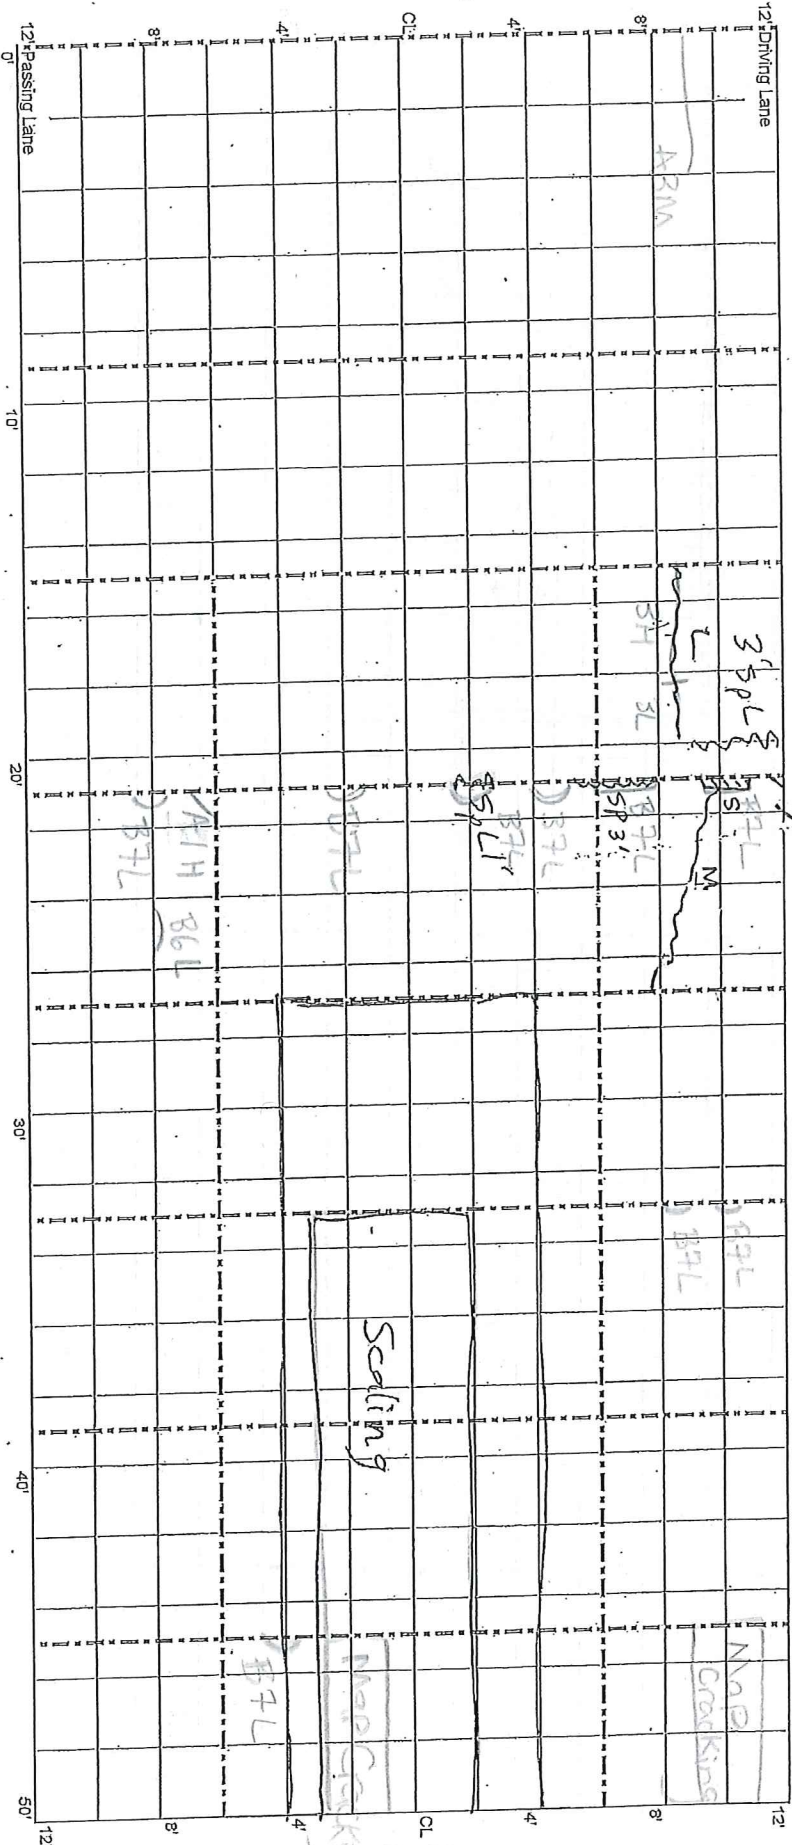
It's unsealed.

notable faulting throughout.

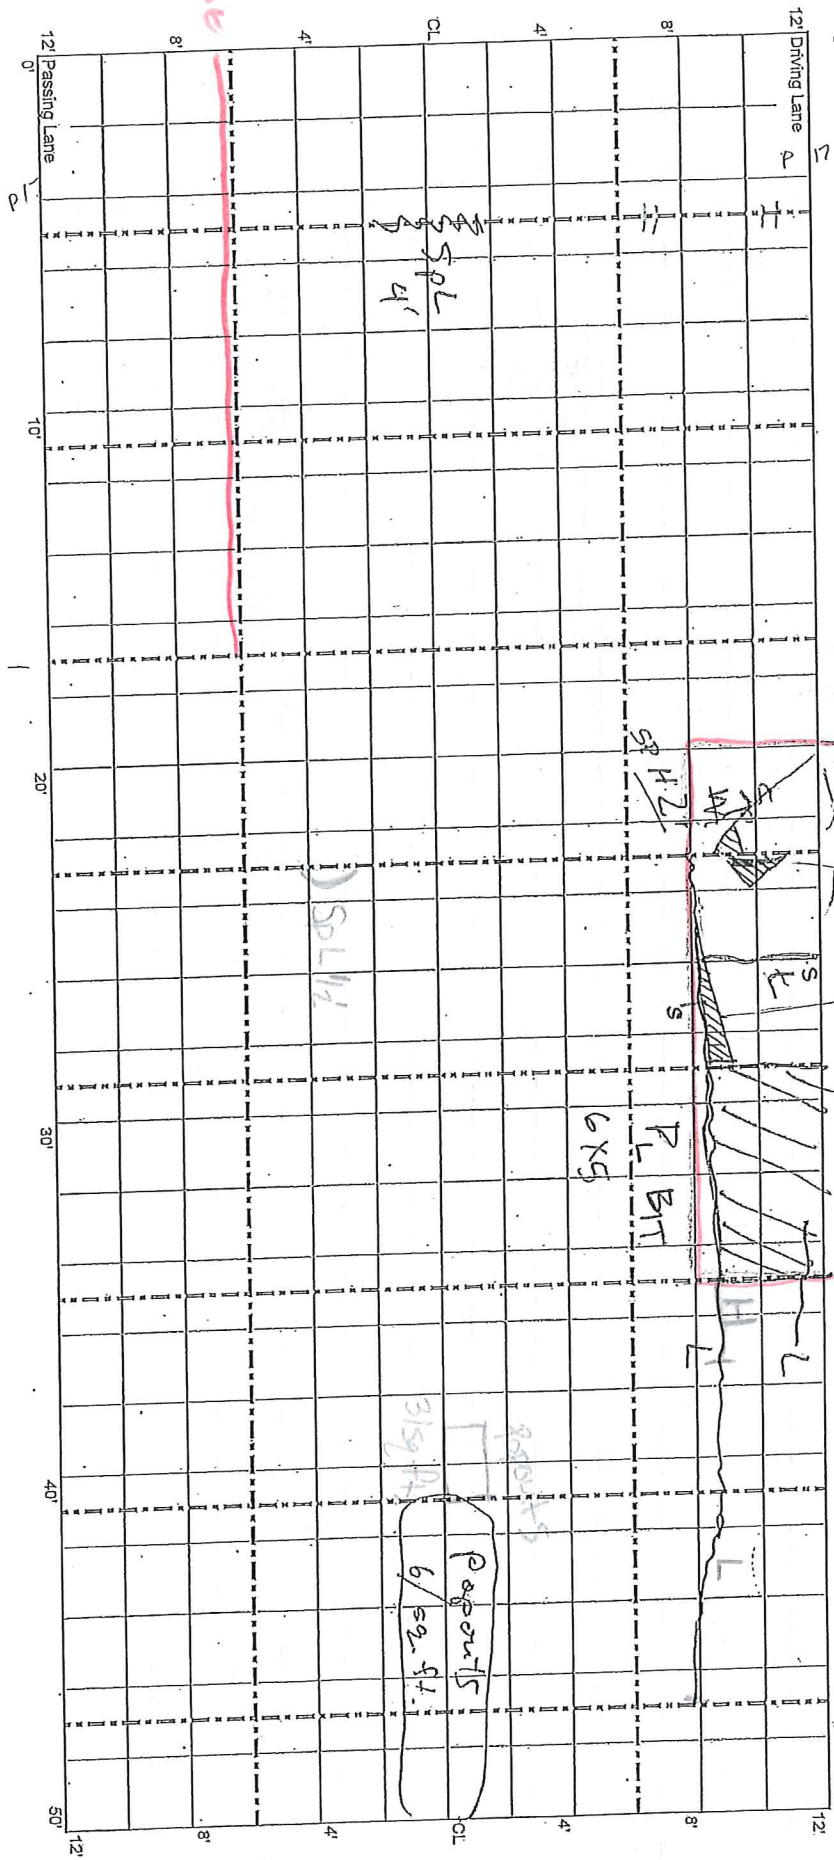
CELLS 214-314  
100 - 150 ft

SHOULDER  
CRACKED  
PASSING  
HMA

JT DAMAGE

5' SEVERE  
H" TO TAPER

30' FAULTING

June 2015  
PATCH REPLACED  
WITH LARGER PATCH  
65' on Survey  
80' TOTAL

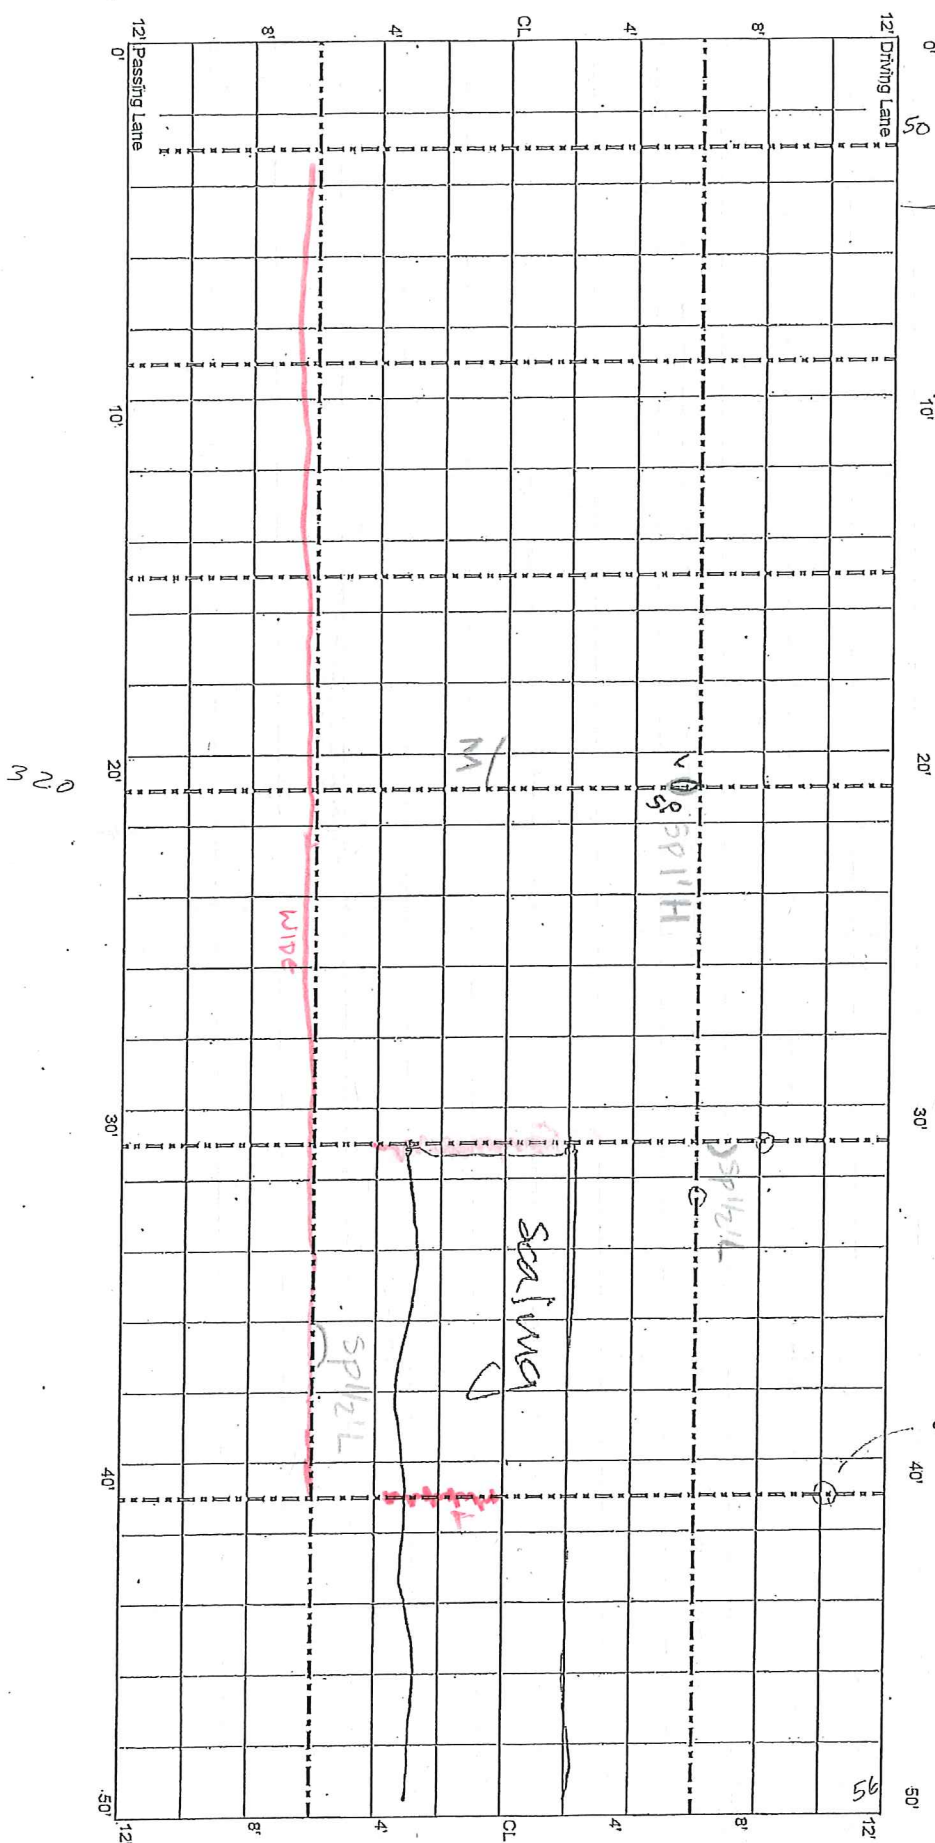
300 - 350 ft

CORE  
MISSING GRAVITY

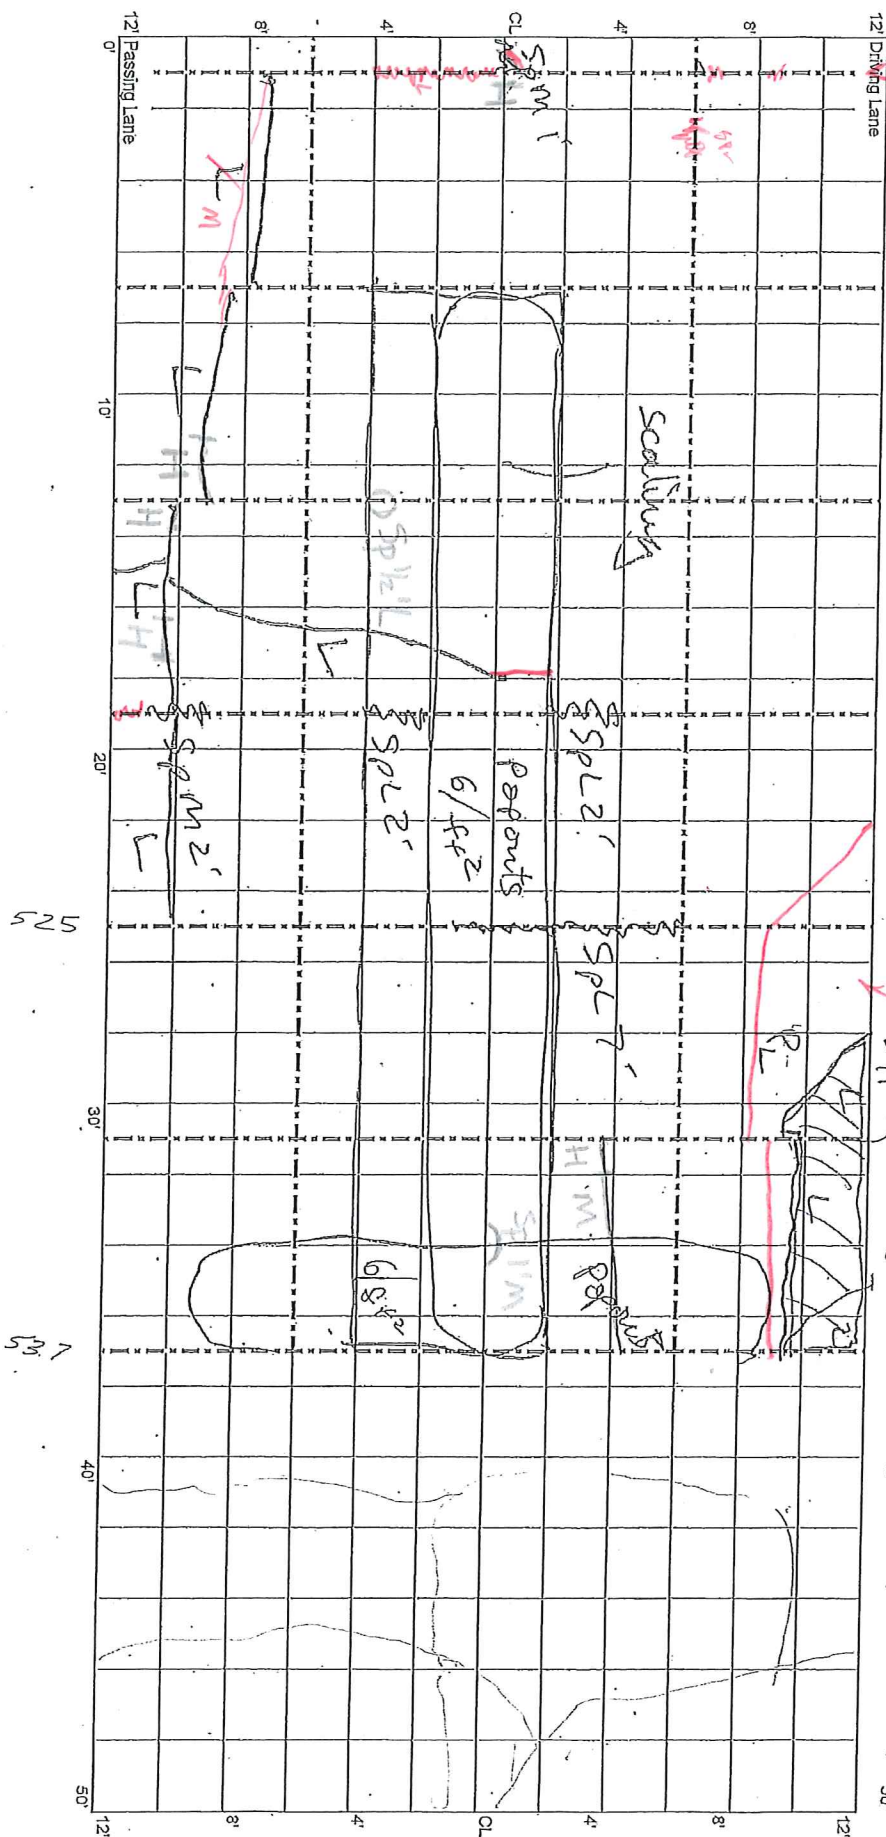
CELLS 614-814  
400 - 450 ft

Scalping

fault joint

cracked concrete  
MISSING 16" x 4"
