File ML13  
Cell 162

CELL 162  
0 - 50 ft

File ML14  
Cell 163

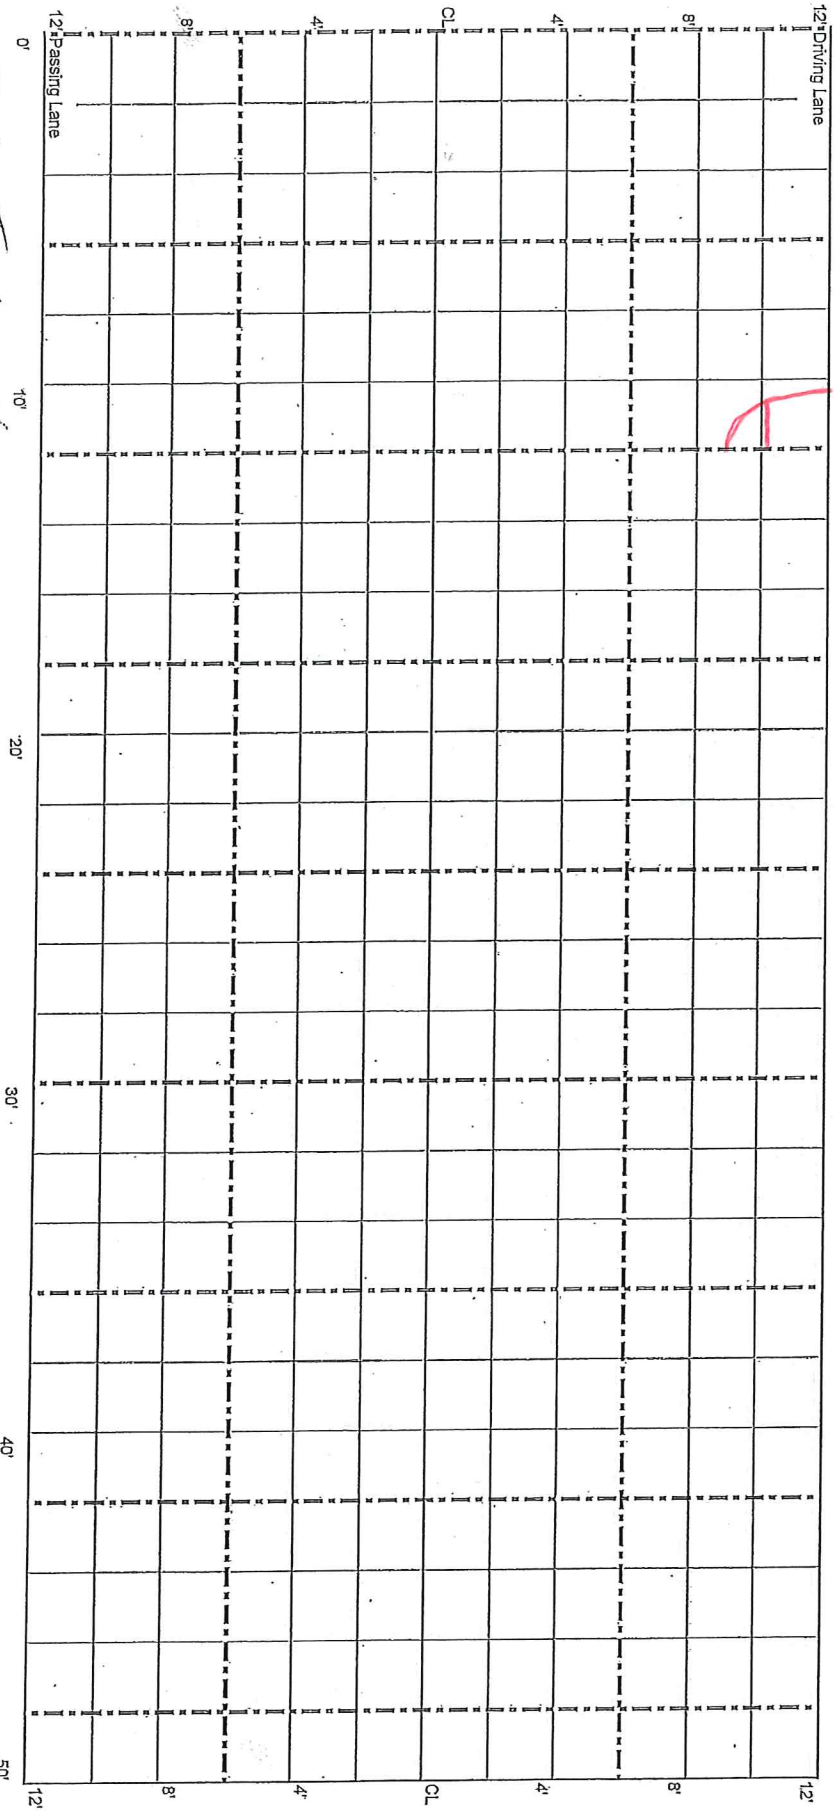
5/6/2014 DAY  
5/13/2015 R18  
All joints sealed.

10/27/2014 DAY  
winter cleaning  
near access ports  
in areas @ it 5100

10/6/2015 NDO REP  
5/16/2016 REP

Surface texture changes  
reported near  
no add'l distress

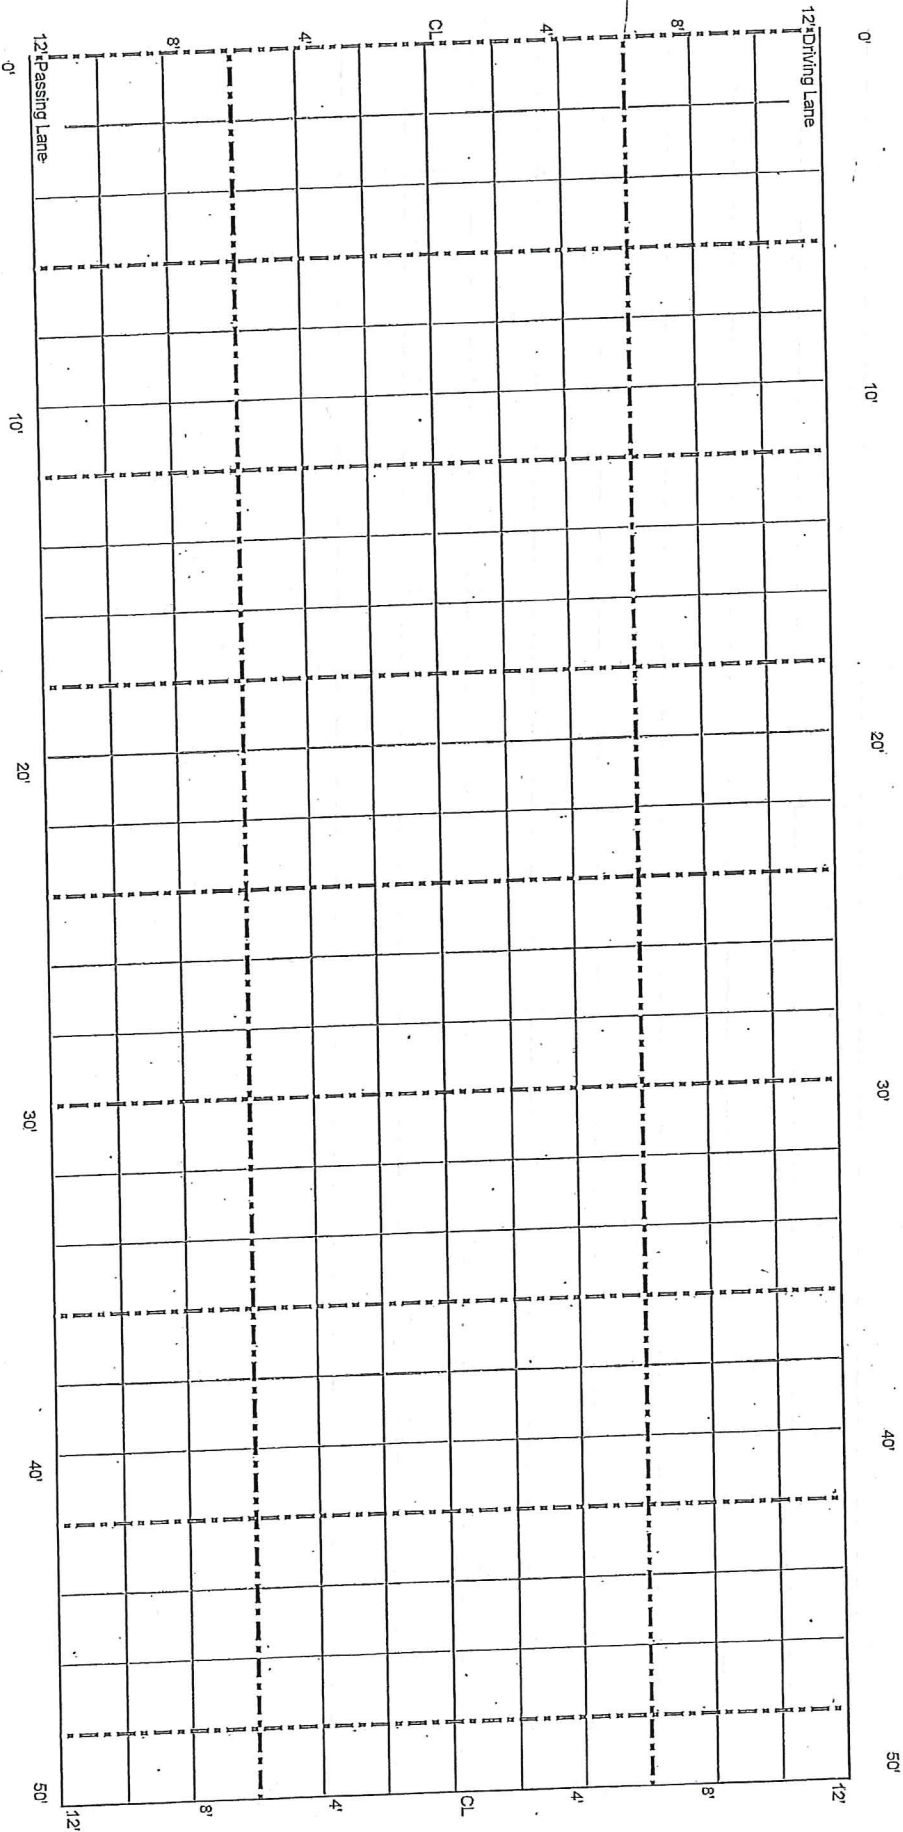
CELL 163  
0 - 50 ft

10/27/2014 DVV  
NO EXAMINED  
DISTRESS

NO DISTRESS. All JTs sealed.

10/6/2015 ASD JCP  
5/16/2016 LEP  
NO NEW DISTRESS
