File LV17

(Previous Survey 10/3/2012)

CELL 33  
0 - 50 ft

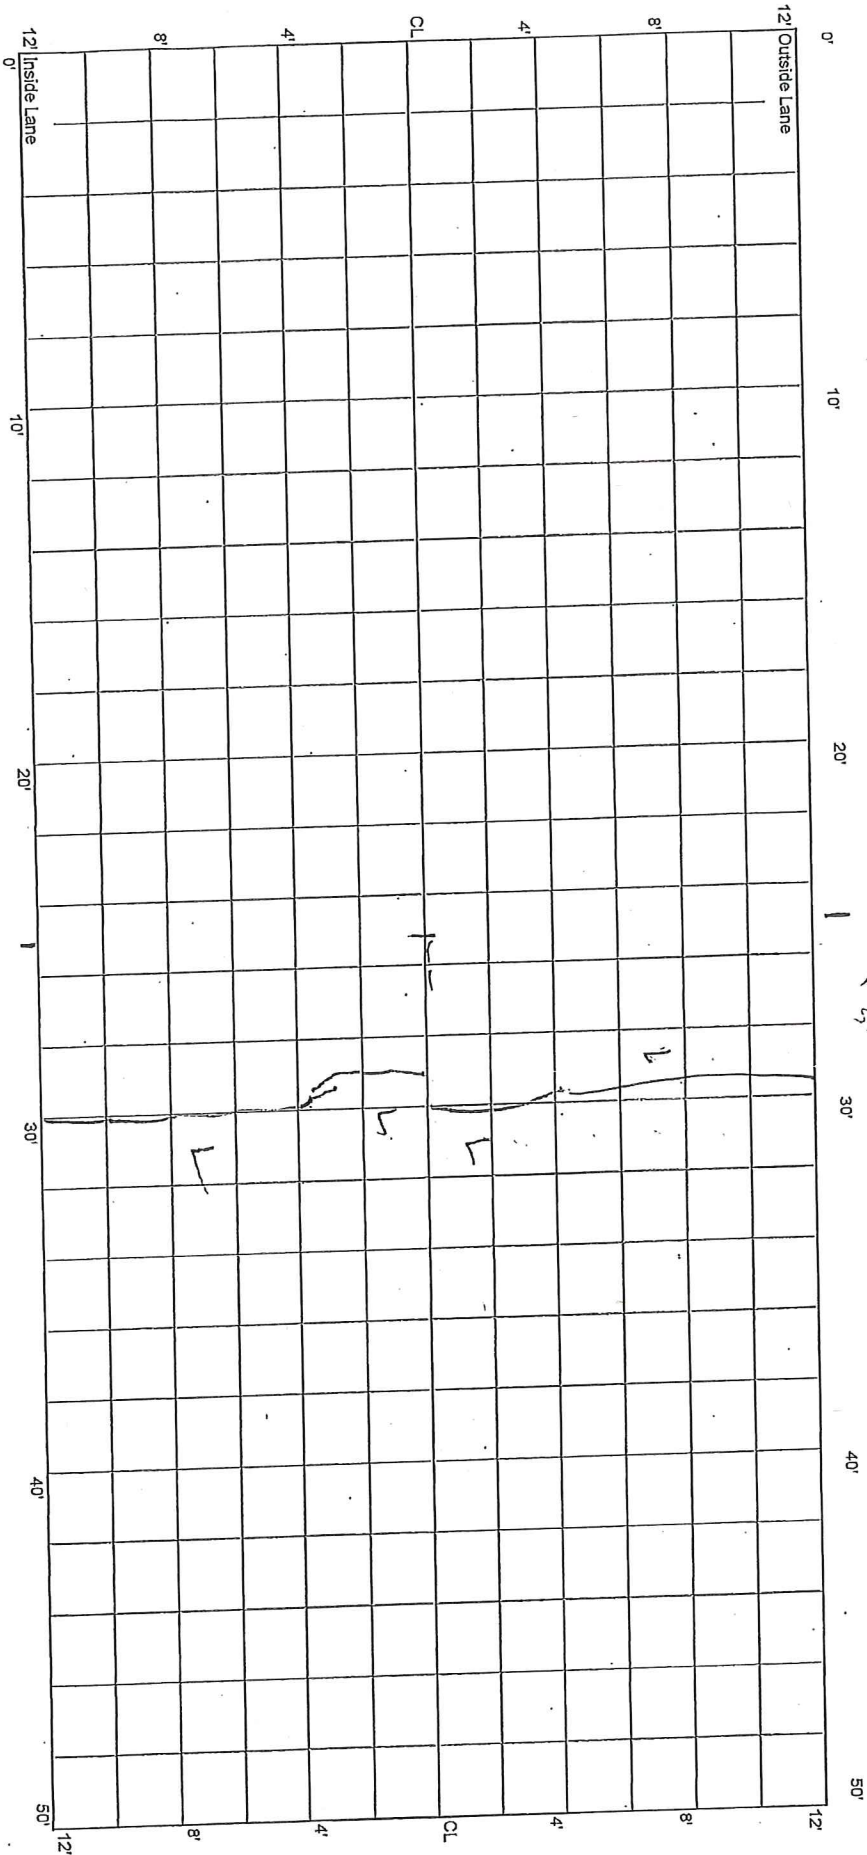
CELL 33  
100 - 150 ft

Centerline  
Rumblestrip  
Stops @ 65-00
