Cell 37  
0-50 ft

File LV21

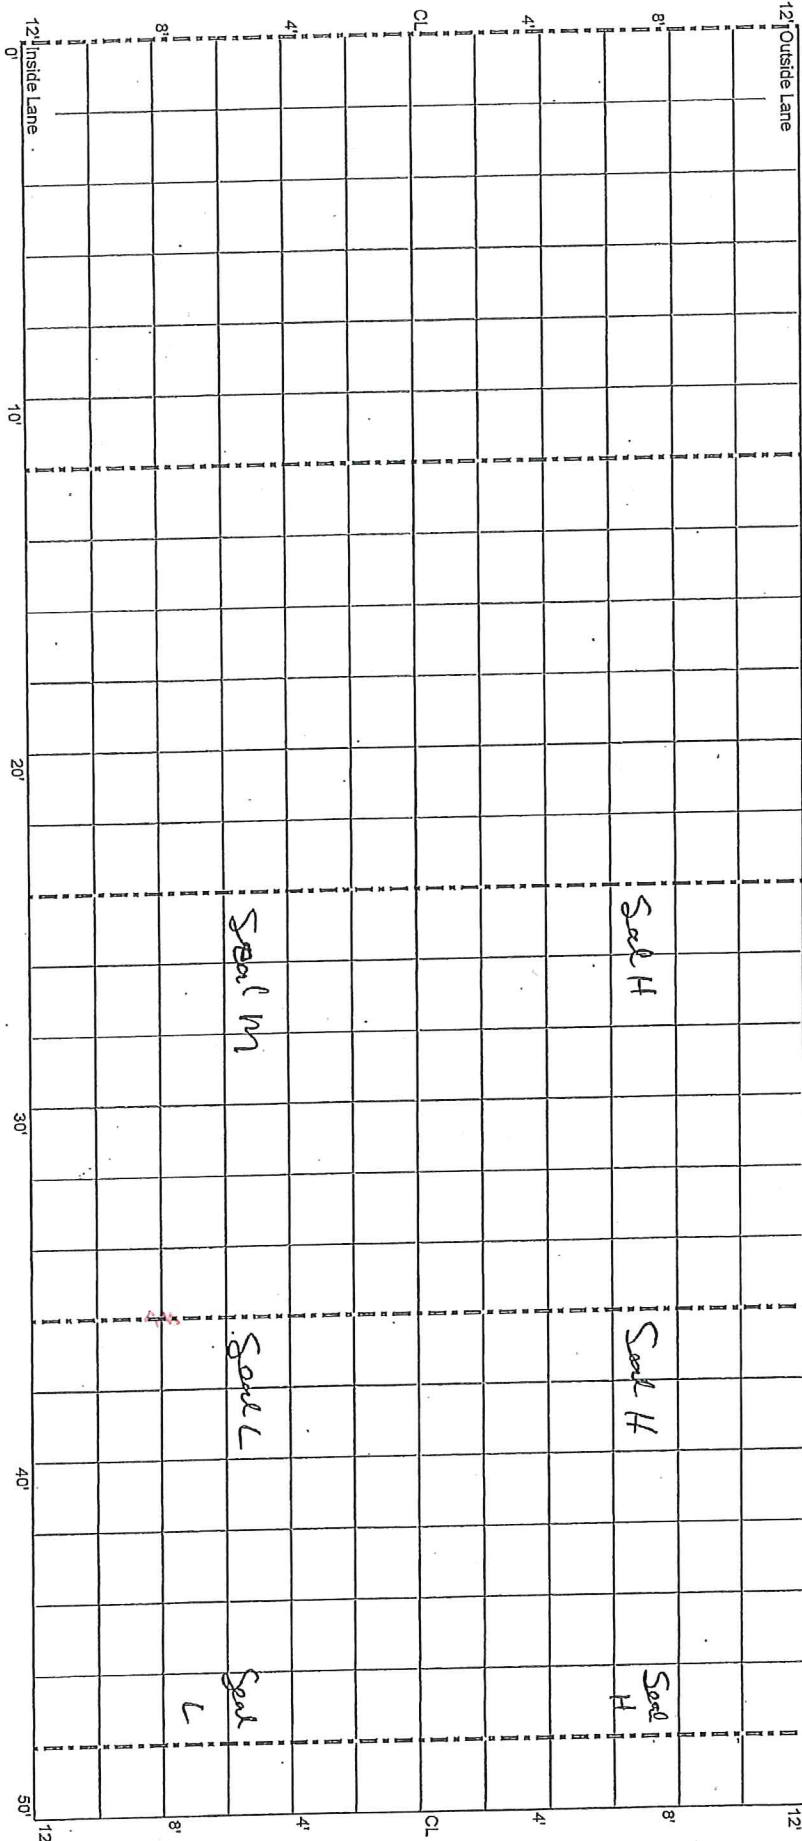
No New distress

Diamond grinding blew out  
sealant in Outside Lane
