CELLS 114-914  
0-50 ft

CELLS 214-314  
100 - 150 ft

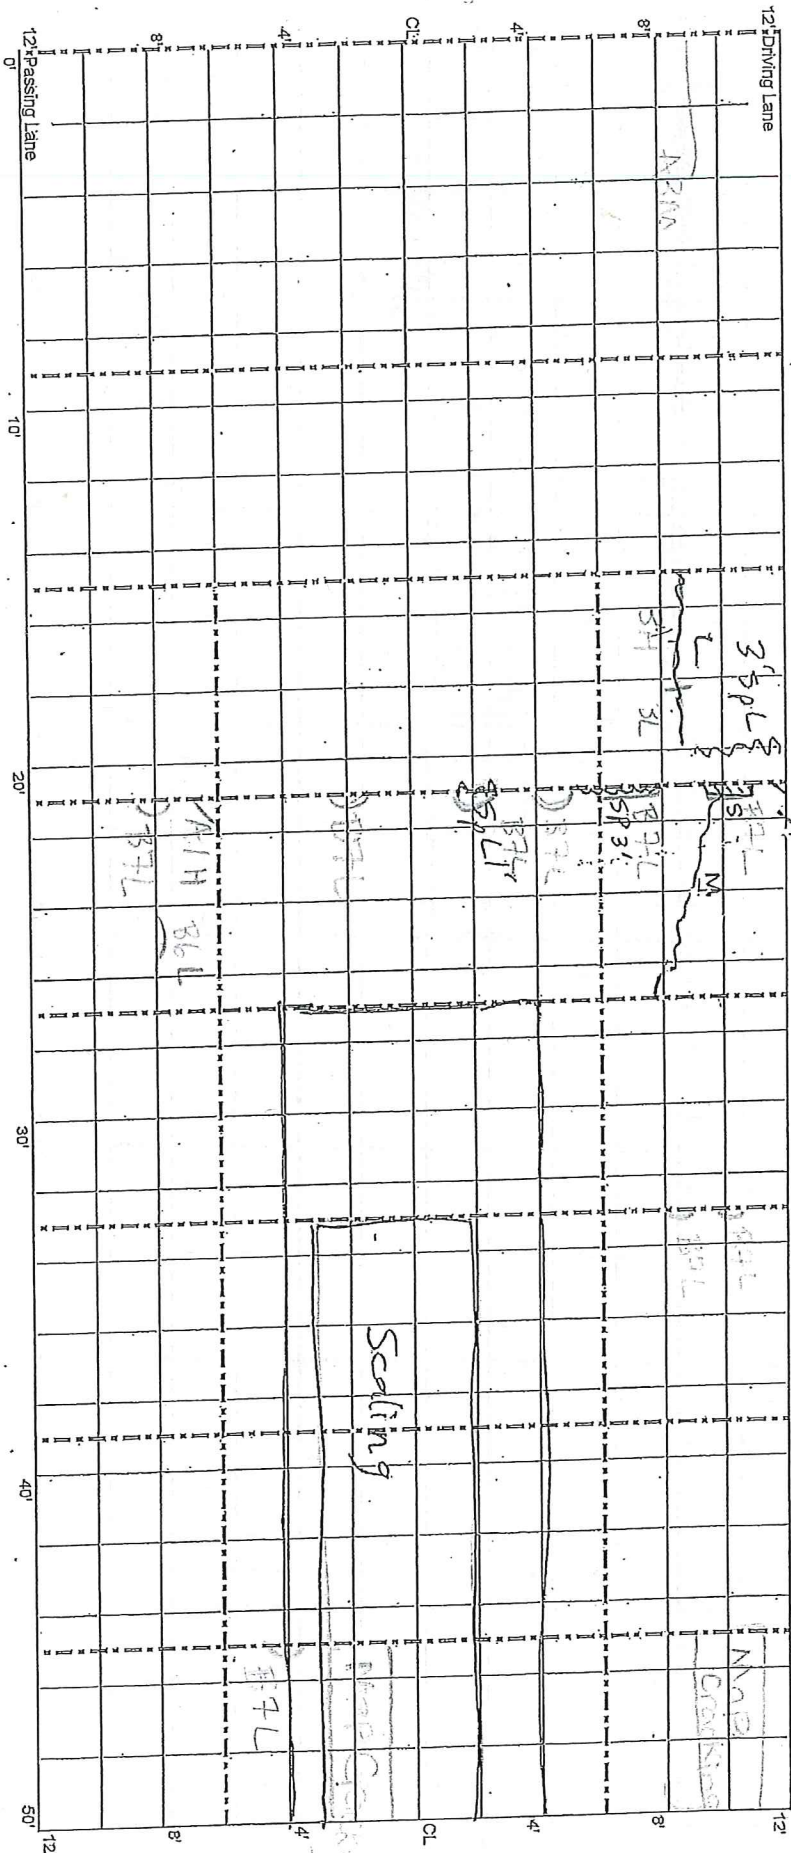
50 ft  
7/5/2016 AEI  
notable faulting throughout.  
-12/2015 R/R

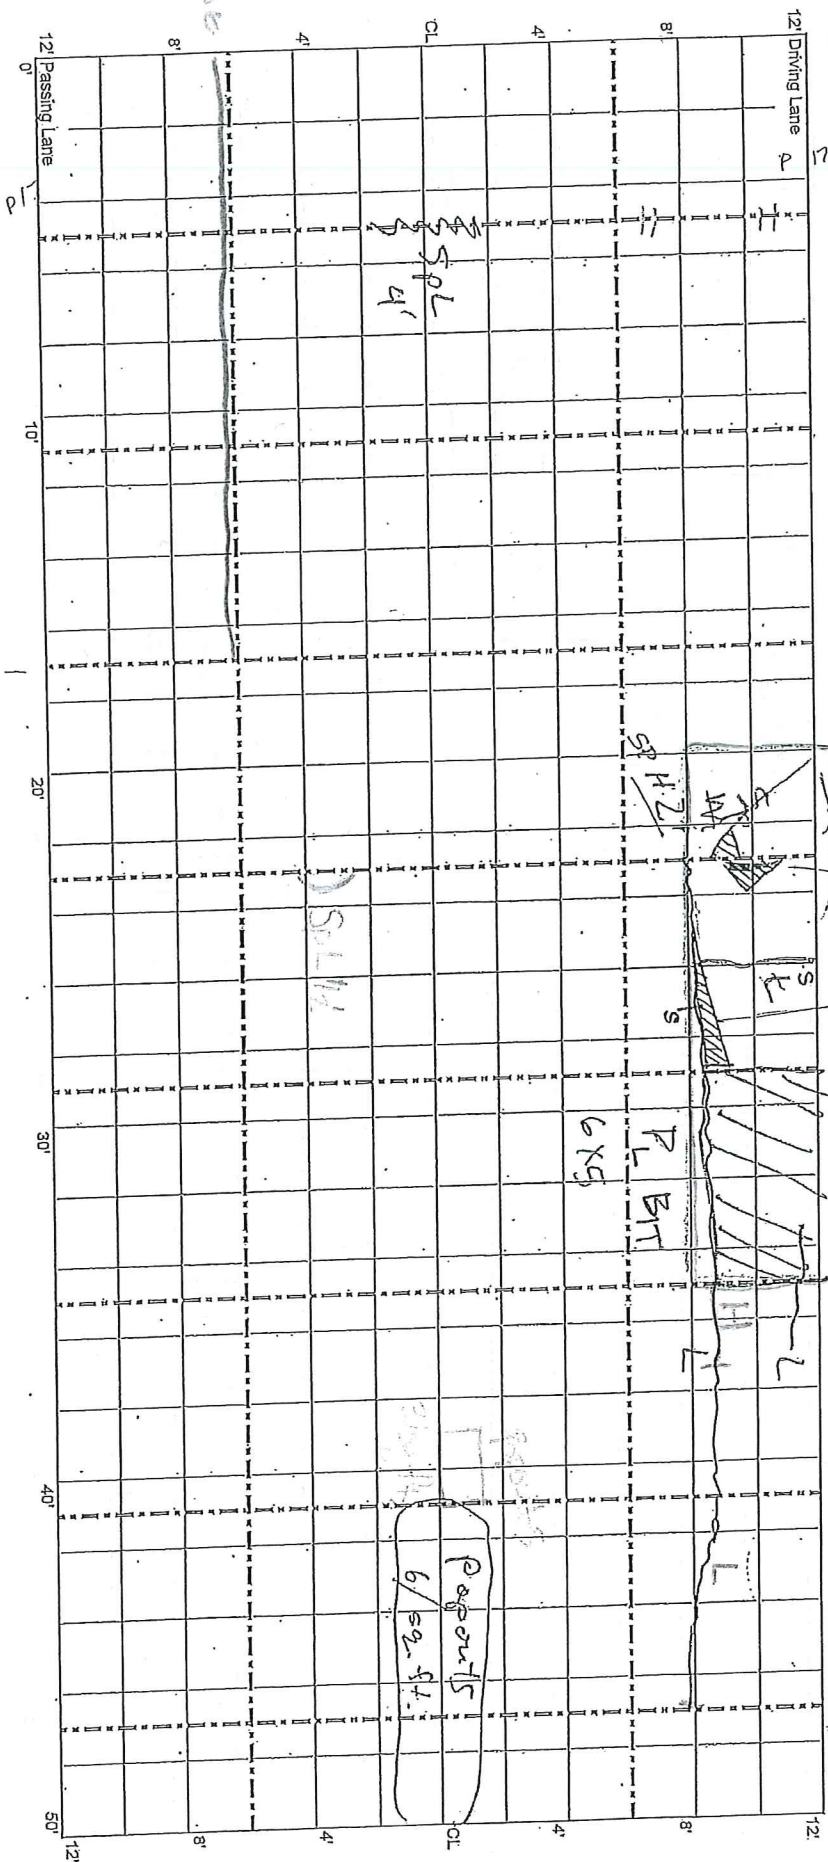
June 2015  
PATCH REPLACED  
WITH LARGER PATCH  
65' SQ on SURFACE  
80' TOTAL

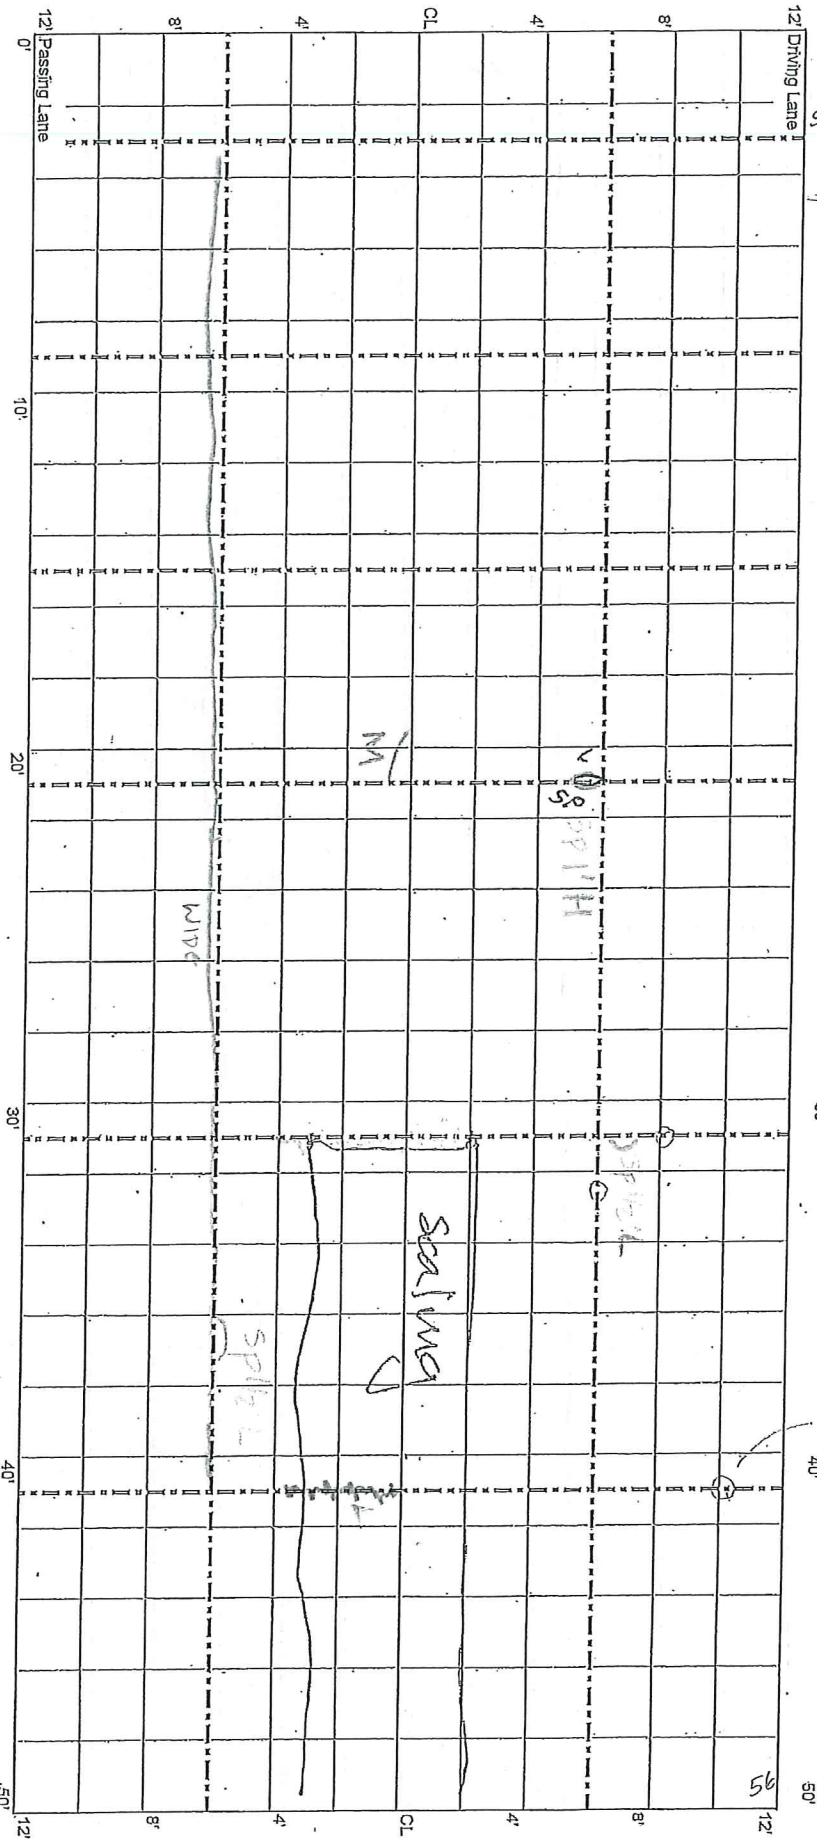
CELLS 514-614  
300 - 350 ft

core MISSING GROUT

cracked concrete  
missing 16" x 4"

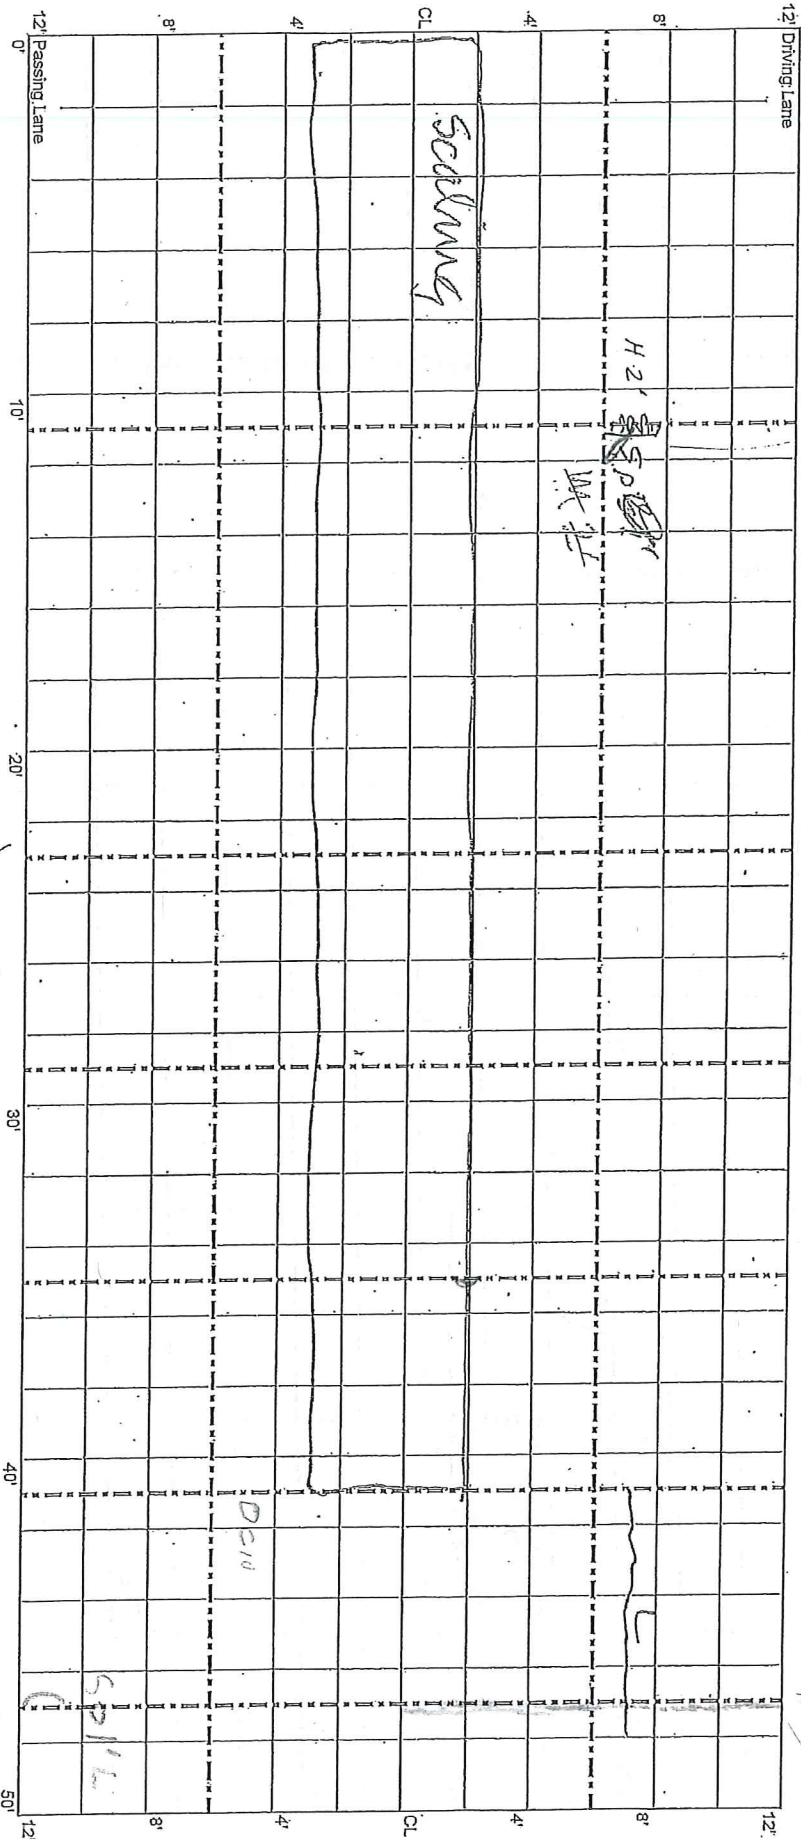
CELLS 614-814  
400 ~ 450 ft

FAULT
