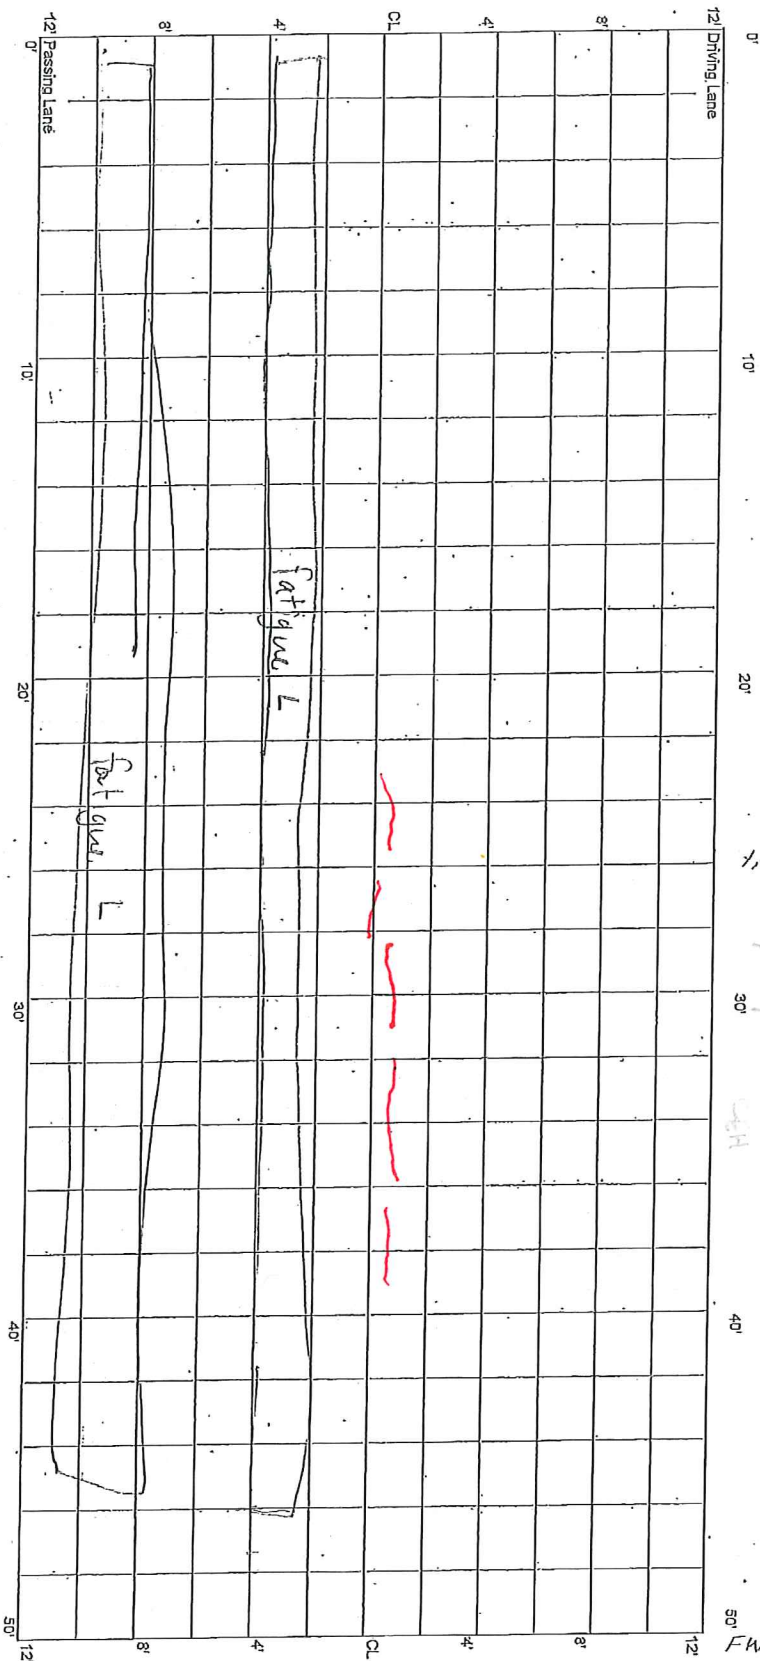
CELL 2  
50 - 100 ft

No distress in remainder of cell (100-500 ft)

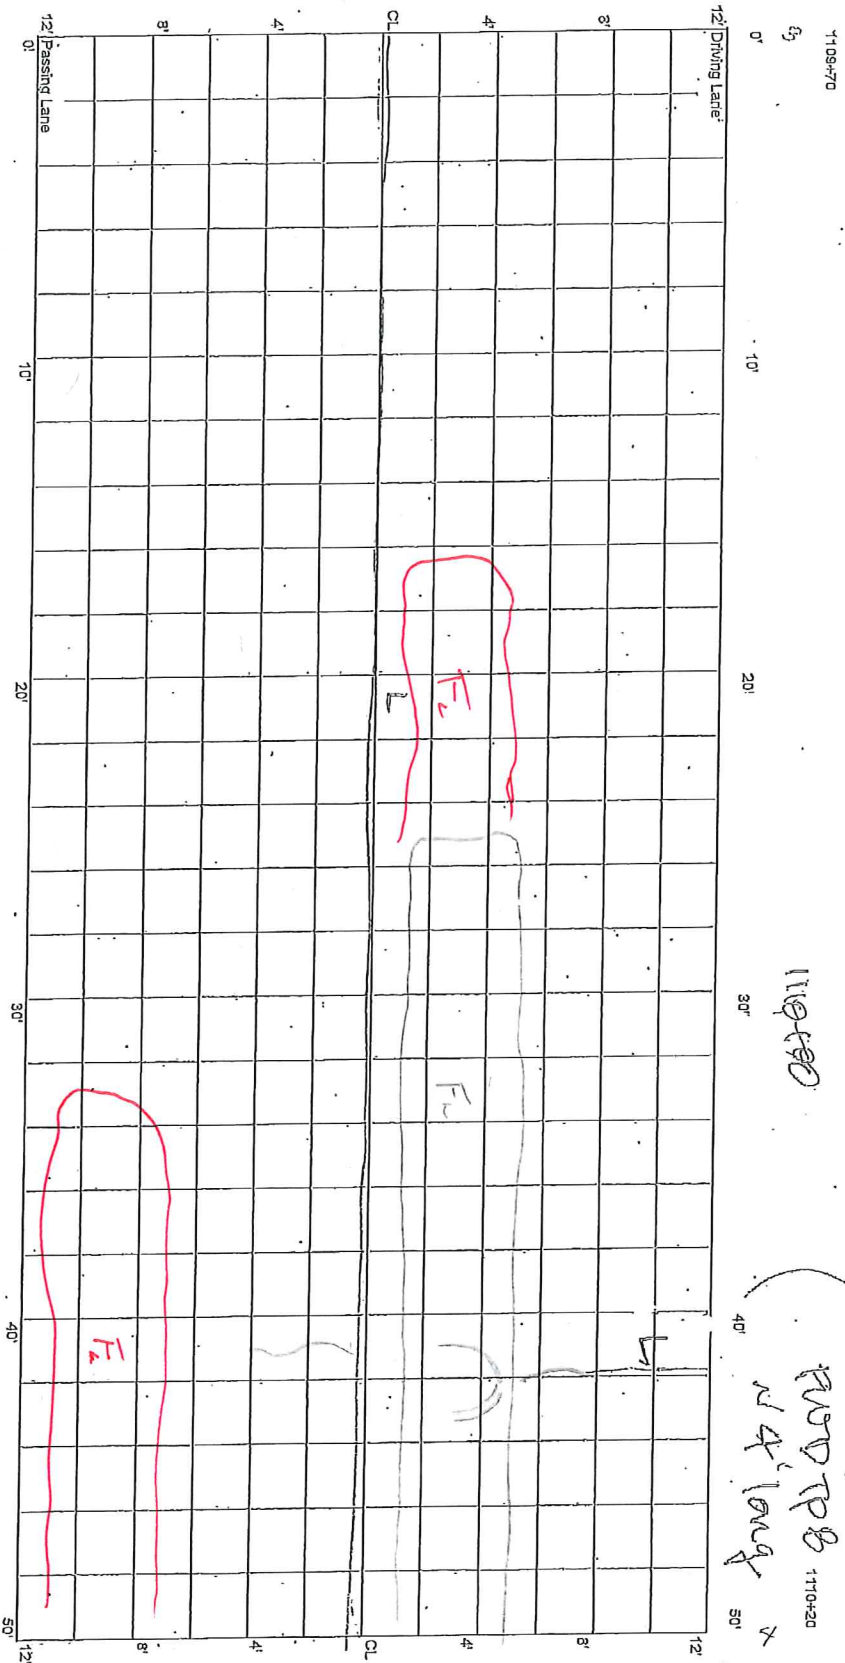
CELL 2  
100 - 150 ft

also similar  
check  
RVD TPB  
11/10/20  
14' long
