File LV21

Cell 37  
0 - 50 ft

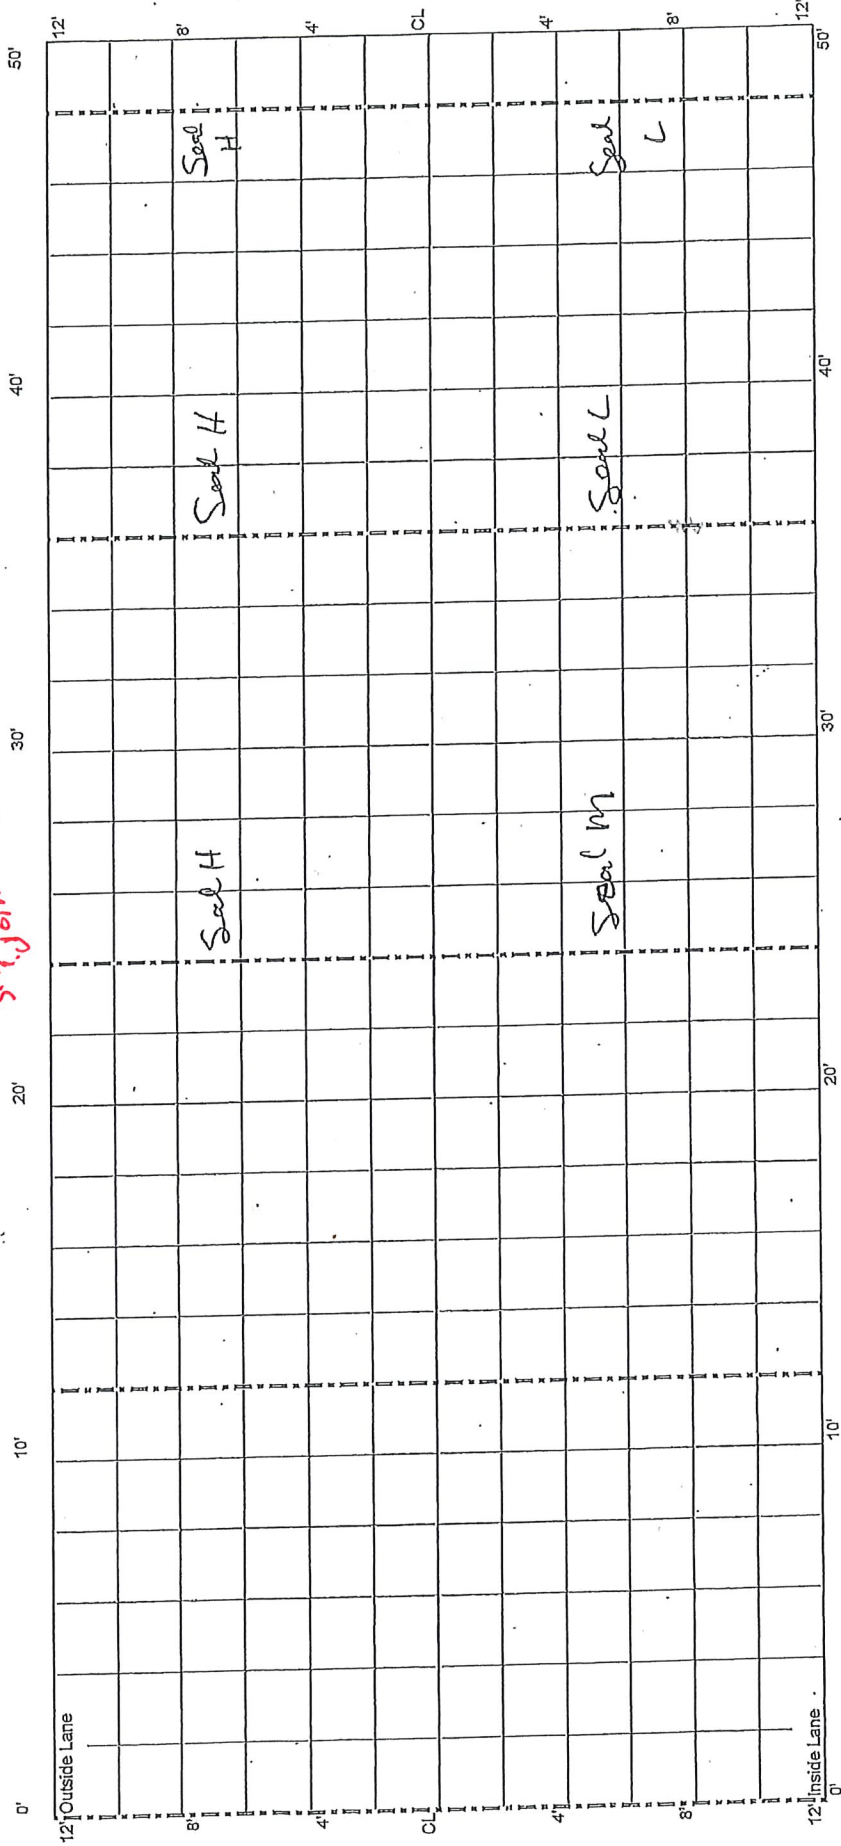
Diamond grinding blew out  
sealant in Outside Lane
