File LV10 11/17/2015 LEP

CELL 78  
0 - 50 ft

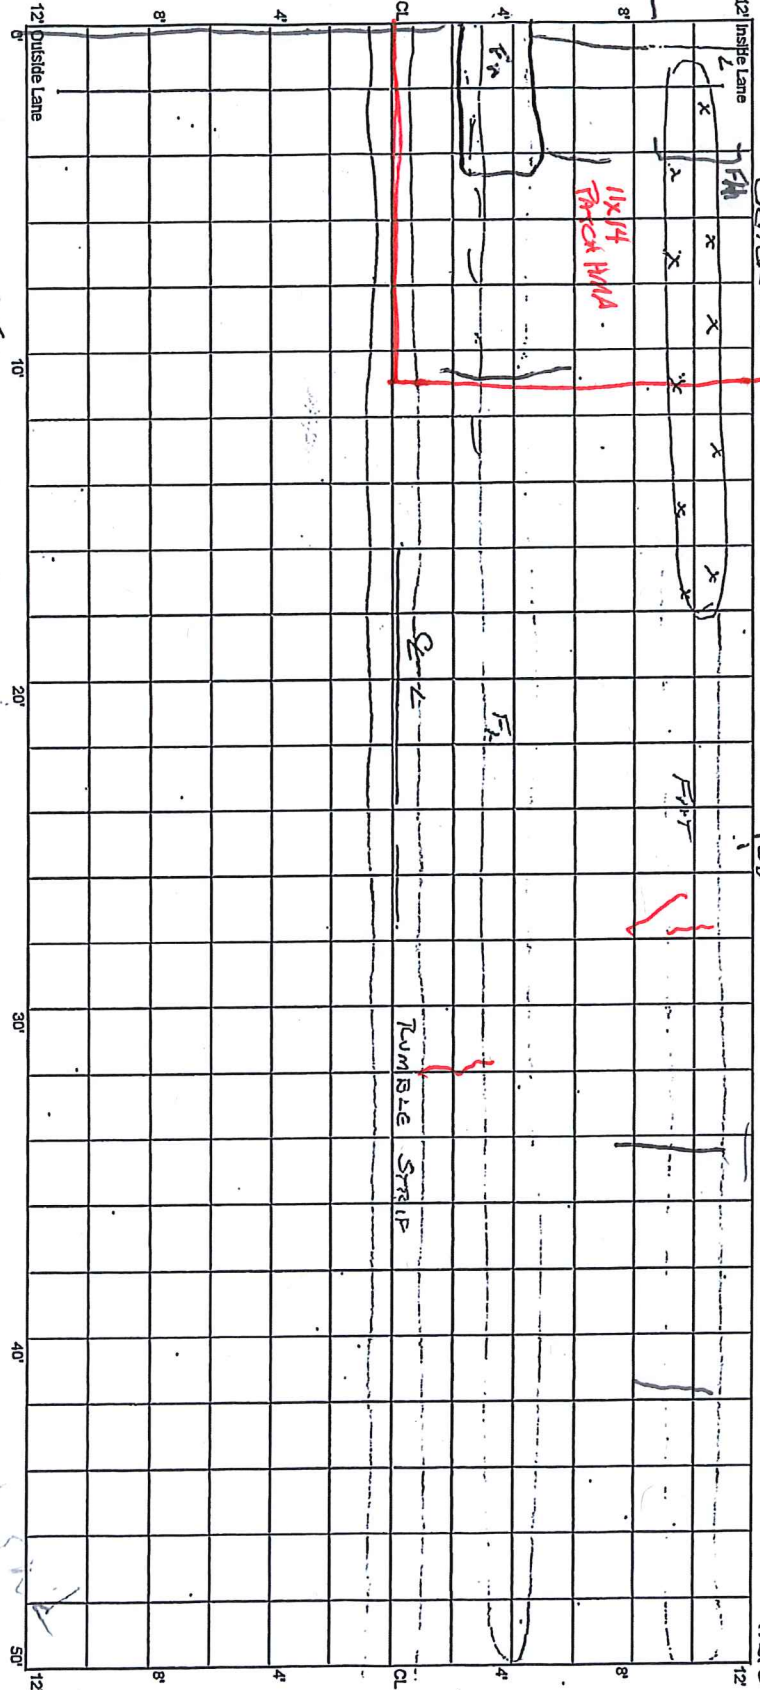
FRAGILE CRACKING

Vio. blc Putting ROUTE THROUGHOUT ENTIRE CELL

texture  
oxidation fines  
+ loss of

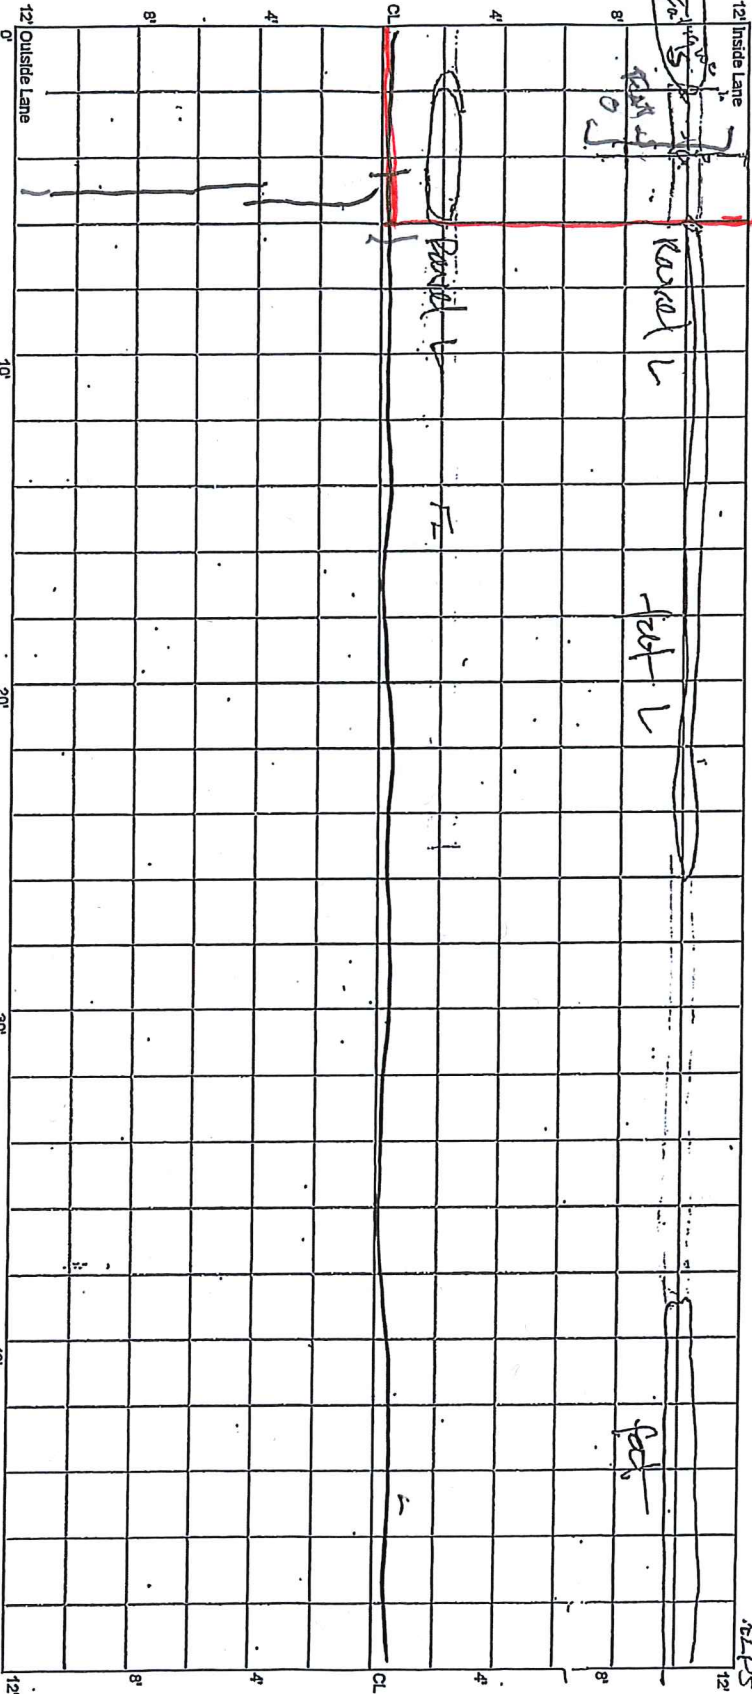
CELL 78  
100 - 150 ft

6x14  
4x14  
72

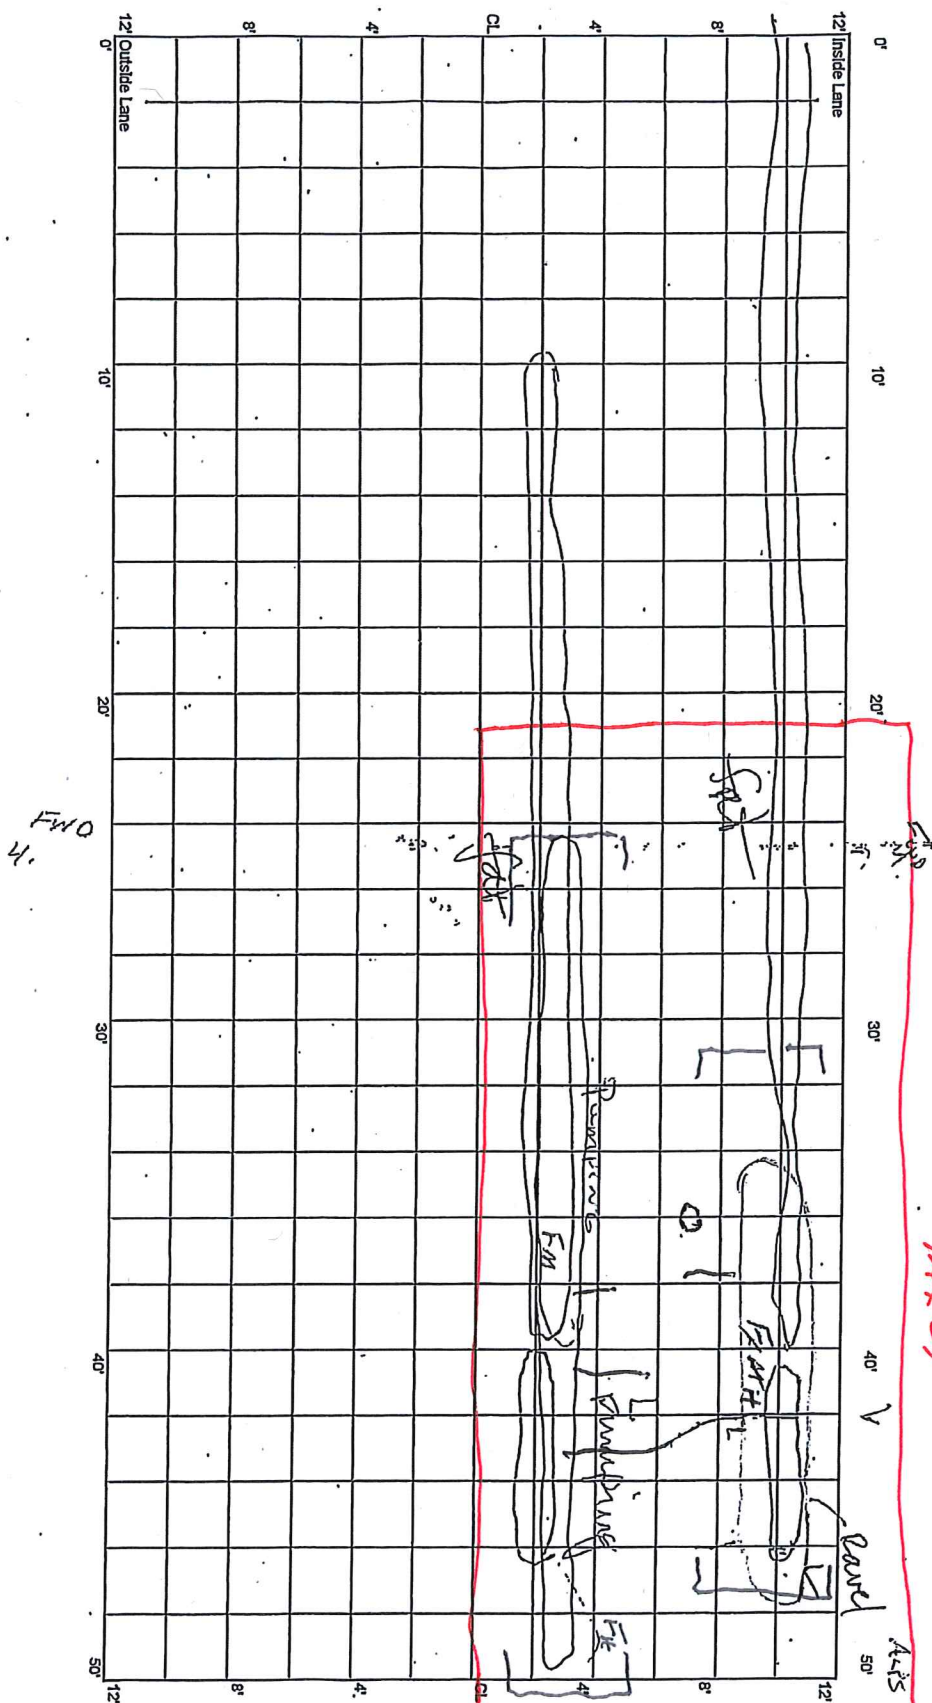
CELL 78  
150' x 200 ft

HMA Patch  
14 x 29

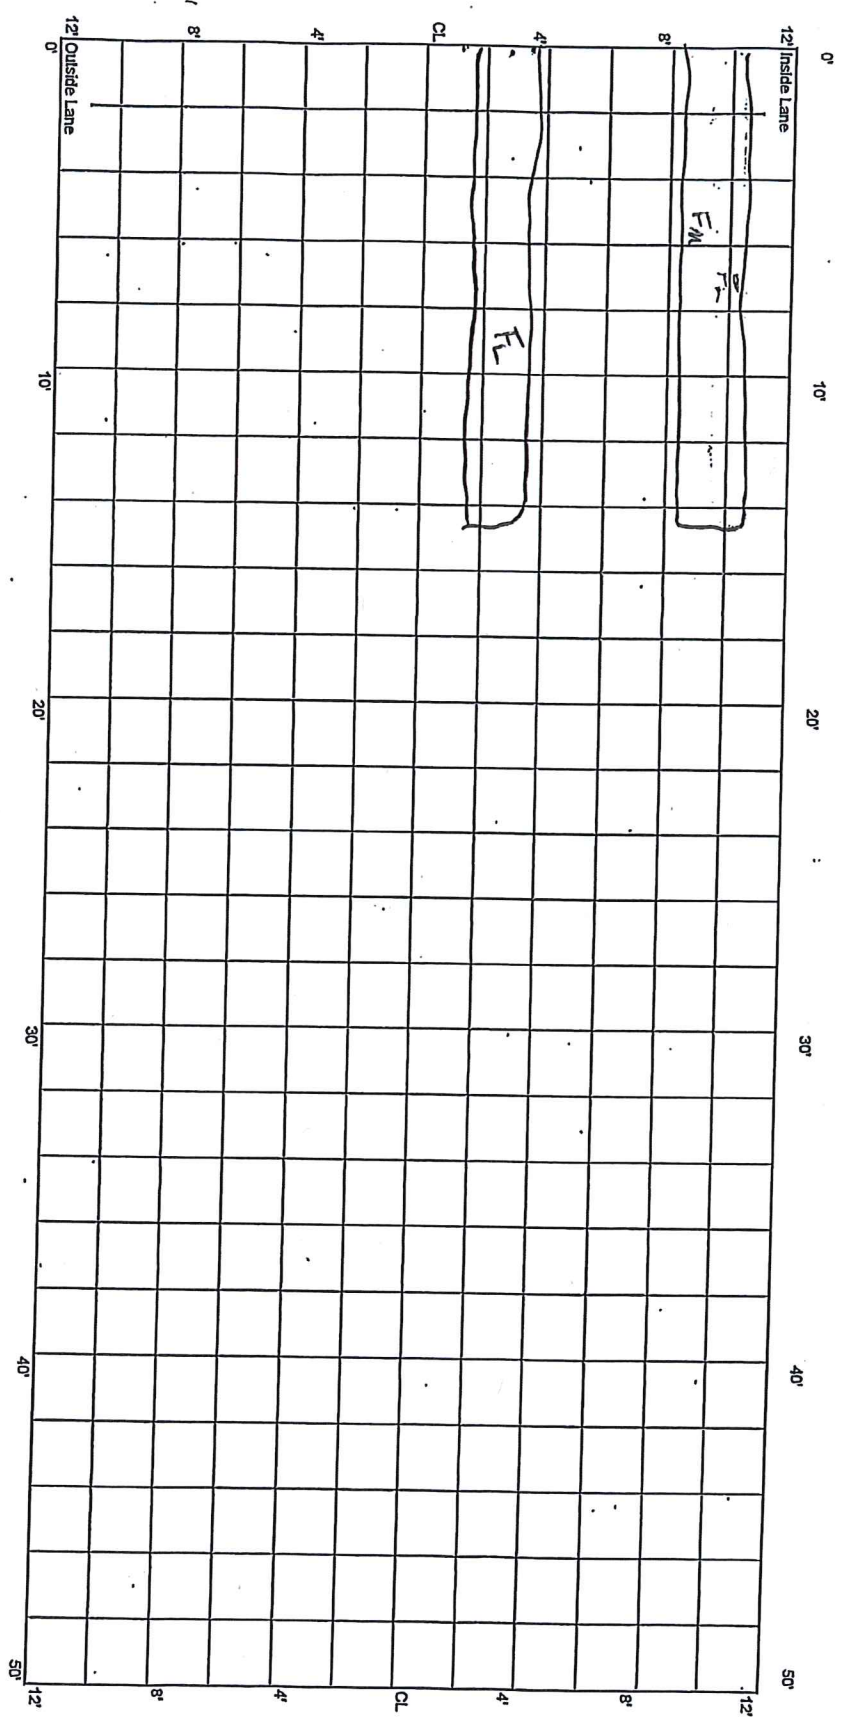
CELL 78  
350 - 400 ft

ENTIRE CELL IS ROTTED  
IN BORN WHEEL PATHS
