# Preliminary Evaluation of LTPP Continuously Reinforced Concrete (CRC) Pavement Test Sections

PUBLICATION NO FHWA-RD-99-086

1999

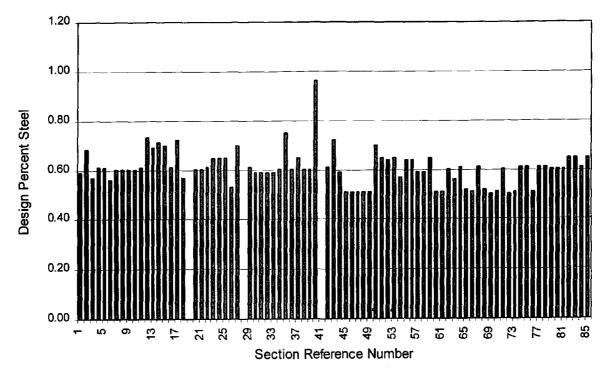
Figure 4. Design percent longitudinal steel.

- 2. Most sections have 0.62 percent or less longitudinal steel. Only 10 sections had steel equal to or greater than 0.7 percent. Fifteen sections had steel equal to or less than 0.5 percent.
- 3. Depth of longitudinal reinforcement was generally greater than 75 mm.
- 4. Spacing of longitudinal bars was generally more than 150 mm.
- 5. Where transverse bars were used, bar spacing was generally greater than 600 mm.

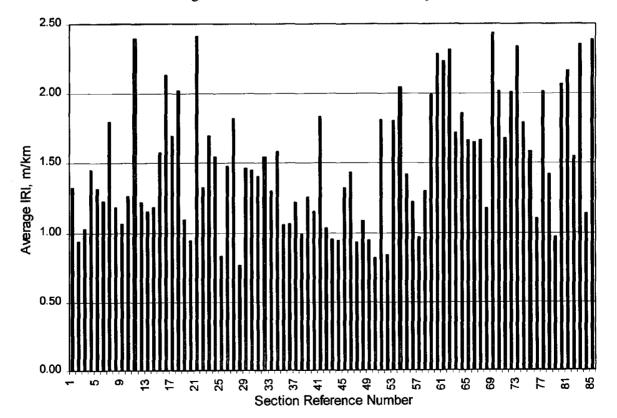
Figure 12. Average IRI summary.

International Roughness Index (IRI) is one of the indices used in the LTPP program for characterization of pavement section roughness. IRI values determined at different test times over the years are available in the database. Values at times that correspond to the latest distress survey dates were used for characterization of profile condition of pavement sections. A summary of IRI data is given in table 5 and figure 12. The IRI values for GPS-5 sections ranged from about 0.7 to 2.4 m/km, with a large number of sections exhibiting IRI values less than 1.8 m/km. Considering the service lives of the CRC sections in the GPS-5 experiment, the CRC pavements are exhibiting good ride characteristics.

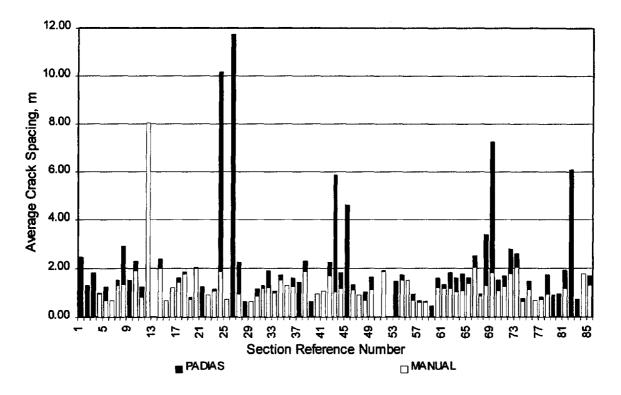
Figure 13. Average crack spacing.

Average transverse crack spacing was calculated by dividing the length of the section by the total number of cracks. The total number of localized failures was found as a summation of the total number of rigid and flexible patches and punchouts. Table 5 gives a summary of GPS-5 distress survey data. Generally, PADIAS surveys predicted larger crack spacings compared to the manual survey, as shown in figure 13. The crack spacing shown in figure 13 is based on the most recent surveys listed in table 5. Overall, the average crack spacing for the GPS-5 test sections was found to be about 1.2 m (4 ft) based on manual surveys. It appears that the photographic procedure fails to adequately identify all low-severity transverse cracking.

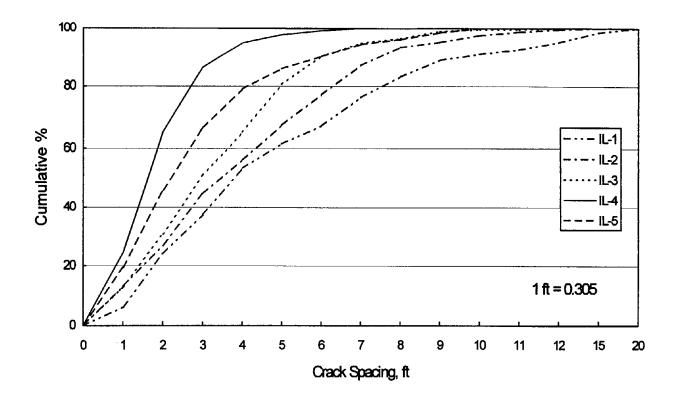
Figure 14. Typical crack spacing distribution plot for a CRC pavement<sup>3</sup>.

Another data type that is currently not available is the data on individual crack spacing. Without this data, analysis of the characteristics of the crack spacing pattern is not possible. Previous studies have shown that frequency distribution curves for crack spacing and plots of "average spacing of the closest five cracks" (ASCFC) can be useful in understanding the behavior of CRC pavements and in determining potential areas of future localized failures. The ASCFC plots can identify poor crack spacing patterns within a section of CRC pavements. Cluster cracking areas and areas with large crack spacings can be easily identified. Wide crack spacing can result in premature crack spalling and "companion" punchouts at the location of wide cracks. Typical frequency distribution curves and the plots of ASCFC are shown in figures 14 and 15. It is believed that in the future, the interpretation of distress data will also include data on individual crack spacing along the 152.4-m length of each GPS-5 test section. Future analysis of the CRC pavements will also benefit if actual distress survey maps are made available to the analysts. Then it would be possible to relate the locations of the failures to crack spacing characteristics at these locations.

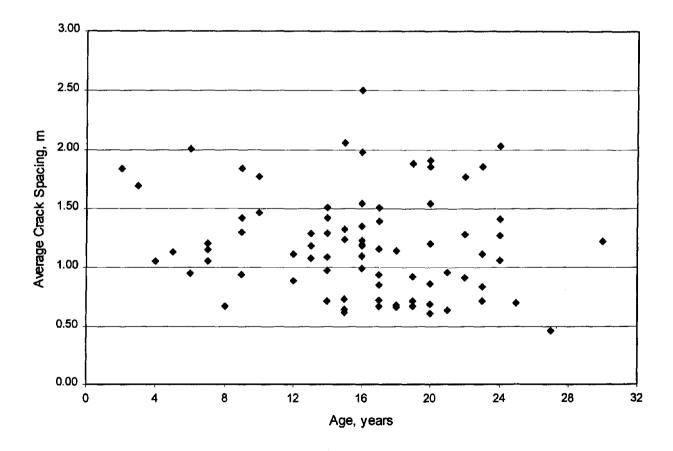
Figure 16. Crack spacing versus age.

It is seen from a review of figures 16 through 27 that no clear trends are evident on the basis of bi-variate analysis of the data. The long-term crack spacing pattern, as represented by average crack spacing, is dependent on the interactions of possibly all of the independent variables considered together with the ambient conditions during the first few days of construction. As such, an understanding of the effect of the variables noted would have to consider the interactions and the confounding effects of each of the variables. One method to account for these effects is to use multiple regression analysis. A limited effort was made to determine if robust explanatory models could be developed for crack spacing using linear regression analysis. However, the results were not promising (low coefficient of correlations) and no further effort was devoted to this activity. Use of empirical analysis was not part of the scope of the study and the results are therefore not reported here.

Figure 16 – Crack spacing versus age.

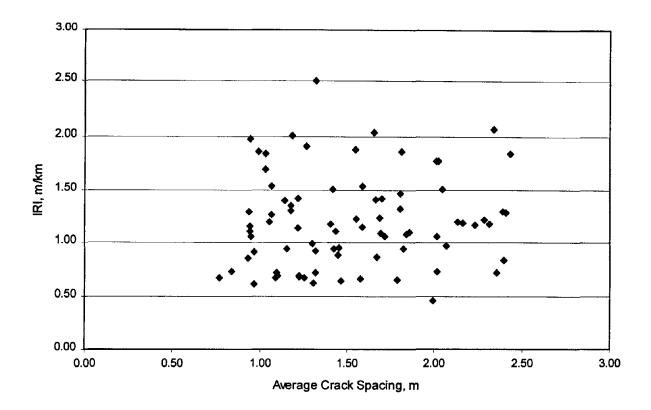
Figure 28. Effect of crack spacing on IRI.

The effect of transverse cracking on ride is shown in figure 28. No clear trends are apparent. This is possibly due to not considering the influence of initial roughness. It should be noted that previous studies have indicated that initially smooth (as-constructed) CRC pavements generally remain smooth, and rough (as-constructed) CRC pavements tend to become rougher with time.

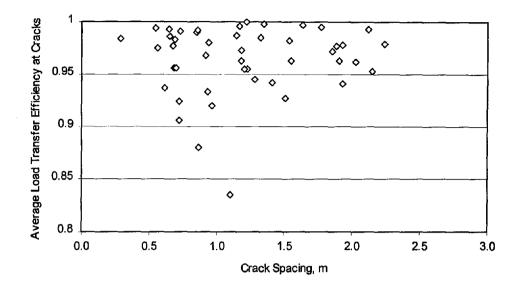
Figure 29. Average load transfer efficiency at cracks versus crack spacing.

To determine the relationship between crack spacing and deflections as measured by the falling-weight deflectometer (FWD), average crack spacing was plotted versus load transfer efficiency and the ratio of the edge deflection and the corresponding interior deflection for sections having FWD data in the database, as shown in figures 29 and 30, respectively. No clear trends in the data can be observed. It is seen that most of the sections exhibited load transfer efficiency at cracks of 90 percent or more. The ratios of the edge deflection and the corresponding interior deflection ranged from 1 to about 2. The variability within the range is possibly due to the time of testing (curling effects), slab warping effects, and the type of shoulder.
