Construction Report for Wisconsin SPS-1

**SPS-1 Construction Report
STH 29, Westbound
Marathon County, Wisconsin
0.5 Miles East of Hatley, Wisconsin**

Sections 550113 to 550124

**Federal Highway Administration
LTPP Division
North Central Region**

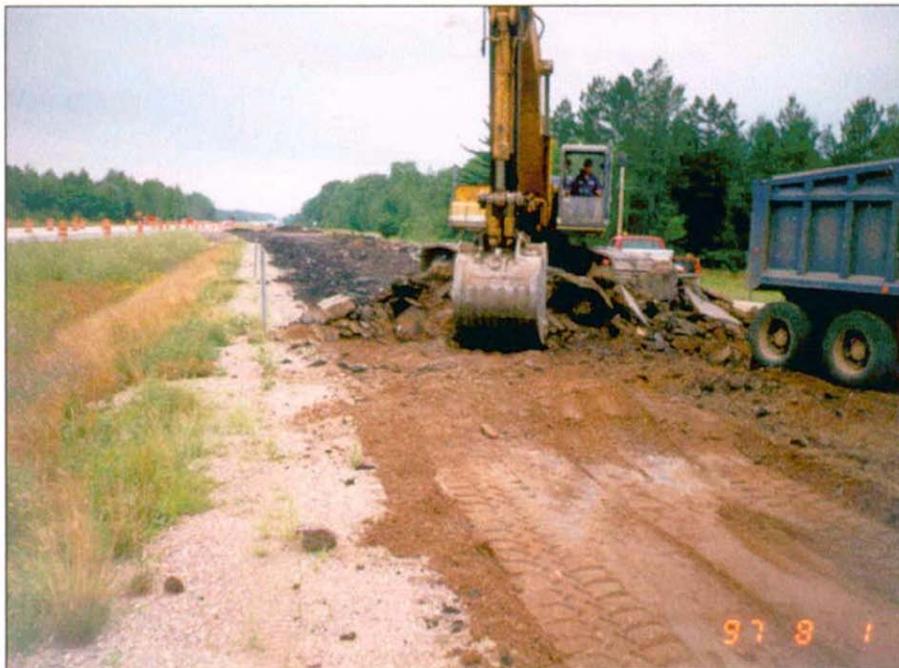
Figure 1. Asphalt removal process using backhoe.

Before removing the existing pavement, Falling Weight Deflectometer (FWD) tests were performed over the sections. This test provided proof of the relative strength of the subgrade. Removal of the existing pavement for this project began in early July 1997. Subgrade preparation followed shortly thereafter. Paving operations were completed by mid-October 1997. When sampling using shelly tubes, remnants of old PCC pavement were found in the subgrade. PCC slabs were removed and subgrade was reworked to bring it back to the required elevation. Figure 1 shows a backhoe removing the existing pavement.

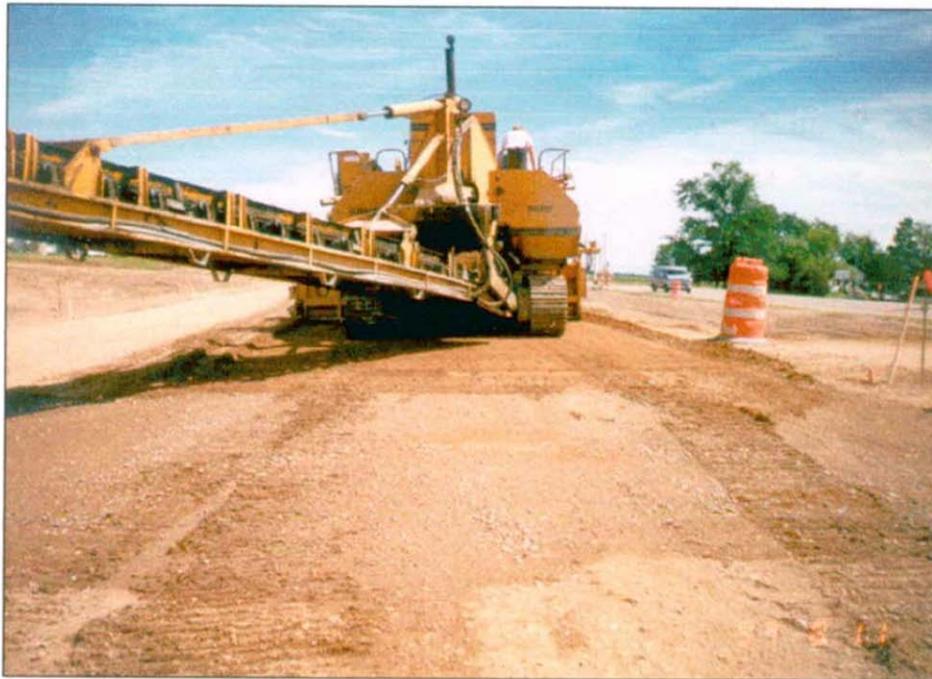
Figure 2. Dense graded aggregate base trimmed using base trimmer.

Preparation of the DGAB layer was performed in August 1997. An 8-ton single drum vibrator roller was used for compaction. Lift thickness ranged from 4 to 6 in, depending on the desired thickness of the layer. When a 12 in DGAB was desired, two lifts of 6 in were typically used. A base trimmer was used to maintain the desired elevation and to trim the excess off the top of the DGAB as shown in figure 2.

All sections dense graded aggregate base layers cut to grade using a base trimmer with an allowable tolerance of 3/4 in

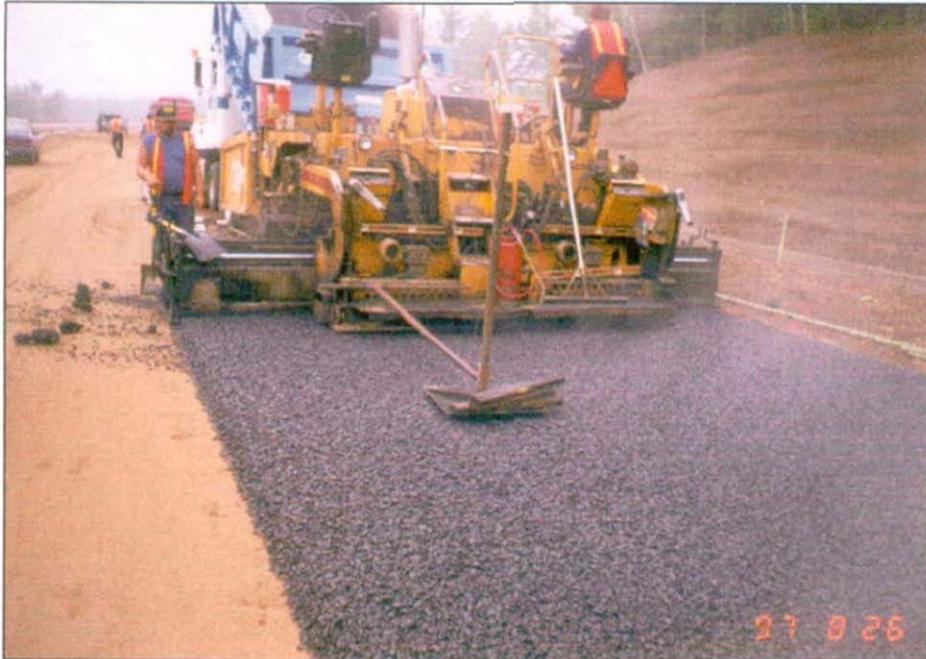
Figure 3. PATB layed using Blaw Knox (PF-172) paver.

The asphalt for the PATB and the ATB was obtained from the Mosinee Drum Mix Plant located 22 miles (30 minutes) from the site. The PATB and ATB layers were paved using a Blaw-Knox model PF-172 paver, as shown in figure 3, with a single pass laydown width of 12.0 ft.

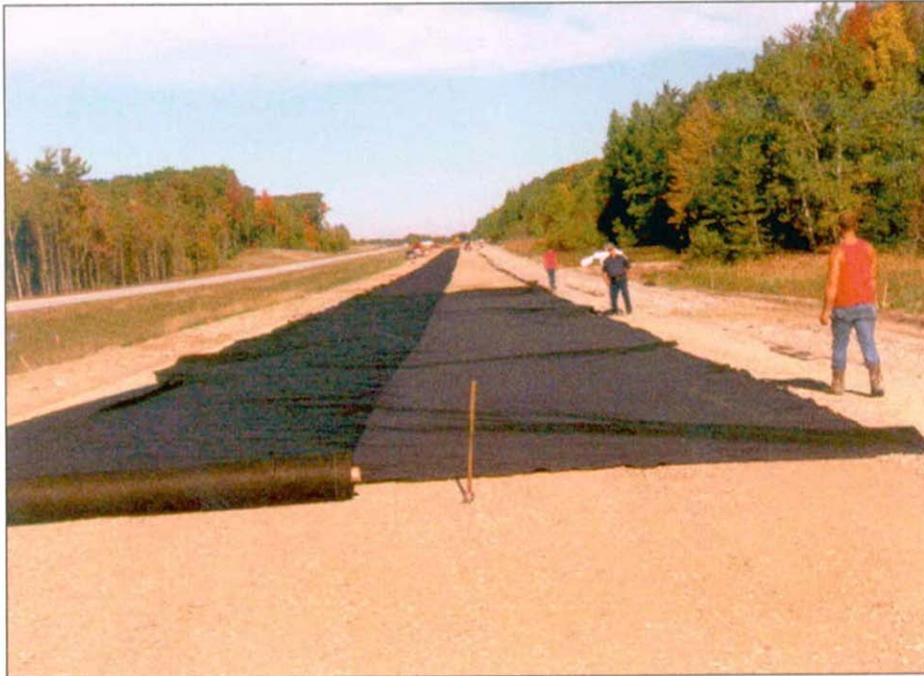
Figure 5. Layout of woven geotextile.

In sections 550122, 550124, and 550123--where the PATB layer was located directly above the subgrade--a woven geotextile fabric was placed immediately below the PATB. This geotextile conformed to ASTM D4354 and was installed according to the manufacturer's specifications. Figure 5 shows the geotextile fabric and the overlap between the 2 lanes.
